Loss of control and collision with terrain involving Cessna 172, VH-EWE

near Moorabbin Airport, Victoria, on 8 June 2018

ATSB Transport Safety Report
Aviation Occurrence Investigation
AO-2018-048
Final – 24 April 2020

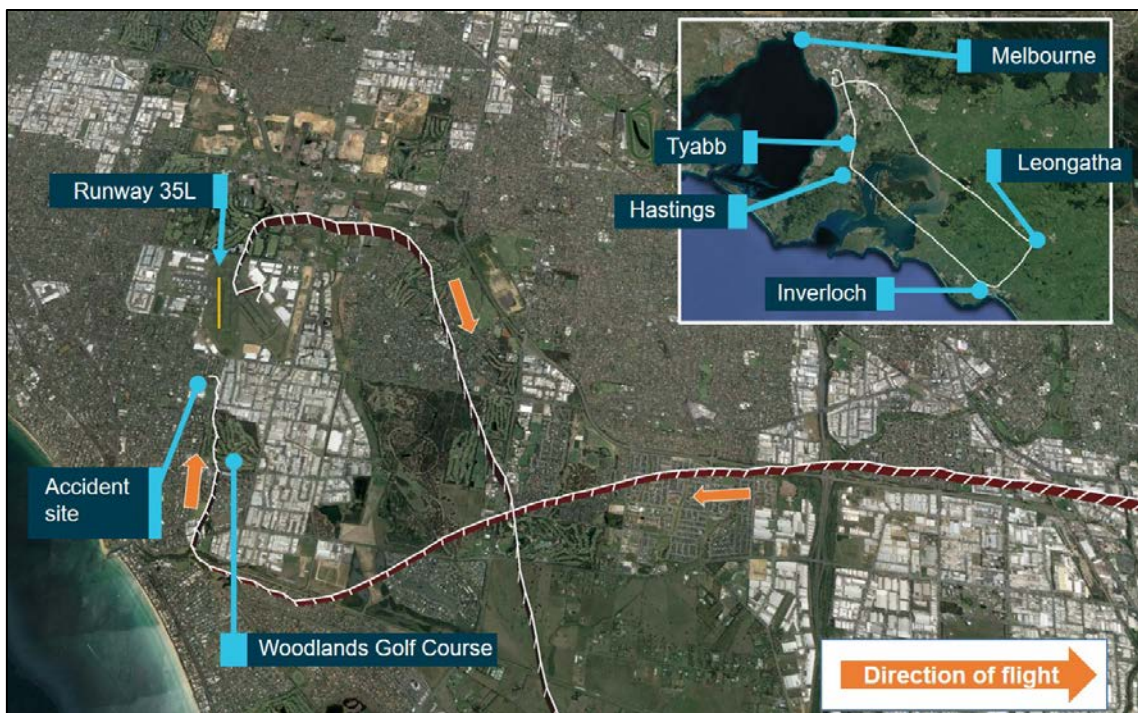
Figure 1: VH-EWE flight path

The aircraft departed Moorabbin Airport at 1604 Eastern Standard Time.¹ Flight tracking data showed that it climbed to an altitude of 3,000 ft above mean sea level and tracked towards Tyabb, Victoria. EWE then tracked south toward Hastings, south-east to Inverloch, and north-east toward Leongatha, before heading north-west to return to Moorabbin Airport (Figure 1 inset).

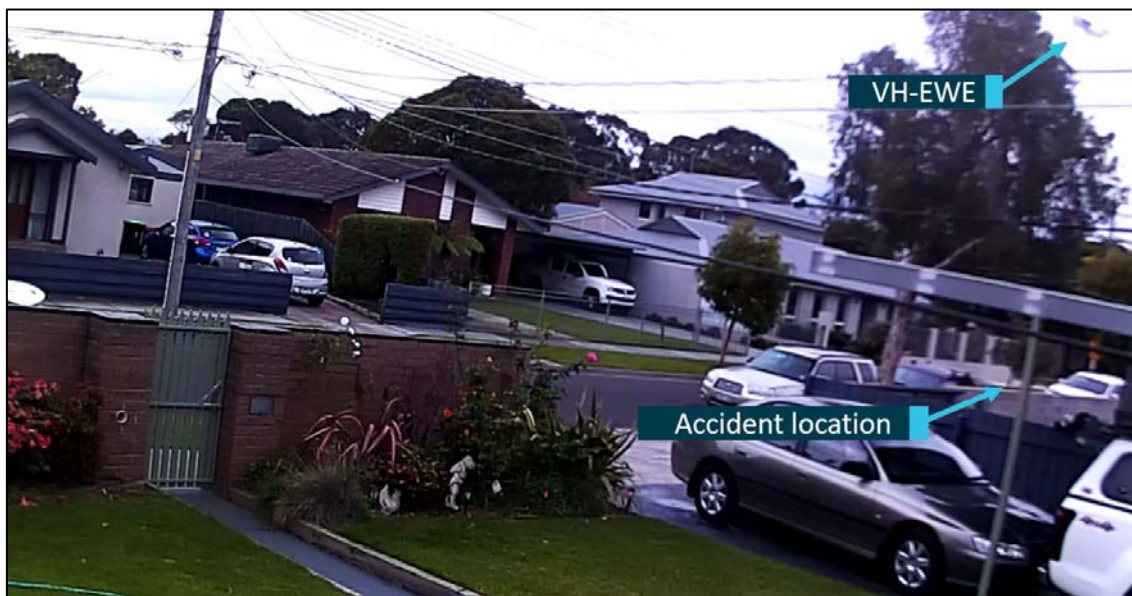
Figure 2: Security camera footage

A security camera located two houses to the west of the accident site captured the accident sequence. The footage showed EWE enter the frame in a slight left bank and initially on about a westerly heading. The aircraft was descending with a nose attitude appearing higher than that for a normal glide (Figure 2). As the aircraft passed behind a tree, the aircraft appeared to stall, indicated by the sharp reduction in pitch attitude and left wing drop (see the section titled *Stall characteristics and recovery*). The left wing subsequently clipped the power service line⁶ to a corner property. The footage showed that the wing flaps were in the retracted position.

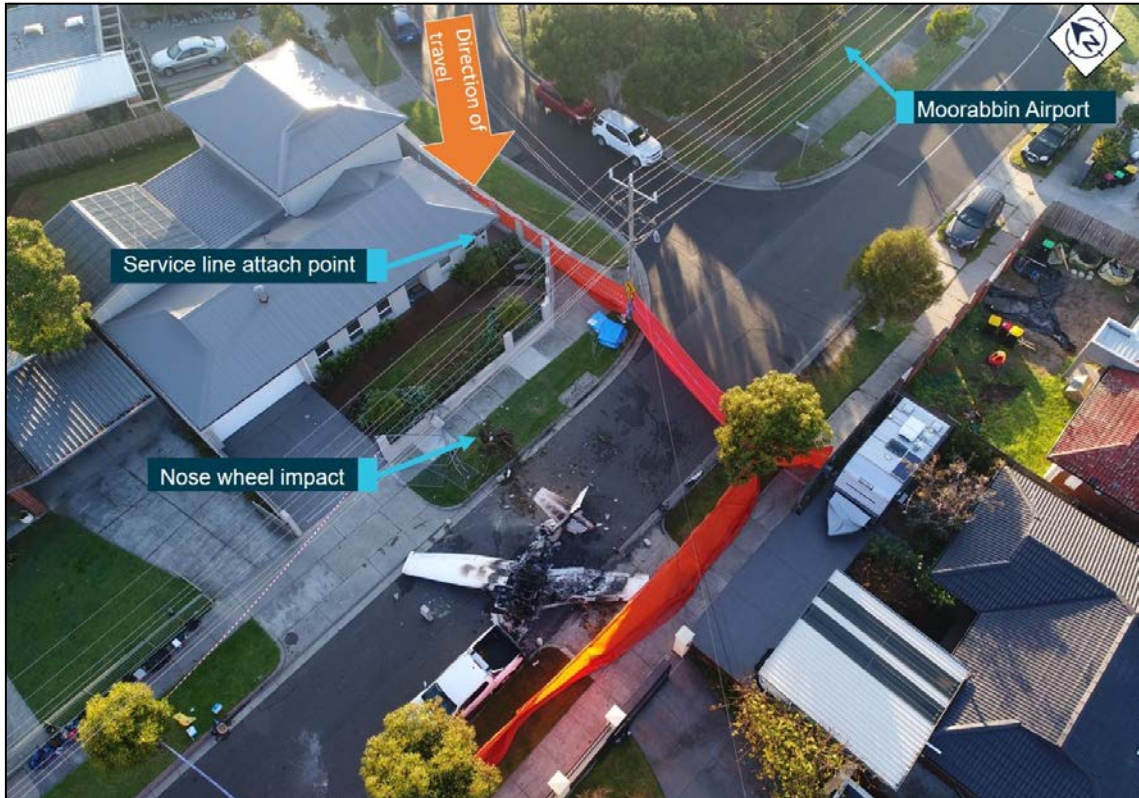
Figure 3: Accident site

EWE collided with the top of a concrete column and tubular steel fence located at the front of a property. The propeller and nose wheel impacted the grass verge with the aircraft stopping behind a parked vehicle on the southern side of the street (Figure 3). A severe post-impact fuel-fed fire commenced immediately. Witnesses reported that ignited aircraft fuel leaked from EWE and flowed along the street gutter.

The pilot was fatally injured and a post-impact fuel-fed fire destroyed the aircraft. There was also some damage to a residential property and the parked car. There were no injuries to members of the public.

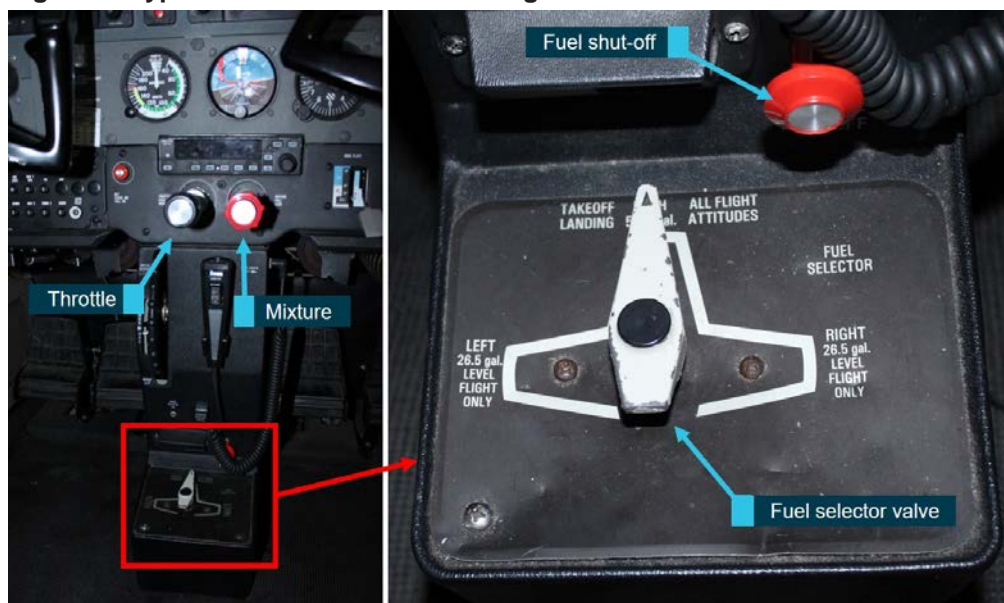
Figure 5: Typical Cessna 172 fuel and engine control locations

A fuel selector valve lever (Figure 5), operated by the pilot, allows fuel to gravity flow from either the left or right, or both wing tanks to a reservoir (feeder) tank. The handle is indexed and therefore cannot be fitted incorrectly. The Cessna 172 pilot operating handbook (POH) recommends checking the fuel selector is in the BOTH position prior to engine start, prior to takeoff, and before landing.

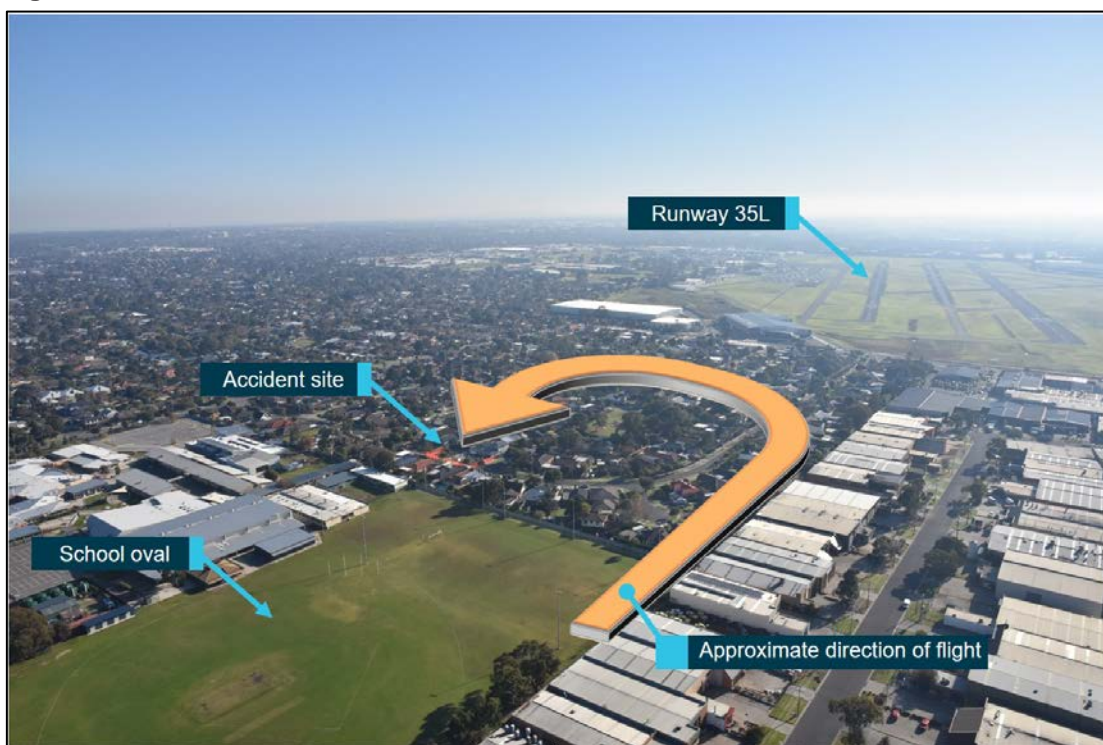
Figure 6: Accident site location

Security camera footage, along with statements from two nearby witnesses, were used to calculate the height of the aircraft at the time of the apparent stall. From this, EWE was estimated to be about 85 ft above ground level at the commencement of the loss of control.

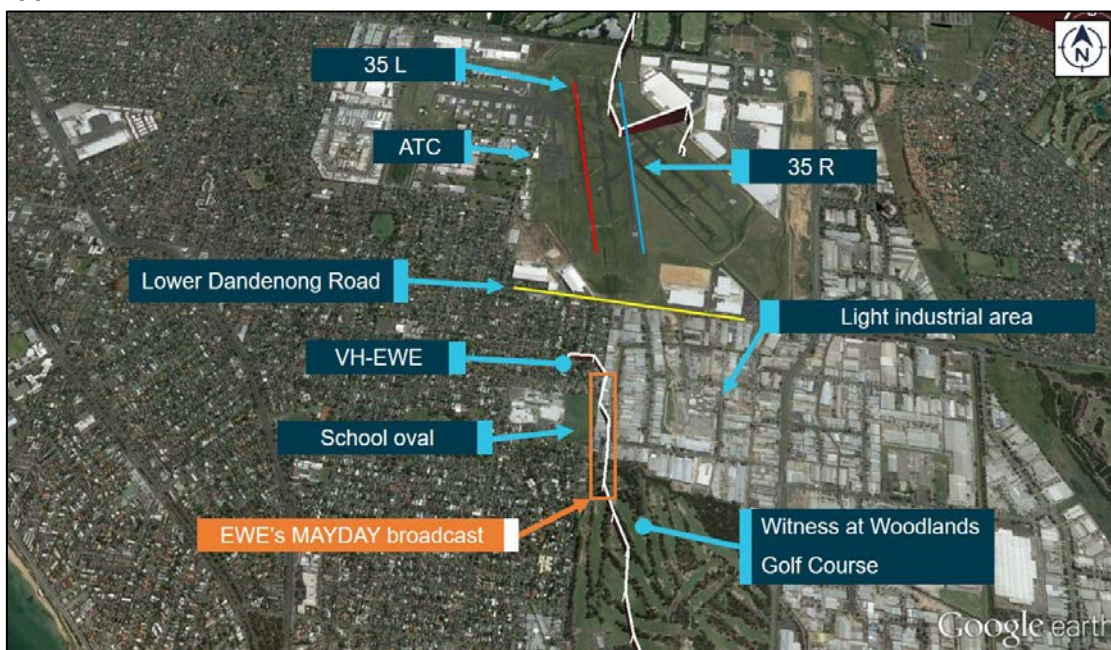
Figure 7: Overview of Moorabbin Airport vicinity showing VH-EWE departure and approach track

The standard approach to runway 35 left (35L) and runway 35 right (35R) involves flight over a nature reserve, a residential area, the Woodlands Golf Course and a light industrial area (Figure 7). Lower Dandenong Road forms the southern boundary of the airport and has powerlines running along its southern edge and the airport perimeter chain-link fence to the north. The area from the fence to the start of 35L, about 240 m, consists of undulating, clear grass ground and two internal airport service roads.
