# Loss of control and collision with terrain involving Cessna 441, VH-XMJ

4 km west of Renmark Airport, South Australia on 30 May 2017

**ATSB Transport Safety Report**  
Aviation Occurrence Investigation  
AO-2017-057  
Final – 30 April 2020

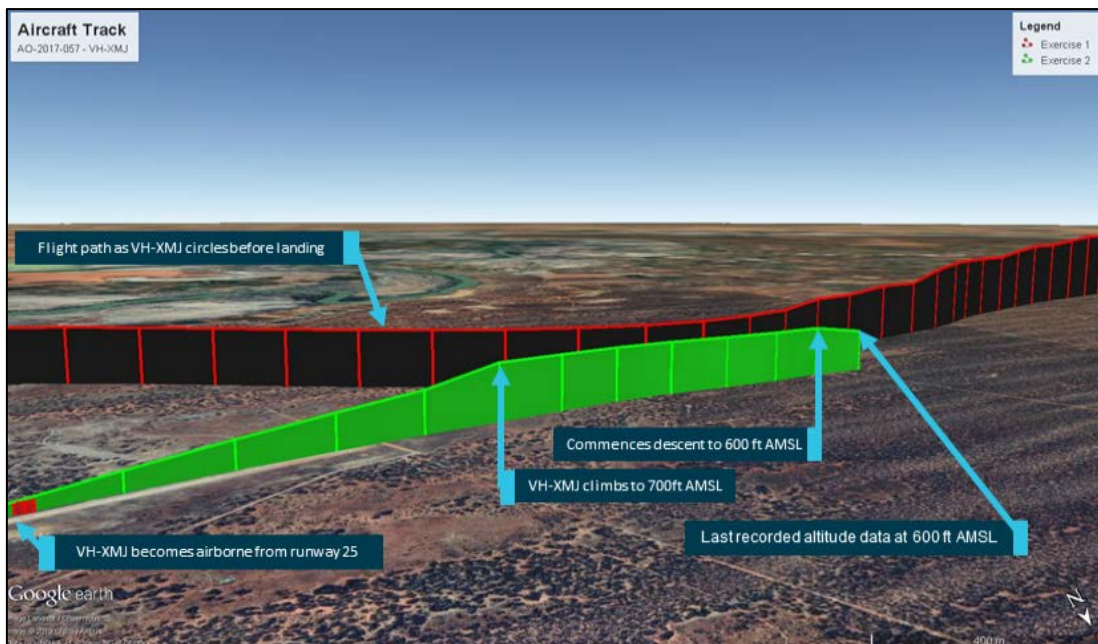
**Figure 2: Altitude information of VH-XMJ (each vertical line represents 5 seconds)**

The aircraft maintained the runway heading until reaching a height of between 300-400 ft above the ground (see the section titled *Recorded flight data*). At that point the aircraft began veering to the right of the extended runway centreline (Figures 1 and 15). The aircraft continued to climb to about 600 ft above the ground (700 ft altitude), and held this height for about 30 seconds, followed by a descent to about 500 ft (Figures 2 and 13). The information ceased 5 seconds later, which was about 60 seconds after take-off.

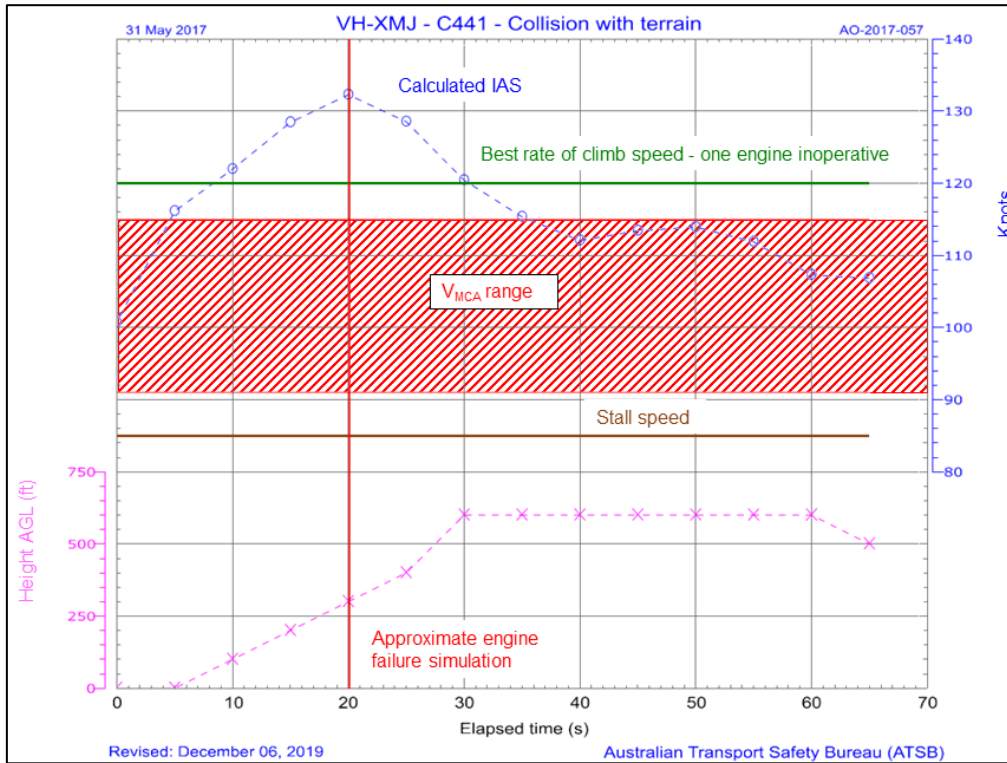
**Figure 13: Indicated airspeed and altitude variation over the final minute of flight**

The data showed a steady increase in airspeed up to about 132 kt, followed by loss of airspeed, brief stabilisation around 110-115 kt, then a further decrease to about 107 kt before the data ended. The maximum recorded airspeed was about 10 kt higher than published OEI best rate of climb speed  $V_{YSE}$  (120 kt, see the section titled *Asymmetric performance*) and occurred at a height of about 300 ft above ground level.

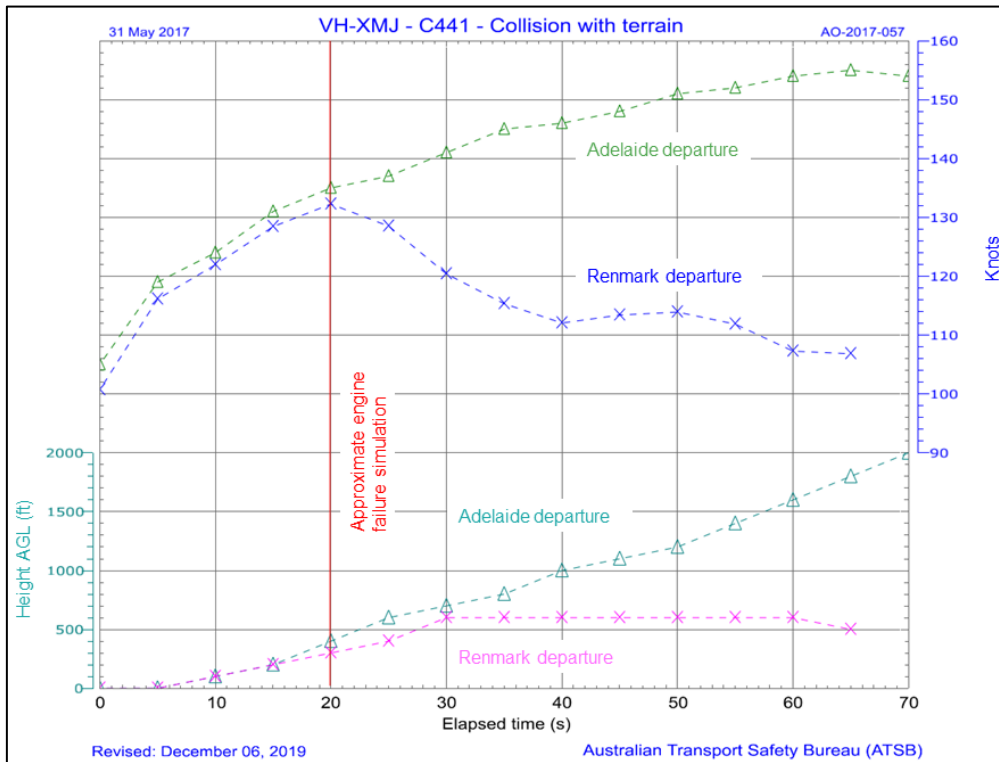
**Figure 14: Departure profile comparison**

Figure 14 illustrates the difference in the calculated IAS and height (above ground level) profiles between the departure from Renmark Airport and the earlier departure from Adelaide Airport.

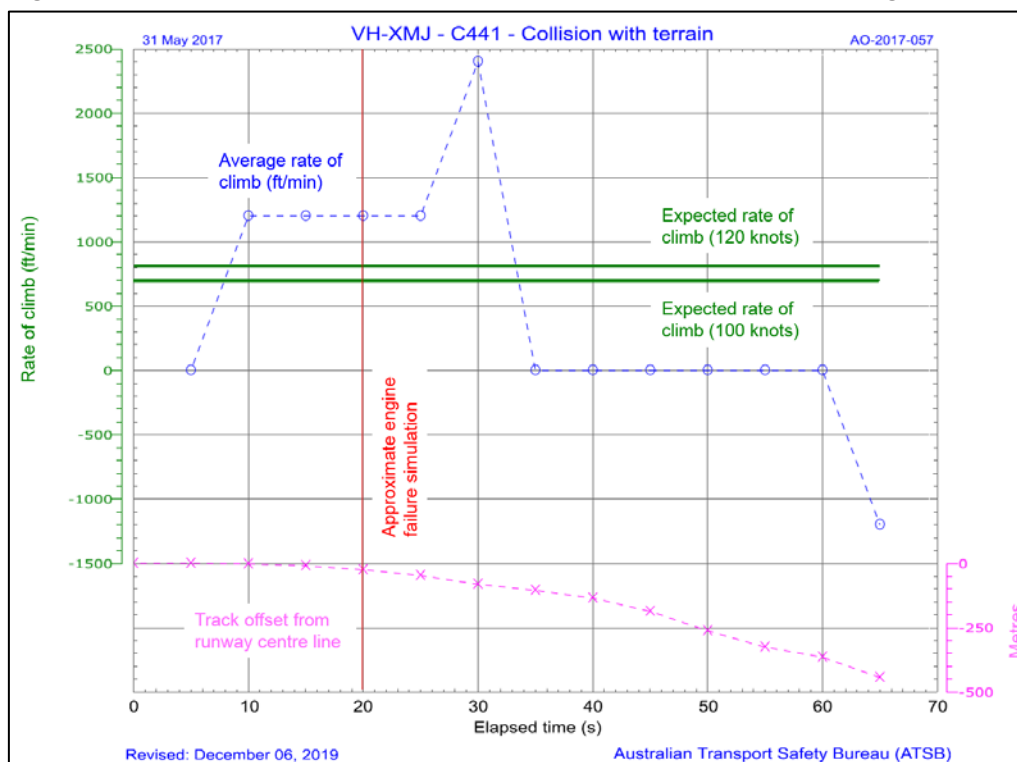
**Figure 15: Rate of climb and track variation over the final minute of flight**

In addition to the airspeed variation, the aircraft's rate of climb was derived from the GPS altitude data and is shown, together with the aircraft's track deviation from the runway heading in Figure 15. The data indicated that the aircraft initially climbed at greater than the expected OEI rate of climb before levelling and maintaining approximately level flight for 30 seconds until the data ended. A review of the airspeed over the same time period identified that it reduced during the peak increase in the rate of climb, suggesting that the aircraft was pitched up to reduce airspeed.

Analysis of the track variation identified that the aircraft deviated to the right of the runway centreline during the final minute of the flight. That movement was consistent with both the prevailing left crosswind component during the departure and a reduction in power on the right engine.

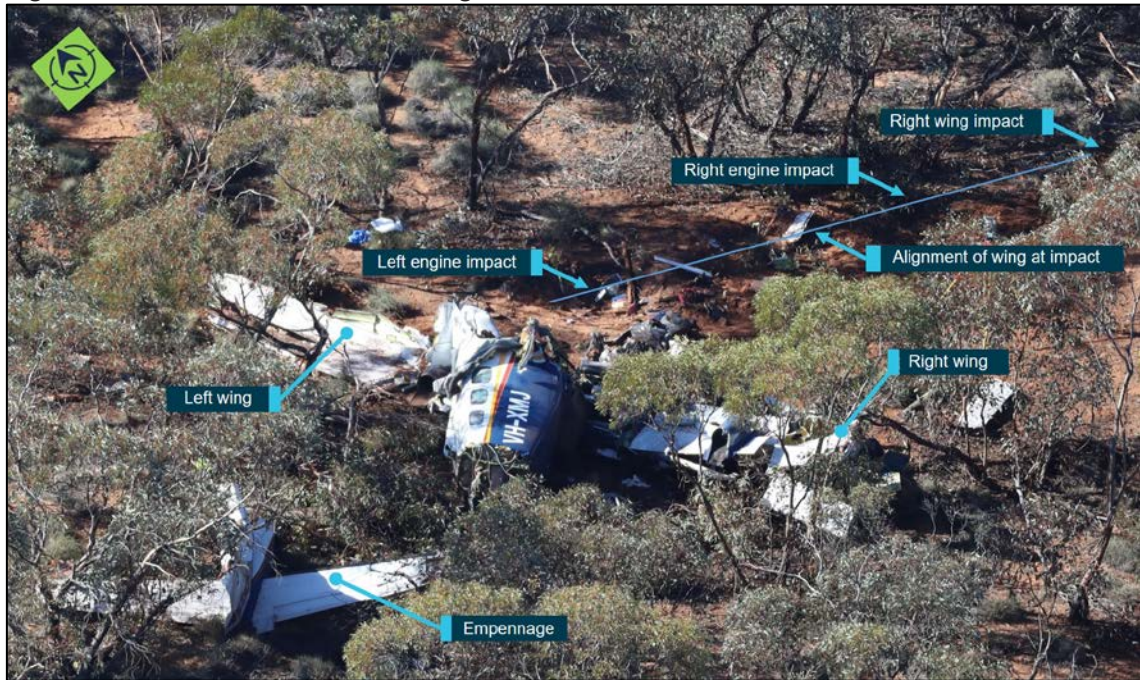
**Figure 19: Accident site and wreckage of VH-XMJ**

The aircraft was destroyed as a result of the ground collision. There was no subsequent fire, however, damage to the aircraft precluded a complete examination of a number of the aircraft systems. On-site examination of the wreckage and later examination of recovered components did not identify any pre-impact faults that could have contributed to the accident.
