Pitch trim runaway (uninterrupted) and partial loss of control, Pilatus PC-12/47E, VH-OWJ

4 km west of Merredin, Western Australia on 14 April 2019

ATSB Transport Safety Report
Aviation Occurrence Investigation
AO-2019-019
Final – 13 May 2020

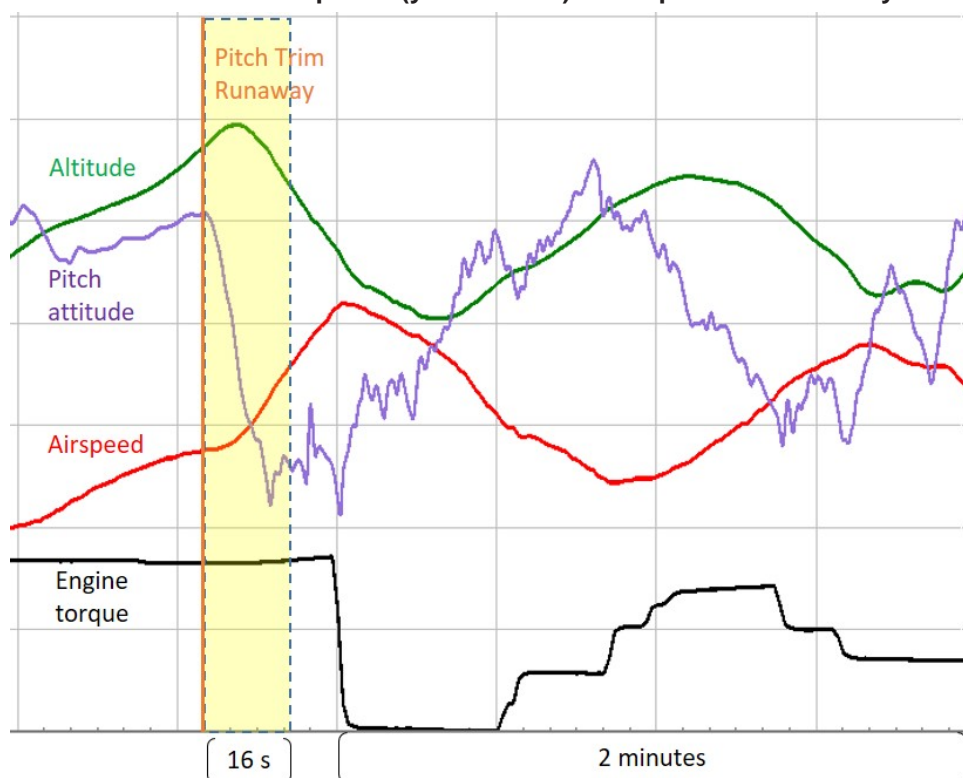
According to the recorded data, the pitch trim continued to operate in the runaway condition until it reached full nose down position 16 seconds after the warnings were issued. During that 16-second period, the following data was recorded (see the indicative flight data plot in Figure 1):

Over the next 6 seconds, the situation continued to deteriorate until the pilot reduced engine torque. At about that point, the airspeed had reached 210 kt and the altitude was down to 2,400 ft. The pilot recalled that the control forces eased somewhat following reduction of engine torque.

Figure 1: Indicative data plot showing key aircraft parameters before, during, and in the 2 minutes after the active phase (yellow band) of the pitch trim runaway.

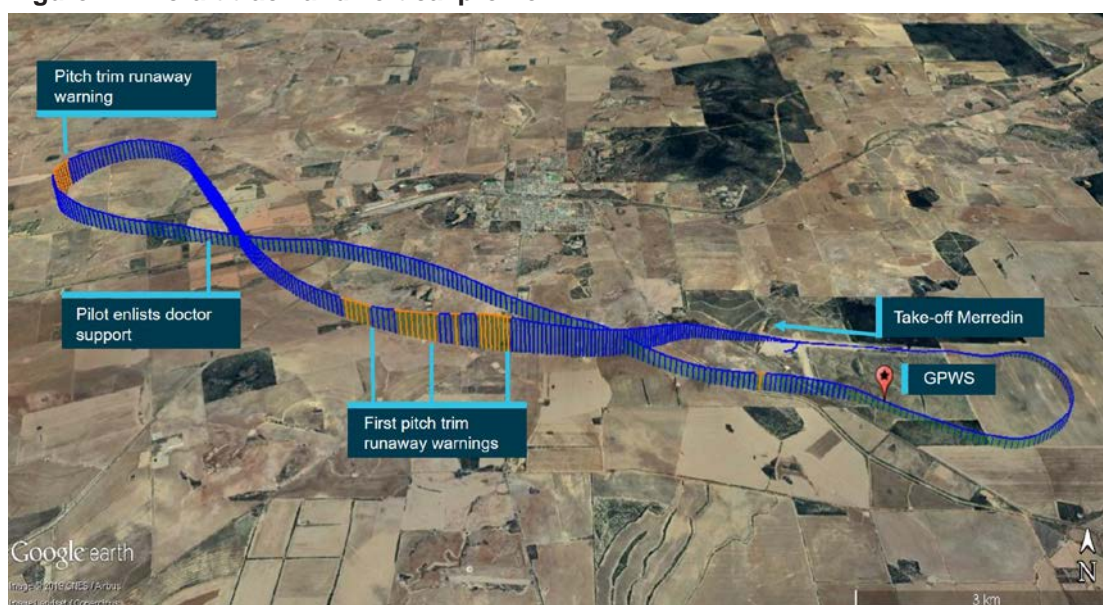
Figure 2: Aircraft track and vertical profile

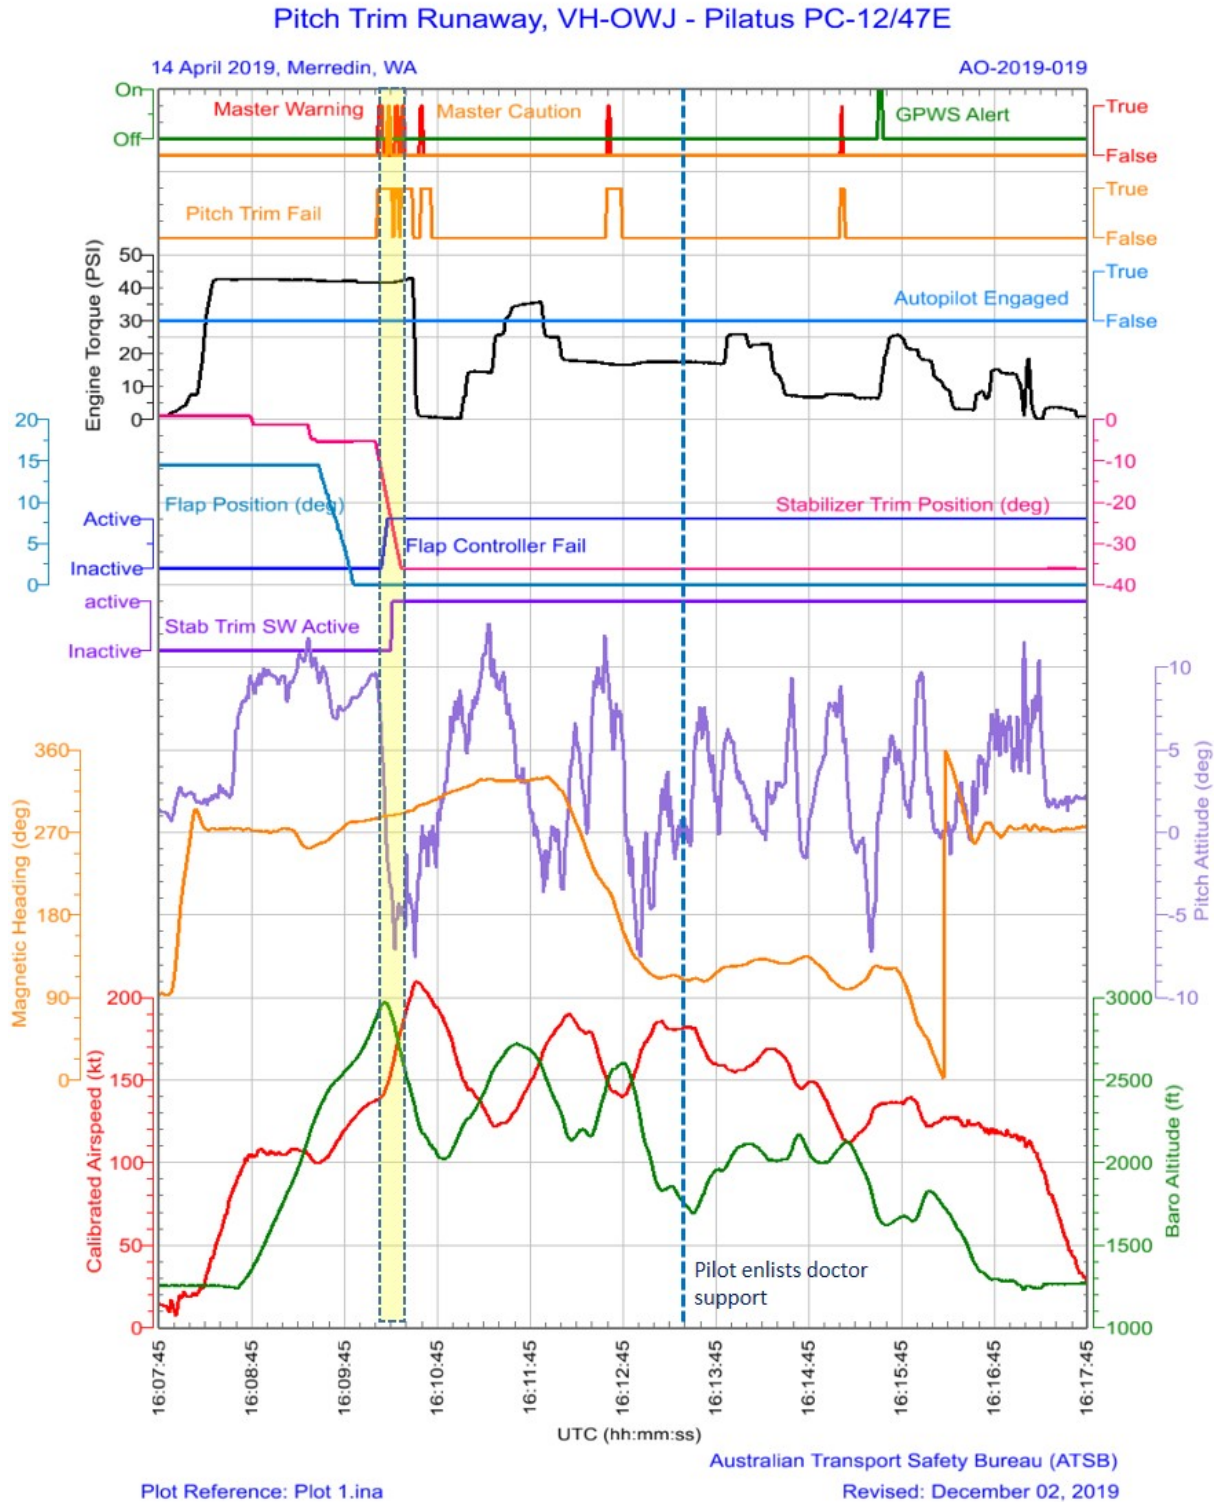
From other correlated parameters in the recorded data, the Trim Interrupt switch was not selected to INTR at any time during the flight.

Figure 3: Recorded data plot for complete flight showing the key parameters and active phase (yellow band) of the pitch trim runaway with start of doctor assistance (blue line).

In this occurrence, there was evidence from flight data of power being removed from the flap system at the beginning of the initial 16-second trim runaway event, consistent with the operation of the Flap Interrupt switch (see Figure 3 - dark blue trace coded as Flap Controller Fail).

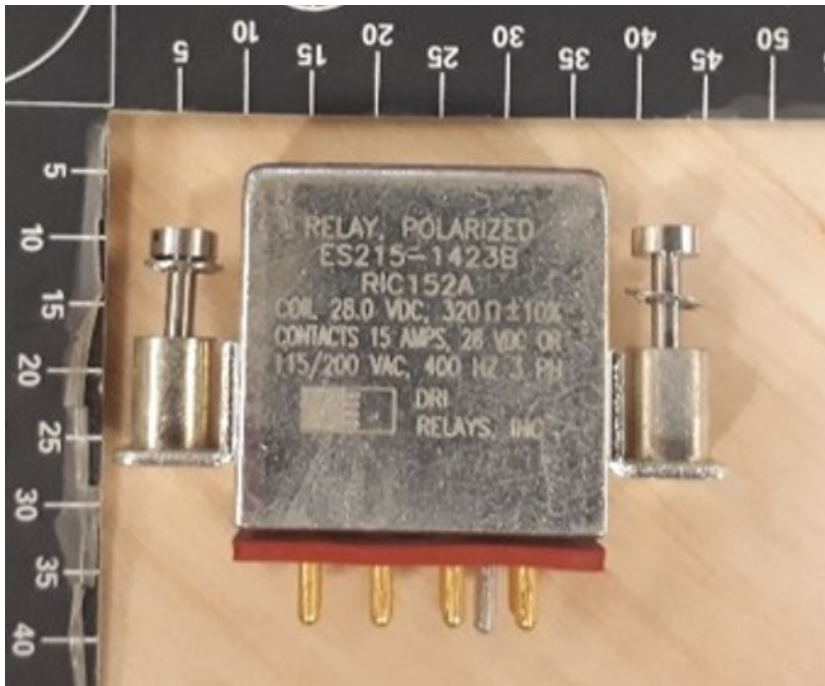
The ATSB examined the manual pitch trim DOWN relay (identification number K161E2) removed from VH-OWJ to characterise the failure mode and assess the implications for continuing airworthiness. A visual inspection of the relay did not identify any anomalies (Figure 7). The markings were consistent with the specifications.

Figure 7: External condition of defective relay

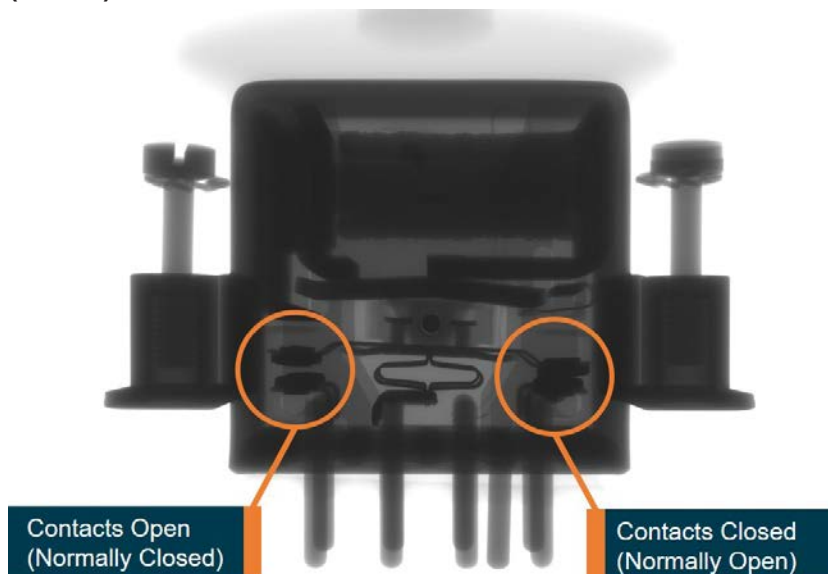
Figure 8: X-ray of defective relay showing anomalous configuration of the contacts (circled).

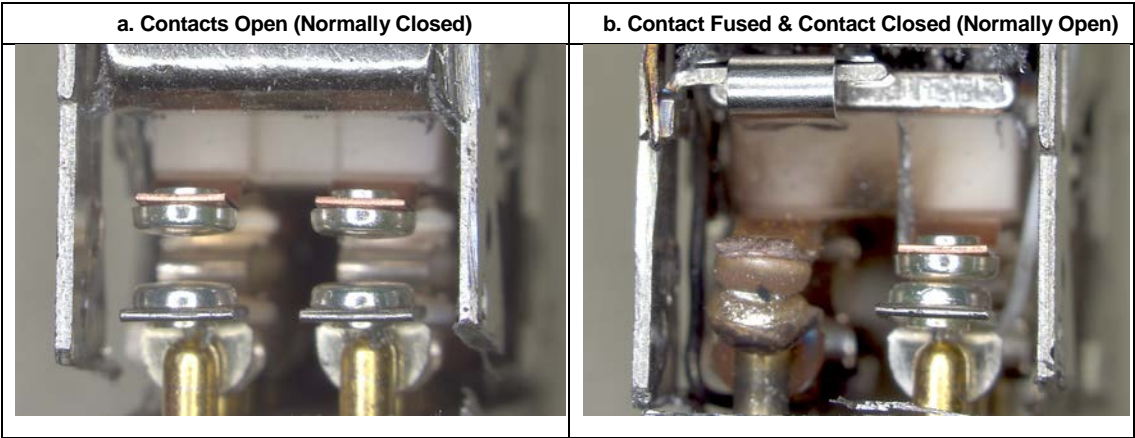
The ATSB detached the casing from the base of the relay to examine the internal mechanism (Figure 9). A visual inspection of the mechanism confirmed the anomalous configuration of the contacts and revealed the failure type for the normally open contacts.

For the relay pole connected to the pitch trim circuit (active), the normally open contact was melted and fused close. There was sooting on surfaces near the contacts and black contaminant from the black caps that covered the contacts. Beads of gold-coloured metallic material was observed on surfaces near the contacts. As a result of the fused contact, the other contacts were fixed in anomalous positions.

The relay manufacturer advised the ATSB that the condition of the contacts was consistent with a significant high-energy event that occurred while the relay was energised. The melting and welding of the contacts without circuit breaker activation is indicative of a short-duration high-current event such as a lightning strike. It was not possible for the manufacturer to determine the root cause of the relay failure.

Figure 9: Opposite end views of relay mechanism showing the two sets of anomalous contact conditions
