# Weather event and collision with terrain involving Robinson R22, VH-KZV

125 km east-north-east of Alice Springs Airport, Northern Territory, on  
24 November 2018

**ATSB Transport Safety Report**  
Aviation Occurrence Investigation  
AO-2018-077  
Final – 21 May 2020

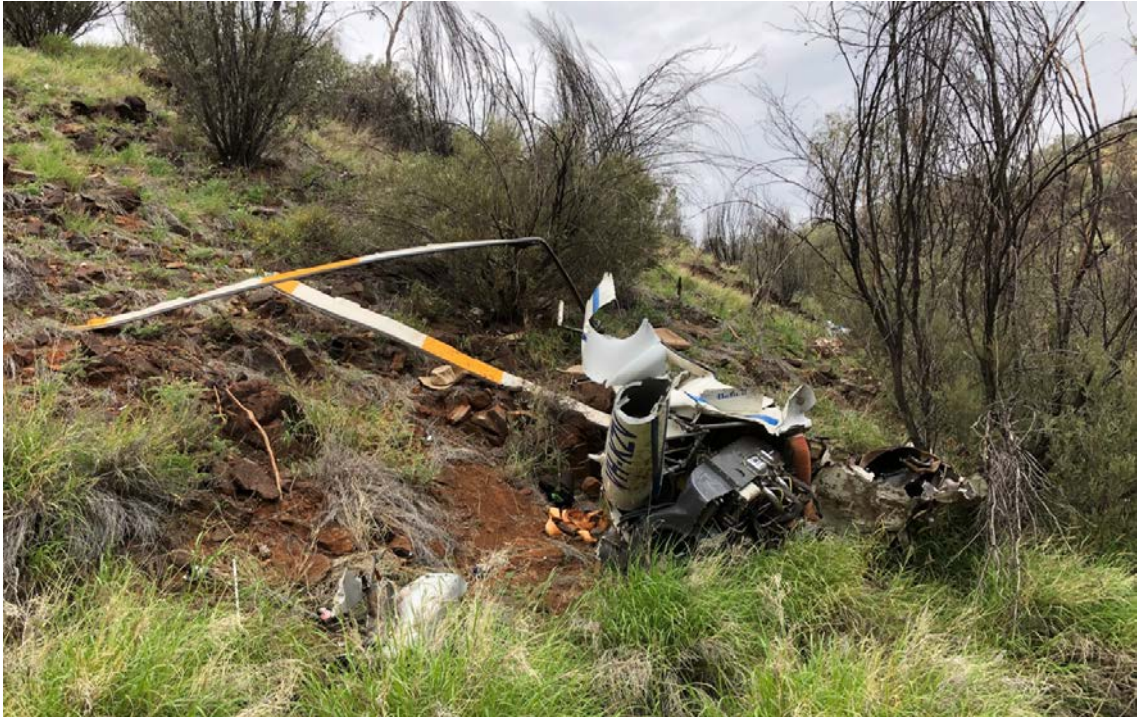
**Figure 1: Accident site main wreckage**

The SAR pilot located the helicopter wreckage at the reported location (Figure 1) and dropped the paramedic nearby to attend to the accident pilot and passenger. The SAR pilot then ferried the two station employees to the accident site. At about 1040, the paramedic found the pilot fatally injured and the passenger seriously injured. The SAR pilot and paramedic, with the assistance of the station employees, retrieved the passenger and transported him to Ambalindum Station for treatment by a retrieval doctor, before moving him to Alice Springs Hospital for further medical attention. The helicopter was destroyed.

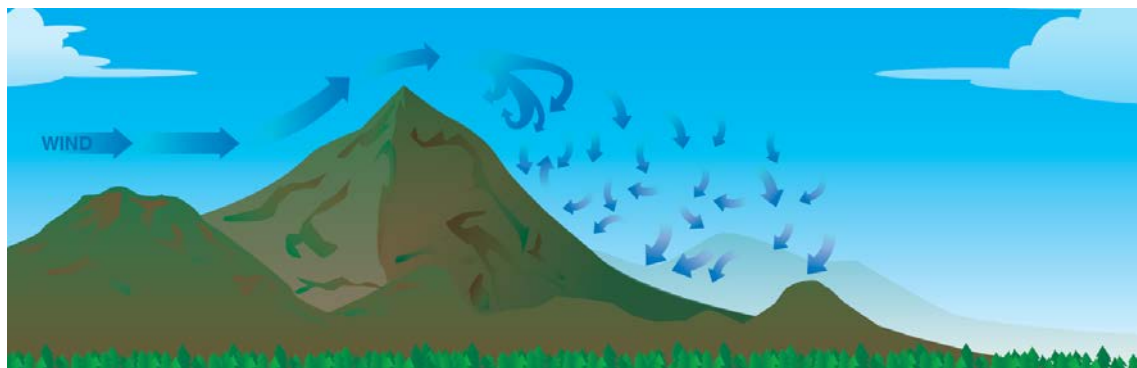
**Figure 2: Potential wind conditions on the lee side of terrain**

According to the United States Federal Aviation Administration (2016) *Pilot's handbook of aeronautical knowledge*, ground topography can break up the flow of the wind and create wind gusts that change rapidly in direction and speed. While the wind may flow smoothly up the windward side of higher terrain, on the leeward side it attempts to follow the contour of the terrain and is increasingly turbulent. The stronger the wind, the greater the downward pressure and turbulence. The downdrafts can be severe in valleys due to the effect of the terrain. Hence, it is recommended to avoid flying in this area when strong winds are present or likely to occur. Figure 2 depicts the potential wind conditions on the lee (right) side of terrain.

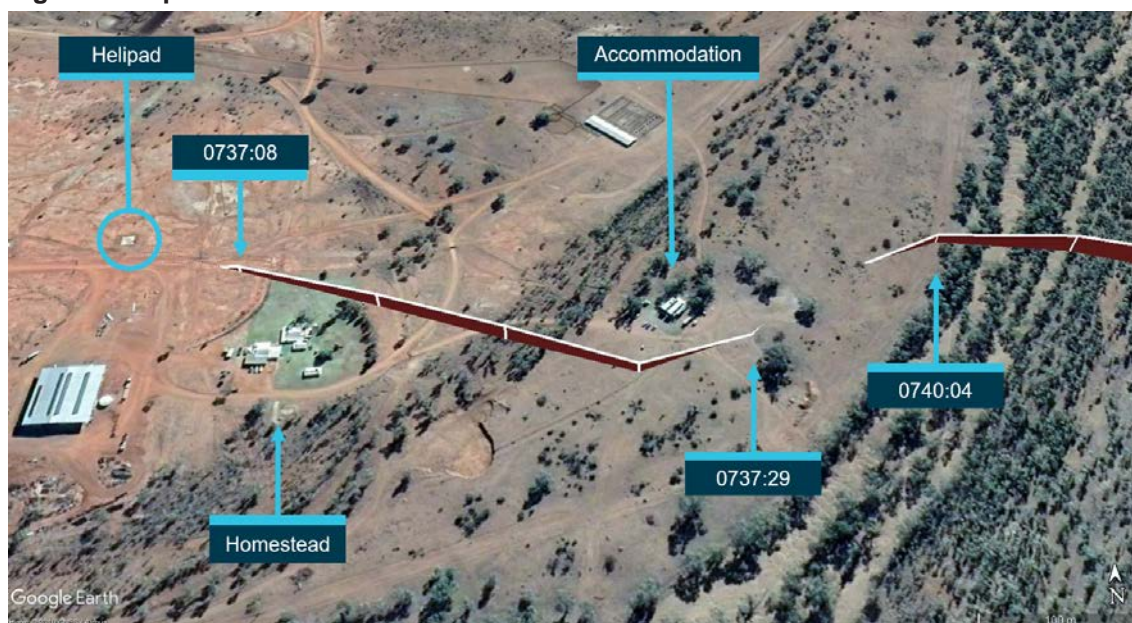
**Figure 3: Departure from the homestead**

For the accident flight, the first recorded data point was from the helipad at 0732 (Figure 3).<sup>14</sup> After transiting to the workers' accommodation block, the helicopter departed at 0740 for the bore site.

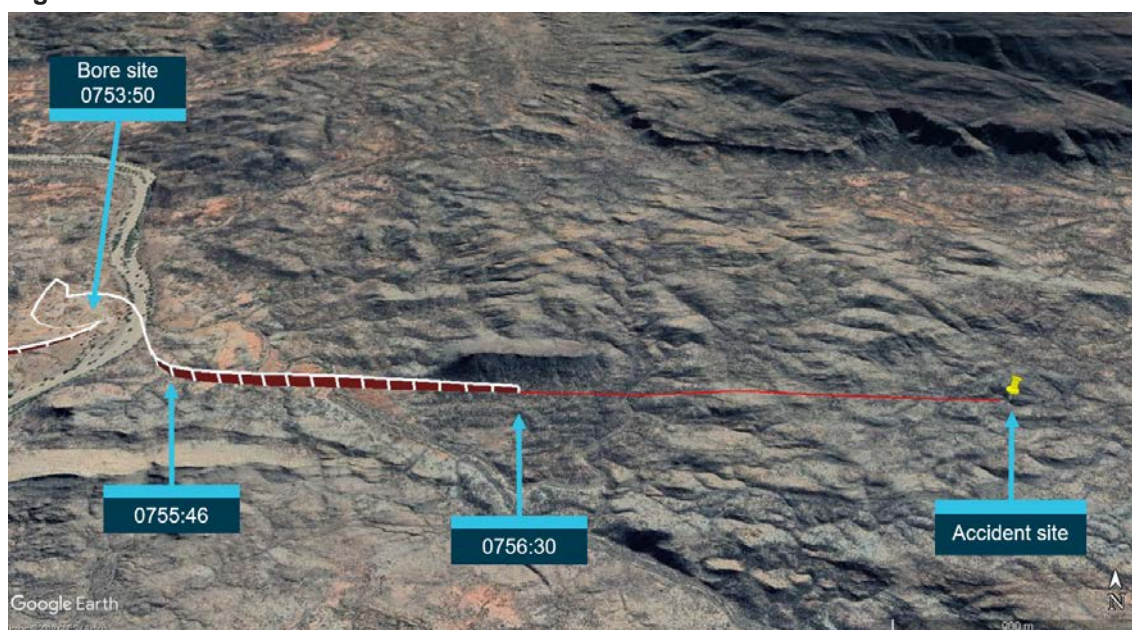
**Figure 4: GPS track from the bore site to the accident site**

Figure 4 shows that, about 2 minutes after taking off from the bore site, at 0755:46, the helicopter was levelled off at about 150 ft above ground level and then entered the MacDonnell Ranges. The final data point, recorded at 0756:30, was located at a height of about 142 ft, with a ground speed of 79 kt,<sup>15</sup> on a direct track towards the accident site. Based on this ground speed, the ATSB estimated that the time between the last data point and the accident site was 56 seconds.

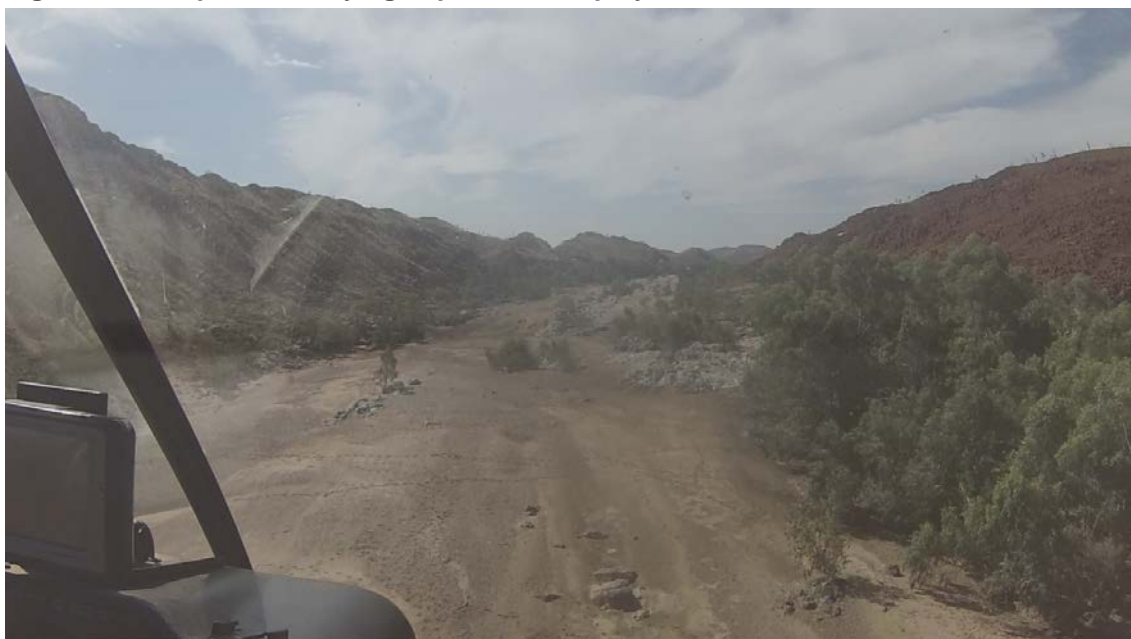
**Figure 5: Example of low flying in previous employment**

The ATSB noted that the evidence of previous low flying suggested his actions may have been normal behaviour and not influenced by alcohol. Therefore, it could not be concluded that his

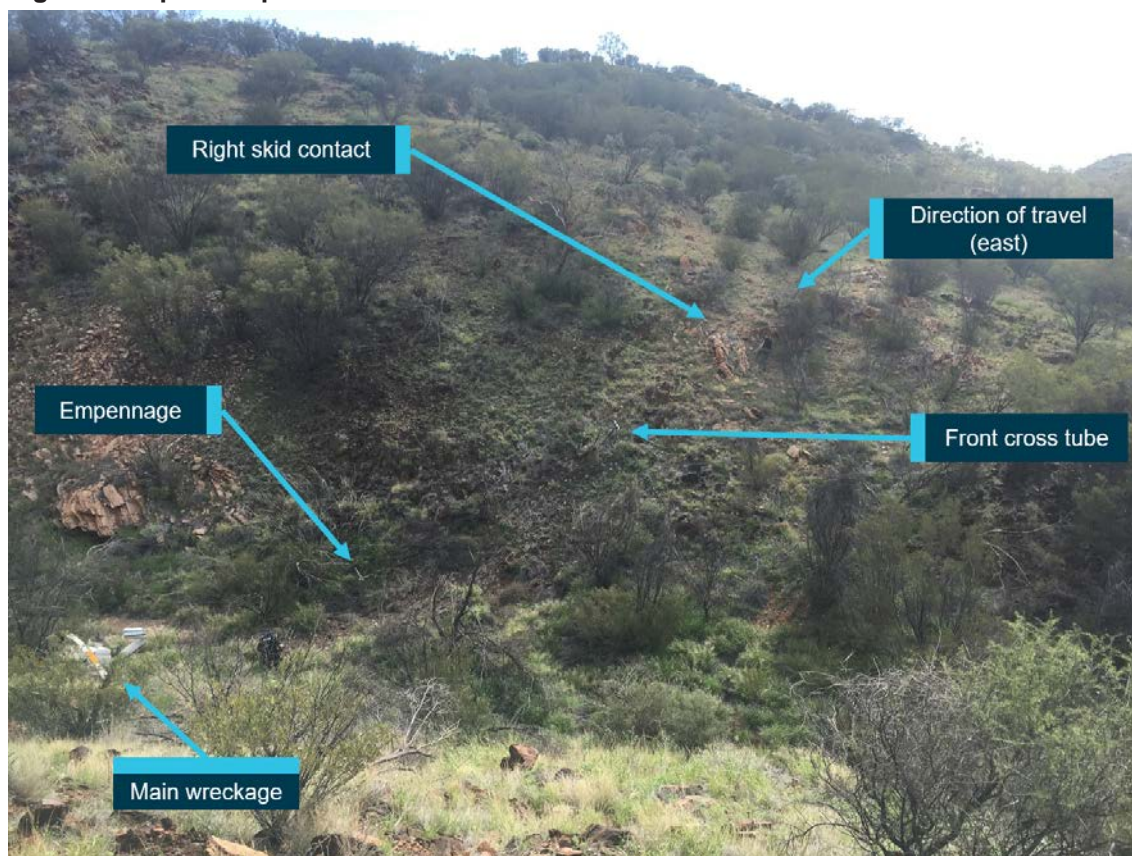
**Figure 6: Impact sequence**

Just prior to crossing the riverbed, the main rotor disc struck and separated the tail rotor driveshaft and empennage from the airframe. The empennage was located just prior to crossing the riverbed, to the right of the accident path. The driveshaft was found on the far side of the riverbed to the right of the accident path and beyond the main wreckage.

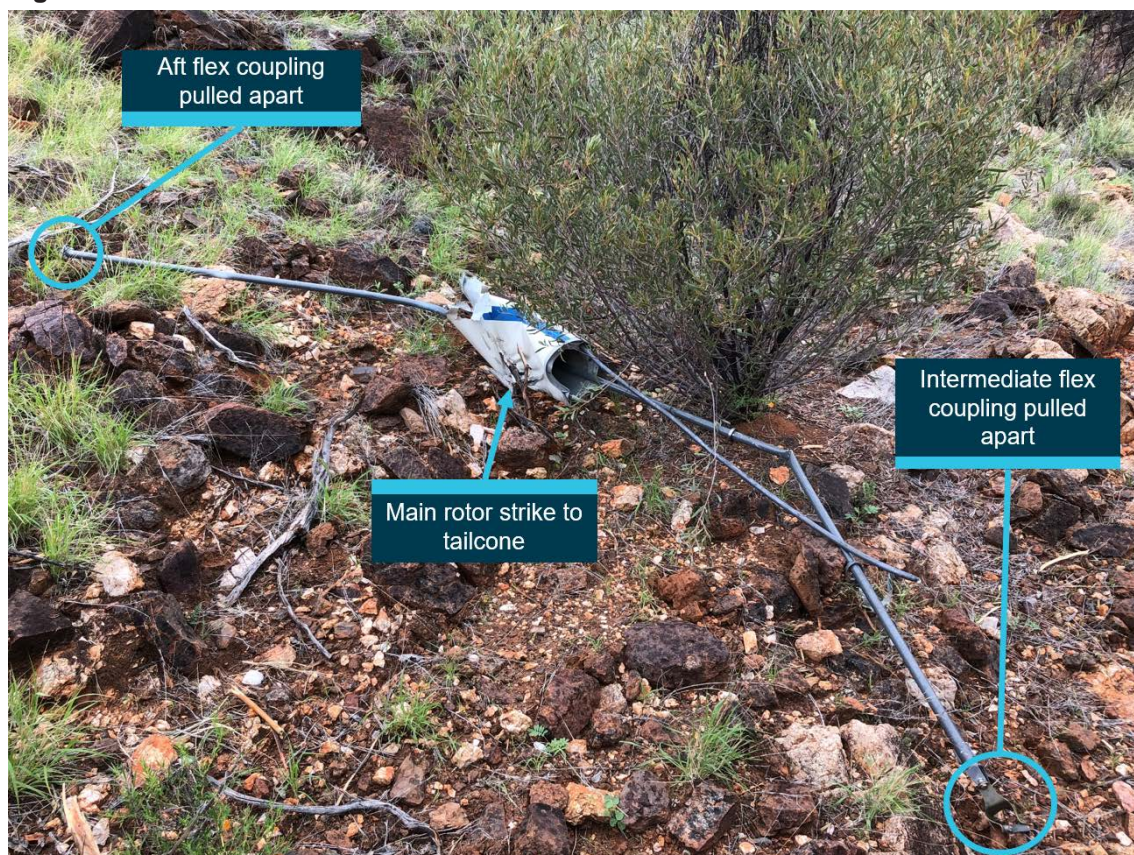
**Figure 7: Tail rotor driveshaft**

The ATSB found no pre-existing defects with the rotors, drivetrain or flight controls, which would have prevented normal operation. The tail rotor driveshaft was folded by the main rotor strike. It was also noted to have been pulled apart at the intermediate and aft flex couplings (Figure 7). This indicated a loss of energy from the main rotor system occurred at some time prior to the main

rotor striking the tailcone.<sup>19</sup> A fuel test on-site and at the point of departure did not identify any visual contaminants or water.

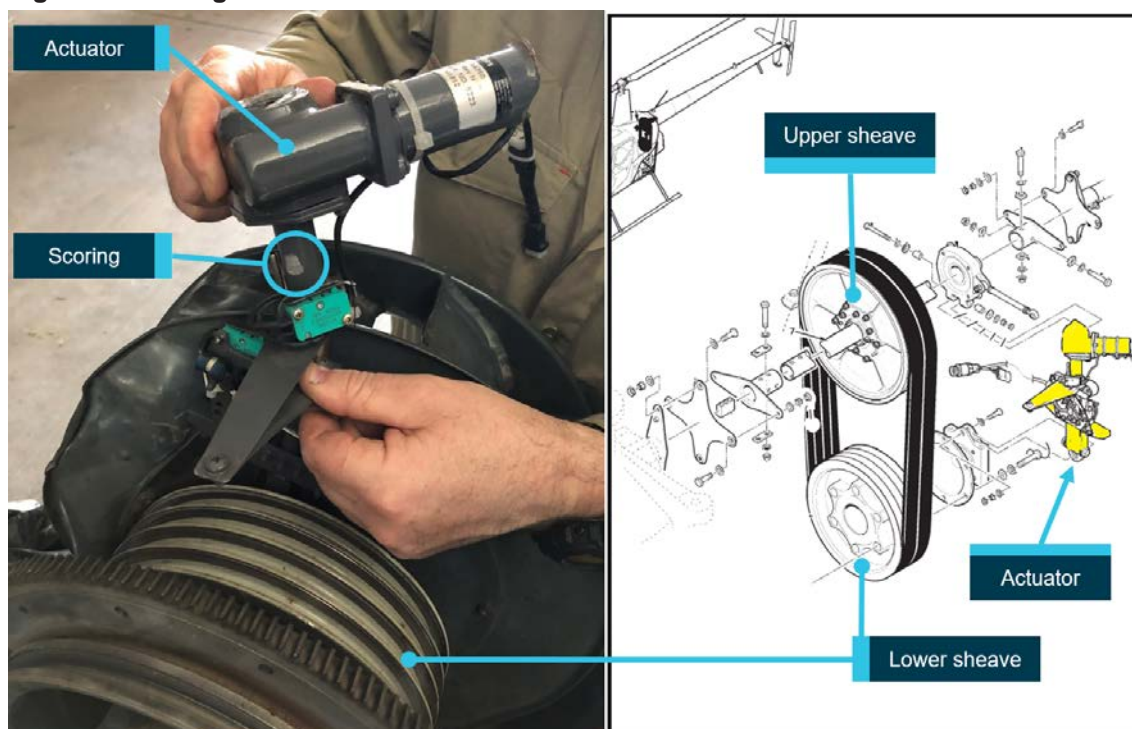
**Figure 8: Scoring to the clutch actuator**

The V-belts were found intact and scoring damage to the V-belt actuator was identified. Robinson advised the ATSB that the length of the actuator indicated it was extended in the normal position for flight and that the scoring was consistent with the upper sheave rotating on contact with the actuator as the helicopter's structure distorted on impact (Figure 8). This indicated that the engine was driving the V-belts and upper sheave at impact.
