# Loss of control and collision with terrain involving FU24 Stallion, VH-EUO

40 km north-east of Bathurst, New South Wales, on 16 June 2017

**ATSB Transport Safety Report**  
Aviation Occurrence Investigation  
AO-2017-062  
Final – 19 May 2020

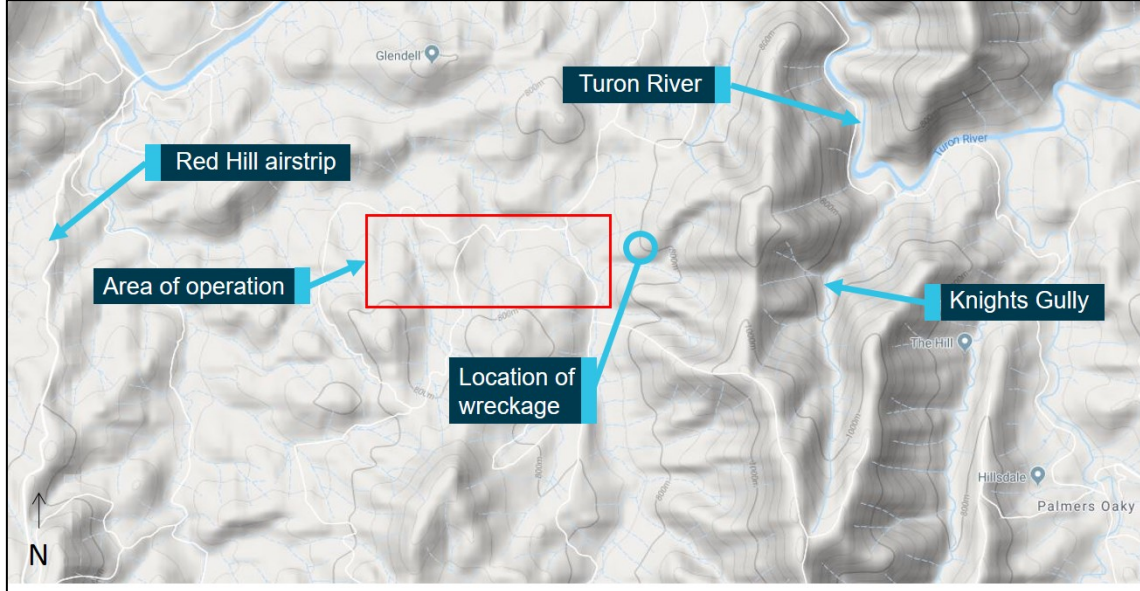
**Figure 4: Topographical map showing the area of operations**

located about 220 m in from the eastern edge of the operation area and part way up an approximately 28° slope rising to the north. Elevation of the site was about 790 m and the aircraft was oriented with the nose toward 286° (approximately west-north-west). The surrounding terrain rose in both the south to north and west to east directions.

Figure 4 shows the area of operation in relation to a ridgeline to the east of the application area.  
Source: Map data: Google, annotated by ATSB

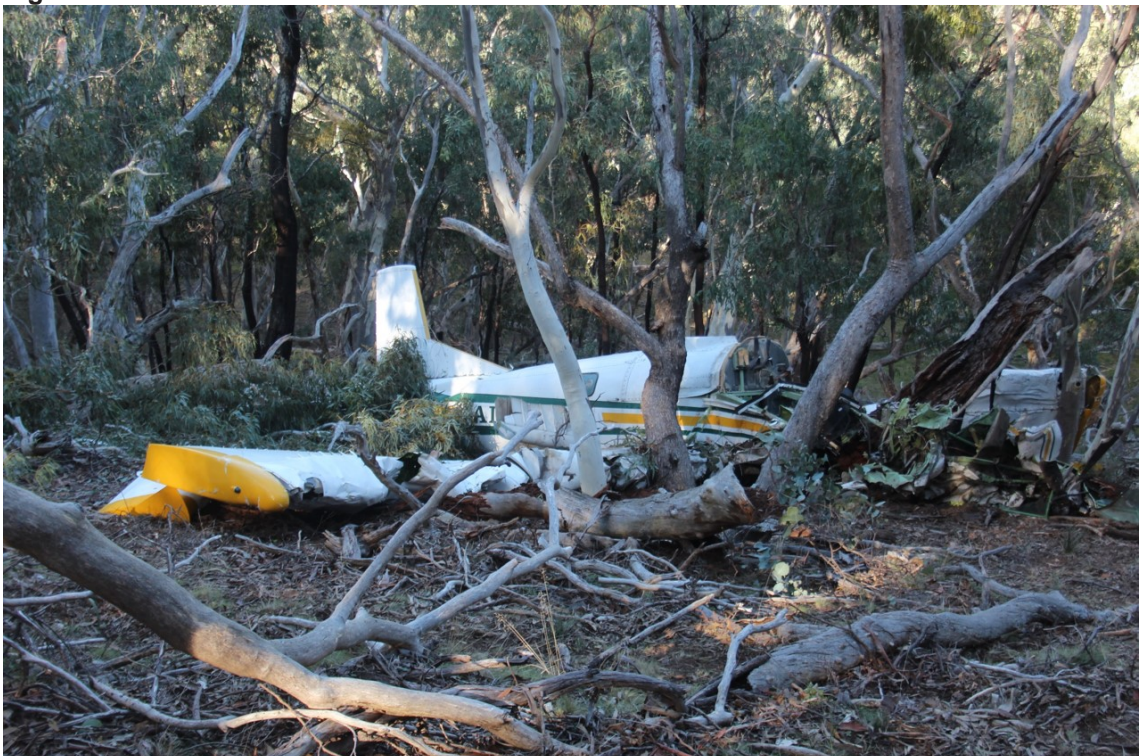
**Figure 5: The accident site**

The accident site was located in a wooded area, with tree heights of about 10 m (Figure 5). Site examination indicated that the final aircraft trajectory was approximately 35° downwards in a steep nose-down attitude. Several large trees about 3 m from the initial ground impact halted forward momentum of the aircraft.

The aircraft was examined for pre-impact defects, with none identified that were likely to have influenced the accident sequence. All of the aircraft and its components were accounted for at the accident site. There was no indication of any fire. The forward fuselage, including engine and cabin, was compressed and twisted. The condition of the wreckage, with minimal structural damage to the fuselage, in addition to the short length of the wreckage trail, was indicative of a relatively low energy impact. These observations are consistent with an aircraft that had stalled at a low level and collided with terrain at low horizontal speed.

On-site examination indicated that the wreckage was consistent with the aircraft aerodynamically stalling at a low altitude resulting in a low speed, low-energy collision with terrain.

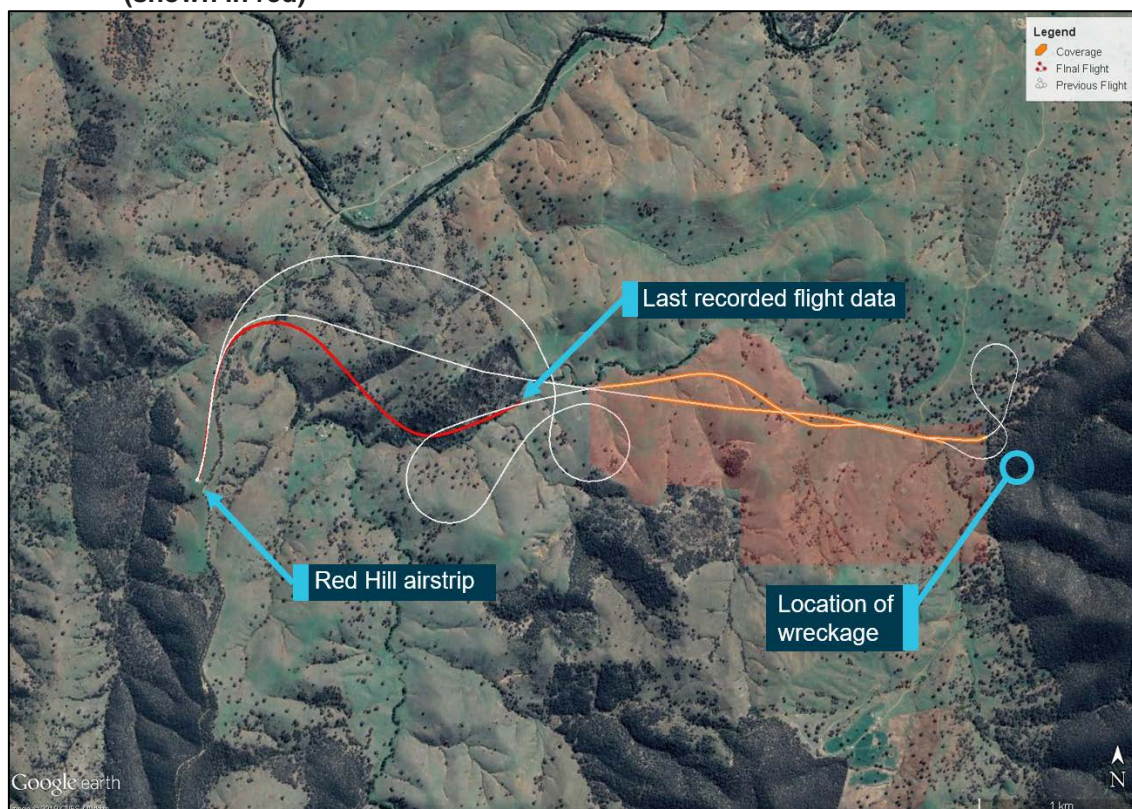
**Figure 7: TracMap data of the penultimate flight (shown in white) and the accident flight (shown in red)**

Figure 7 shows TracMap flight data for the accident flight in red and the previous flight in white. Areas on the previous flight where fertiliser was applied are shown in orange. The red shaded area shows the approximate area of application for this job. Also shown by the annotations are the Red Hill airstrip and the location of the wreckage.

Data for the accident flight, identified in red in Figure 7, showed the aircraft taking off to the north at 1405. This time the aircraft turned earlier to the southeast before turning back to the northeast on a track similar to that of the previous flight. At 14:06:59, just before the aircraft reached the application area (the shaded red area in Figure 7), recorded flight data ceased. About 17 hours later, the wreckage of the aircraft was found about 3 km to the east of the last recorded position.

Figure 7 shows that this is exactly what the pilot had done on the first flight of the Bingletree job. The first application run was conducted in an easterly direction. At the end of the first run the pilot turned north, away from the ridgeline, before conducting a procedure turn to reposition the aircraft for the return run in a westerly direction. If this procedure were continued for the rest of the job, there would have been no operational reason for the aircraft to enter the area of rising terrain to the east of the application area where the accident occurred.

The recorded flight data ceased at 1406:59, 2,870 m from the eastern end of the application area. Analysis of previous flights by the pilot that day indicated that application runs were conducted at an average speed of 100 kt (51.4 m/s) and that procedure turns took about 30 to 35 seconds. Assuming the aircraft travelled at 100 knots and in a straight line, it would have taken about 56 seconds for the aircraft to travel from the point of last recorded flight data to the other side of the application area.
