# Data entry error and operational non-compliance involving Airbus A320, PK-AZE

Perth Airport, Western Australia, on 24 November 2017

**ATSB Transport Safety Report**  
Aviation Occurrence Investigation  
AO-2017-114  
Final – 2 June 2020

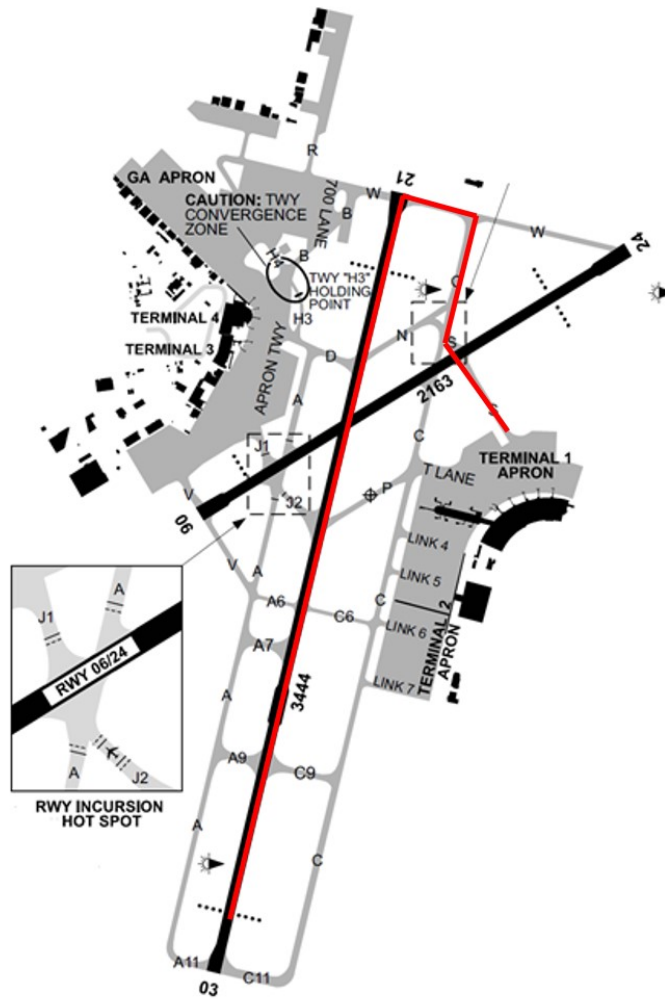
Figure 1: Taxi and take-off path (in red) of PK-AZE

At 1213, the flight crew received a taxi clearance from ATC and commenced taxiing (Figure 1). The clearance included a series of instructions to taxi to the holding point for runway 21 on taxiway 'Whiskey'. The flight crew read back this clearance correctly.

At 1218, the Perth tower controller provided instructions to hold short of runway 21. Shortly after, he cleared the flight crew to line up on runway 21. The flight crew read back both instructions correctly. Prior to reaching the holding point for runway 21, the flight crew received an electronic centralised aircraft monitor (ECAM)<sup>5</sup> message BRAKE SYS 1 FAULT.<sup>6</sup> The captain reported that he actioned the message using the appropriate checklist. After actioning the message, the captain reported feeling there was something wrong, but was unsure of the issue.

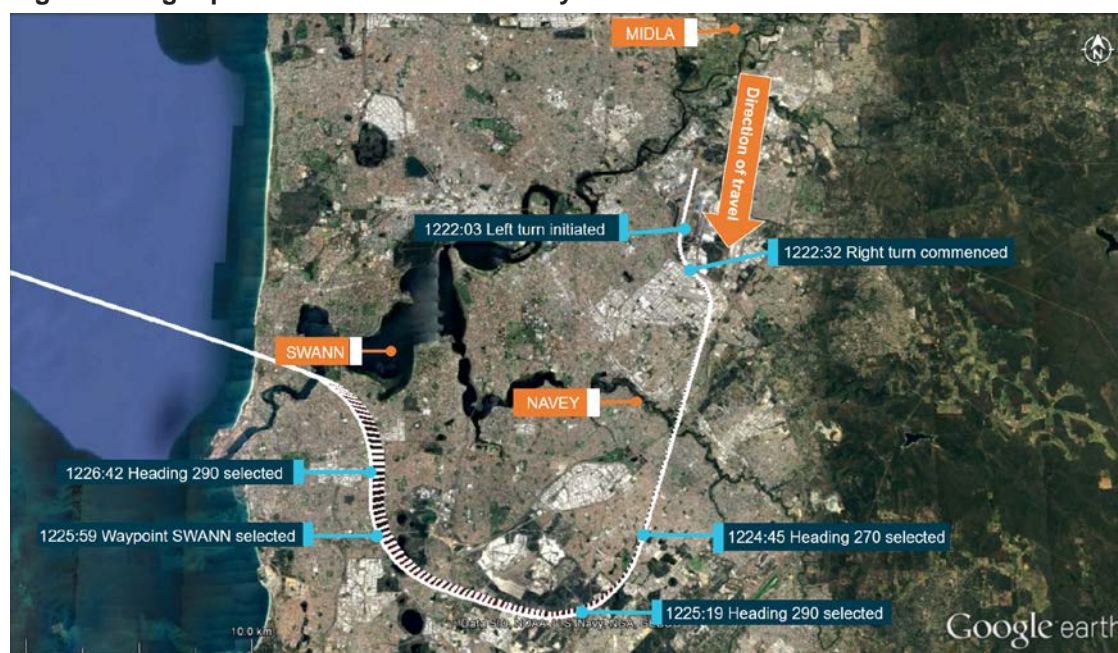
**Figure 2: Flight path of PK-AZE from runway 21**

After becoming airborne during take-off, both pilots' navigation displays showed the next waypoint<sup>10</sup> was MIDLA (Figure 2). Both flight crew noticed the flight director<sup>11</sup> on their primary flight display was commanding a left turn. Shortly after, following the flight director, the FO turned the aircraft left and then engaged the autopilot. Recorded flight data showed the aircraft was manually turned at 223 ft above ground level (AGL) (refer to section titled *Minimum height of turns*).

diverging from the instructed heading. The controller repeated the instruction to turn to heading 290°. The flight crew selected 290° on the flight control unit and re-selected heading mode, and the autopilot turned the aircraft to that heading (Figure 2).

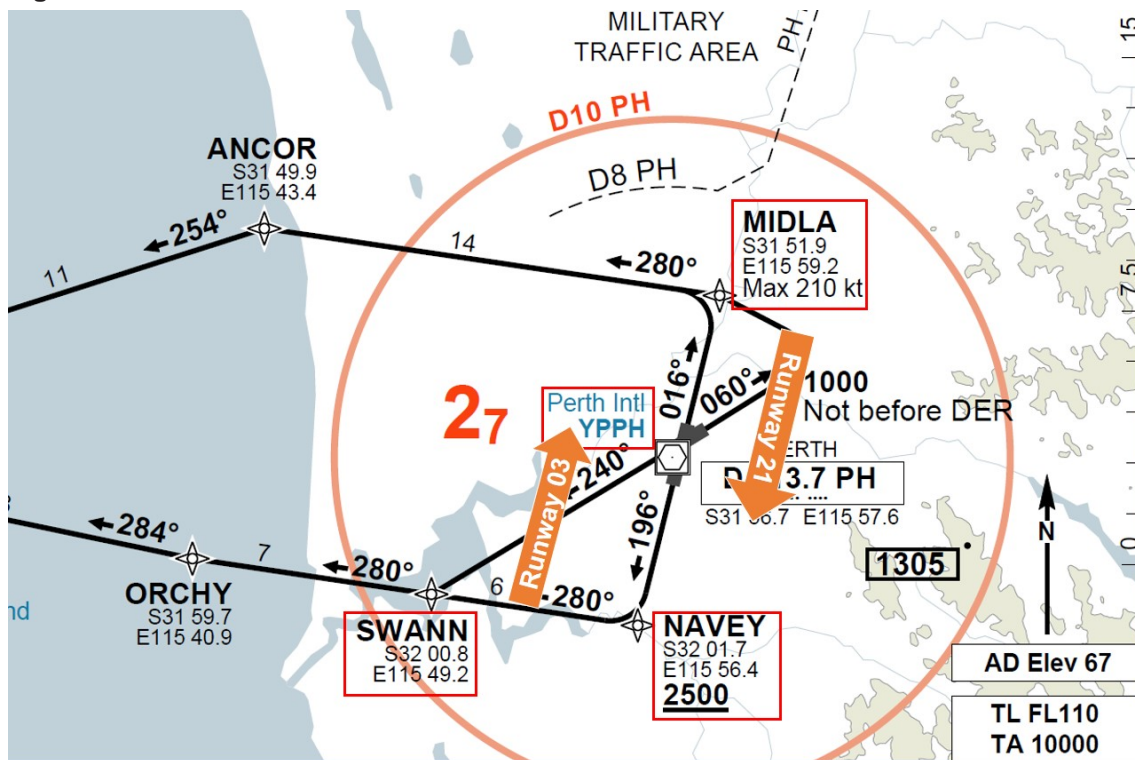
Figure 3: AVNEX TWO AirAsia SID chart

At Perth, the 'AVNEX TWO' SID was used for both runways and in all directions (Figure 3). When departing from runway 03 using this departure, after take-off the crew were to maintain a heading of 016° (magnetic) for 4 NM (about 7 km) and conduct a left turn at waypoint MIDLA. For runway 21, the crew were to maintain a heading of 196° for 4 NM (about 7 km) and turn right at waypoint NAVEY at or above 2,500 ft above mean sea level.
