Loss of control and collision with terrain involving YAK-9UM, VH-YIX

19 km west-north-west of Latrobe Regional Airport, Victoria, on 7 September 2018

ATSB Transport Safety Report
Aviation Occurrence Investigation
AO-2018-061
Final – 17 June 2020

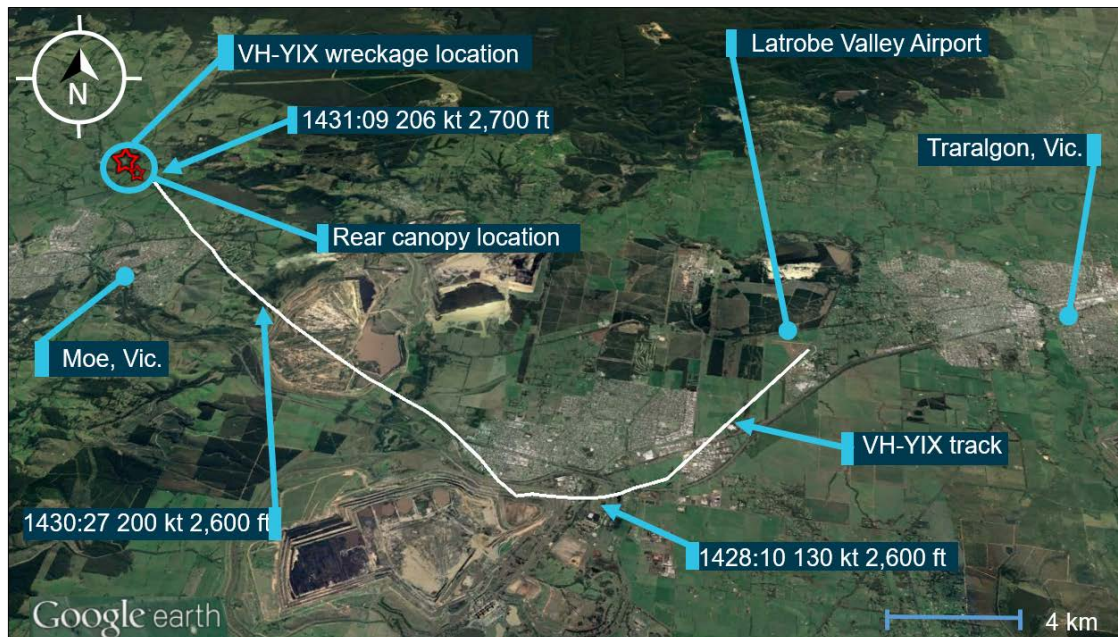
Figure 1: Flight track of VH-YIX

The YAK 9 initially maintained runway heading as it continued to climb. At 1428, it was identified by military radar turning off runway heading to the west at about 130 kt (Figure 1). The aircraft climbed to about 2,600 ft above mean sea level (AMSL). About 4.6 km to the south-west of Latrobe Regional Airport, it was observed on radar to level out.

At 1431:09, the aircraft was about 18 km to the north-west Latrobe Regional Airport at about 2,800 ft, and travelling at 206 kt groundspeed when the pilot began to conduct what ground witnesses assessed as aerobatic manoeuvres. Radar contact with the aircraft was lost during those manoeuvres. The aircraft briefly reappeared on radar at 1431:34, at about 3,100 ft, (2,900 ft above ground level) with a groundspeed of 157 kt. This was the last contact received by radar, and showed a 49 kt reduction in groundspeed during the 25-second period when the aircraft was not visible on radar.

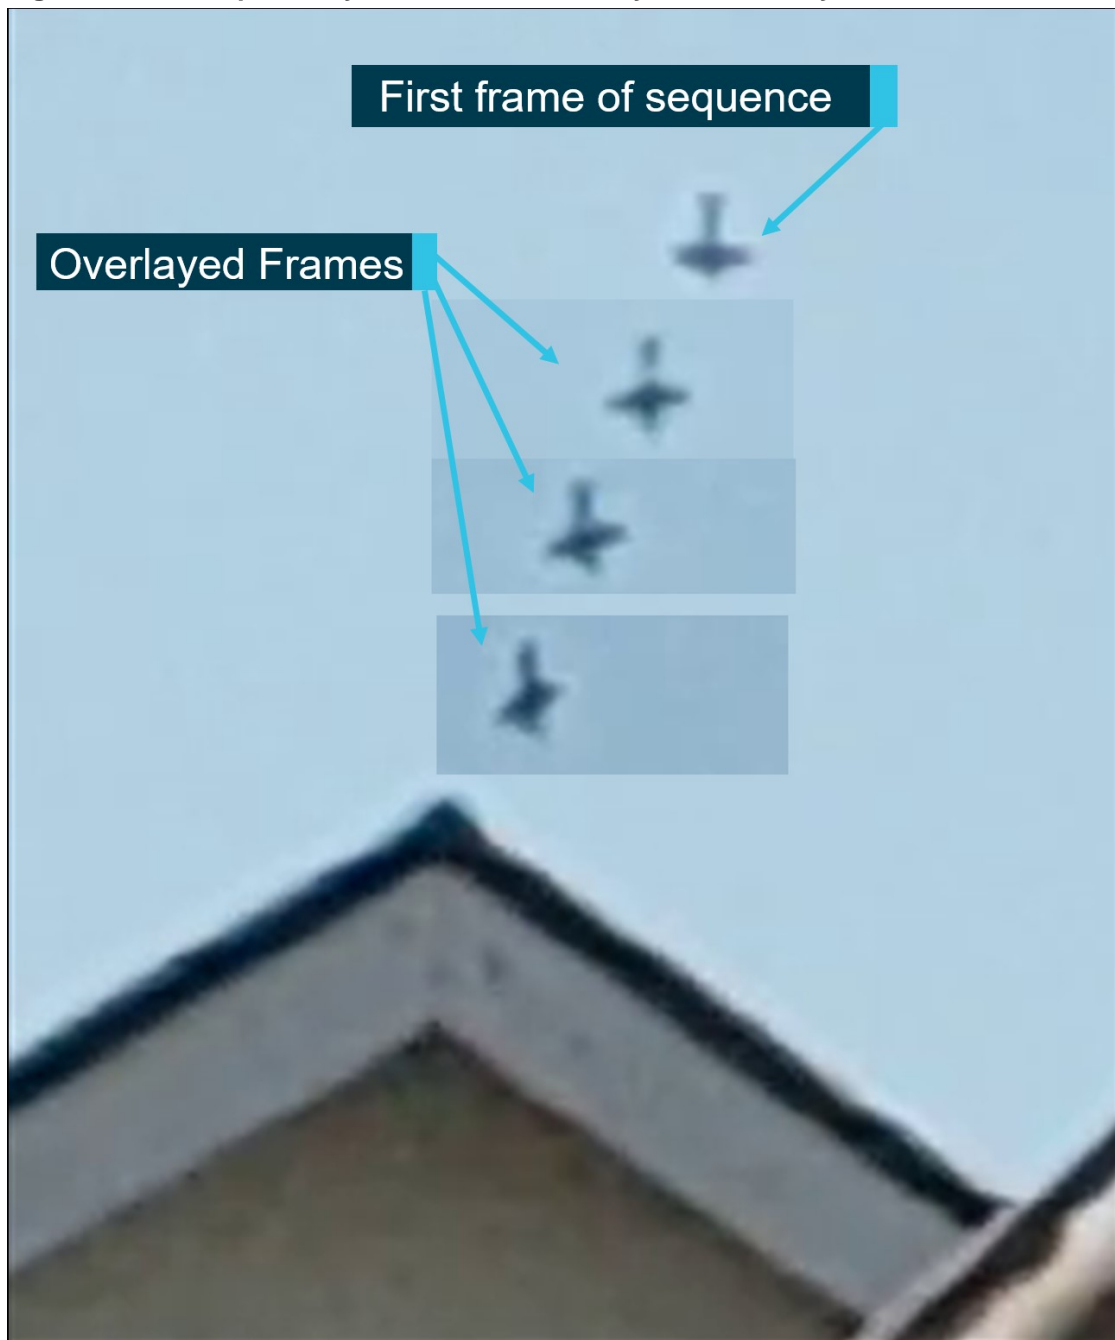
Figure 2: Video captured by a witness with overlaid ATSB analysis

Witnesses in the Moe region, who were actively watching the aircraft from the ground, observed the YAK 9 conduct a series of what appeared to be aerobatic manoeuvres. One witness described what appeared to be a roll followed by a loop. They stated that as the aircraft came out of the bottom of the loop, the aircraft appeared to conduct an abrupt left turn before it began spiralling towards the ground. Video taken by another witness showed the aircraft in a spinning, steep nose-down attitude prior to disappearing from view (Figure 2). These four frames were captured over 0.48 seconds.

Analysis of video footage provided by a witness indicated that VH-YIX was established in a spin when the aircraft disappeared from view below 1,000 ft above ground level (AGL). The aircraft damage and localised nature of the accident site confirmed that the aircraft collided with terrain in a right wing-low and nose-down attitude at high vertical speed and with little forward movement. That impact signature was consistent with the aircraft established in a spin.

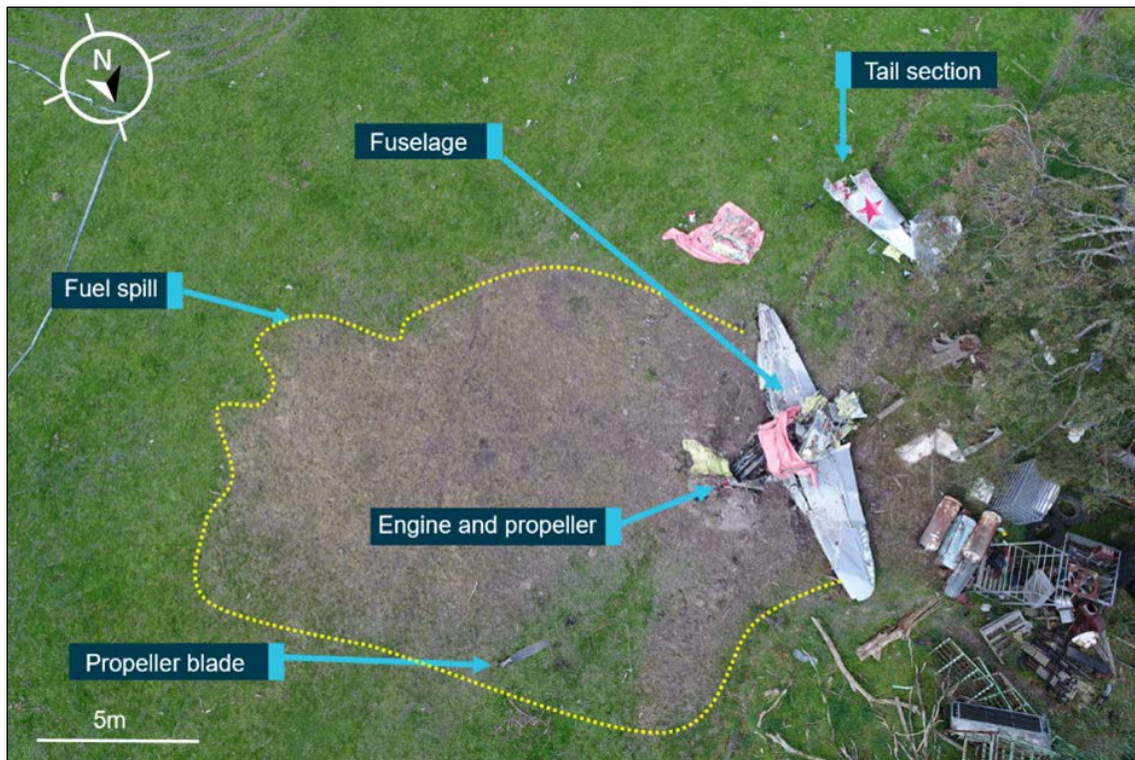
Figure 4: Major features of the wreckage at the accident site

The site inspection confirmed the presence of all the major flight control surfaces including trim tabs, the tailplane, fuselage and wings.

Fuel burns to grass were identified forward of the aircraft's orientation. This was the result of the highly compressed wing structure rupturing the main leading edge fuel tanks, allowing fuel to escape on impact, chemically burning vegetation adjacent to the accident site.

The lack of wreckage trail, high compression of the aircraft structure and close proximity of the majority of the aircraft pieces indicated an impact at a high vertical speed with little forward movement.

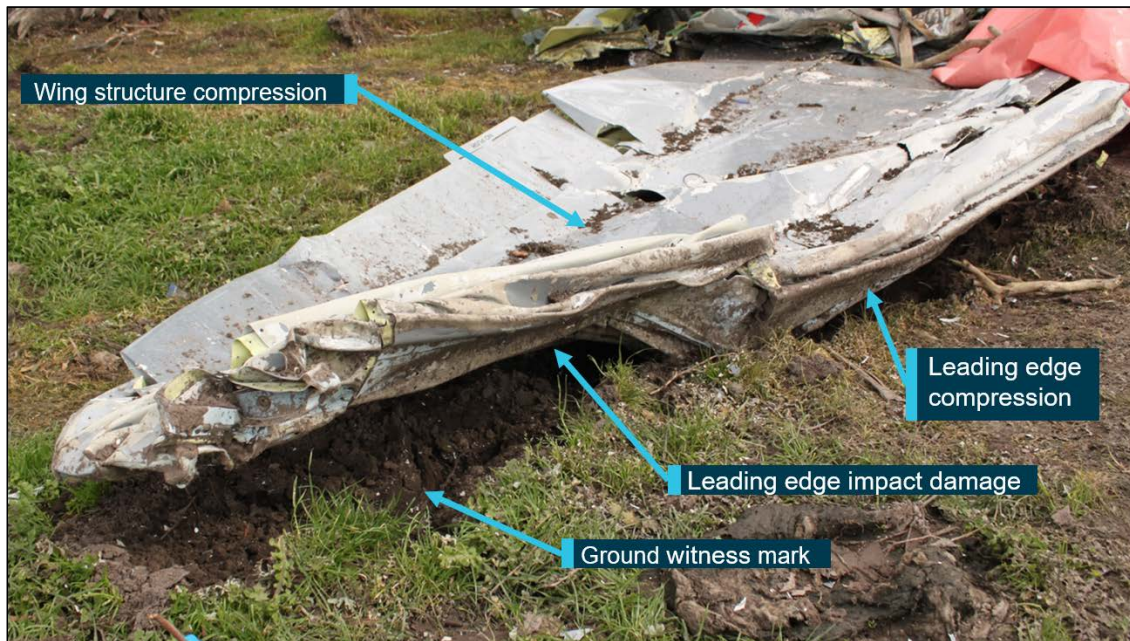
Figure 5: Right wing structure impact damage

Ground impact marks and aircraft damage indicated that the YAK 9 collided with terrain in about a 30° right wing low, and 30° nose-low attitude (Figure 5). This attitude and wreckage distribution was consistent with the wreckage pattern of an aircraft established in, or partially recovering from, a spin.

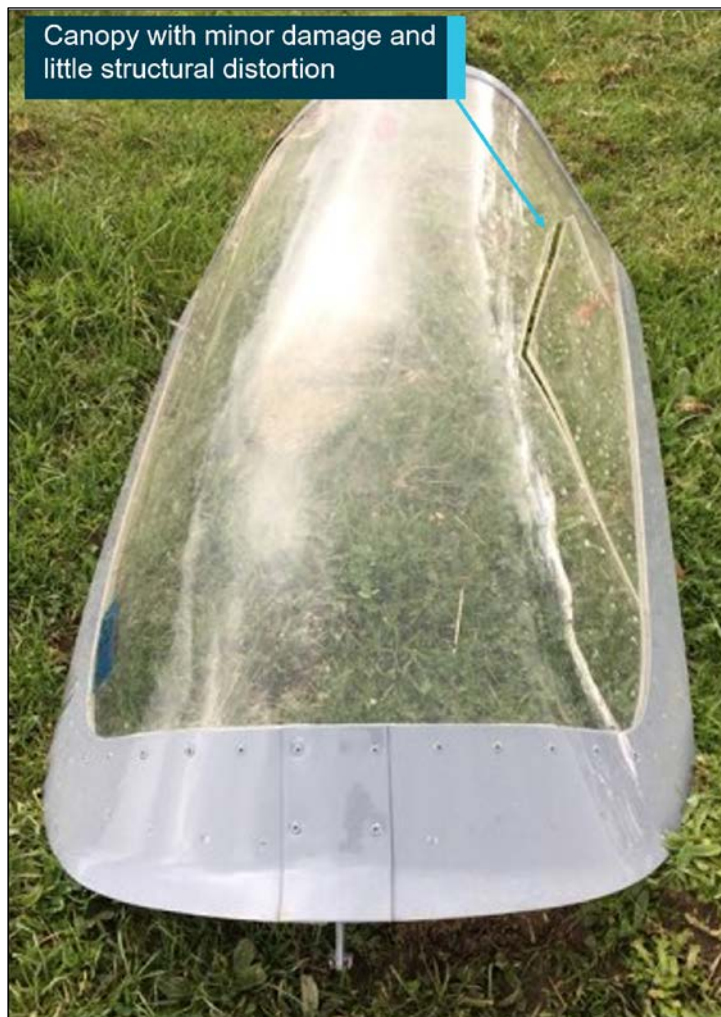
Figure 6: Forward looking view of the rear canopy

Assessment of canopy photographs identified that the canopy was relatively intact, sustaining only minor damage upon separation from the aircraft and some further damage on impact with the ground. The canopy's transparency contained two large cracks on the left and right side; originating at the forward corners of the canopy frame and extending rearward. The transparency was contained within its alloy frame. The forward part of that frame, identified as the canopy bow, had buckled in a rearward manner, likely due to impact with the ground (Figure 6). There was no evidence that the rear canopy contacted the aircraft structure, including the flight controls, following detachment.

While it remains unknown if an open rear canopy may have a detrimental effect on airflow over the rear control surfaces of the YAK 9, it is unlikely to have been sufficient to cause a loss of control as it was open from the commencement of the take-off. However, the canopy's departure from the airframe was probably sudden and could well have distracted the pilot. Given the proximity

- The rear canopy was unsecured before take-off and consequently separated from the aircraft during flight. This increased the risk of damage to aircraft structure, distraction of the pilot and possibly adverse handling qualities.
- Post-accident examination of the aircraft identified incomplete maintenance practices, including inadequate airframe anti-corrosion measures and insecure primary flight controls and seat fasteners.
- The aircraft was operated without the maintenance release or the flight manual, which deprived the pilot of important operational and maintenance-related information.

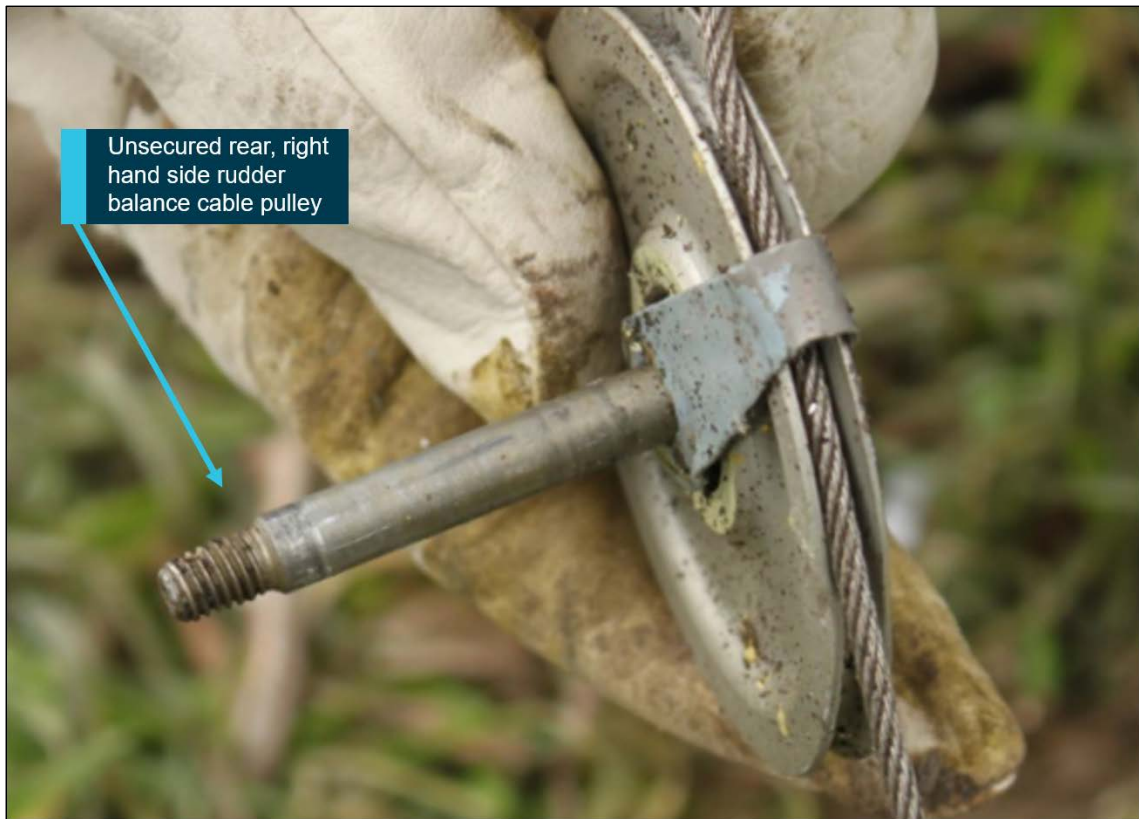
Figure 7: Rear right rudder pulley, found away from the airframe.

able to be located and there was no evidence that the fastener had failed due to force associated with the impact sequence (Figure 7).

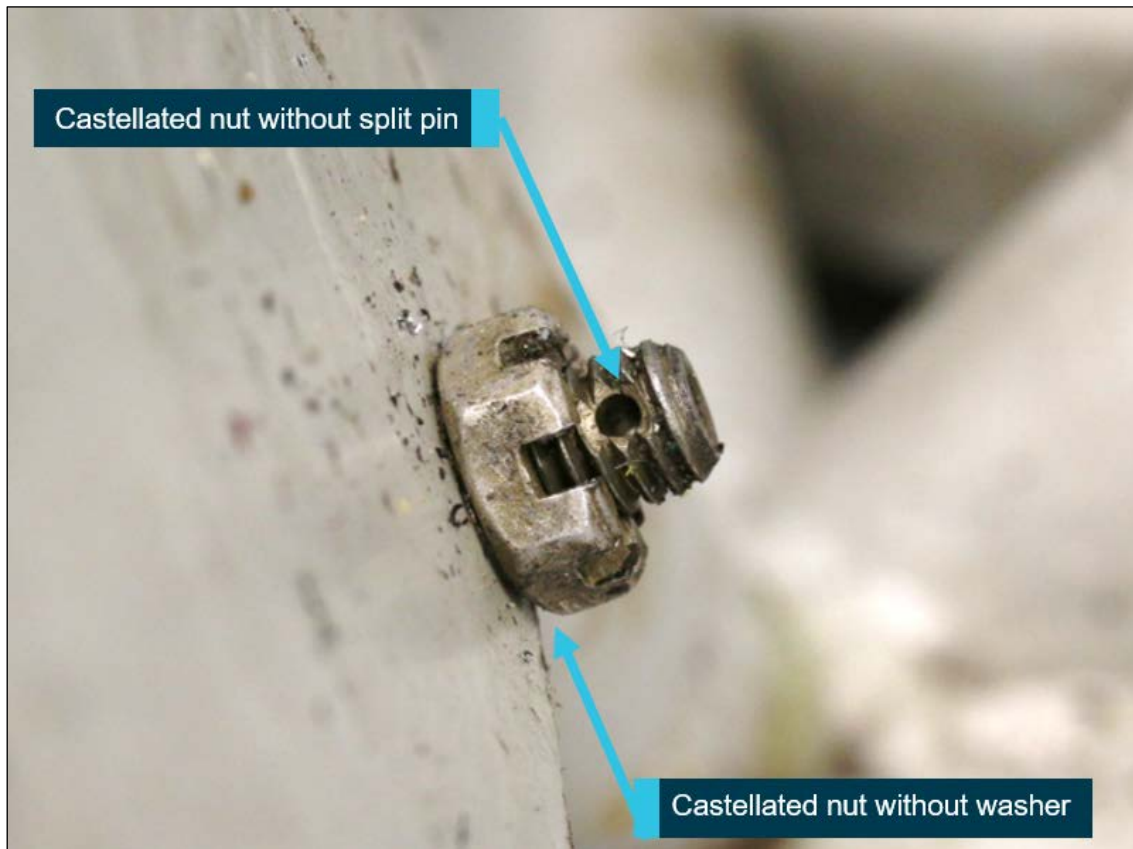
Figure 8: Left side rear rudder balance cable bolt and castellated nut

An additional anomaly was noted with the left-side rudder pulley. Although the castellated nut was present on the bolt threads to that pulley, no split pin had been fitted. Furthermore, even if one had been fitted, the fastener arrangement would not have prevented loosening of the castellated nut (Figure 8).
