Loss of control and collision with terrain involving BRM Aero S.R.O Bristell LSA aircraft, VH-YVX

Stawell, Victoria, on 5 October 2018

ATSB Transport Safety Report
Aviation Occurrence Investigation
AO-2018-066
Final – 29 June 2020

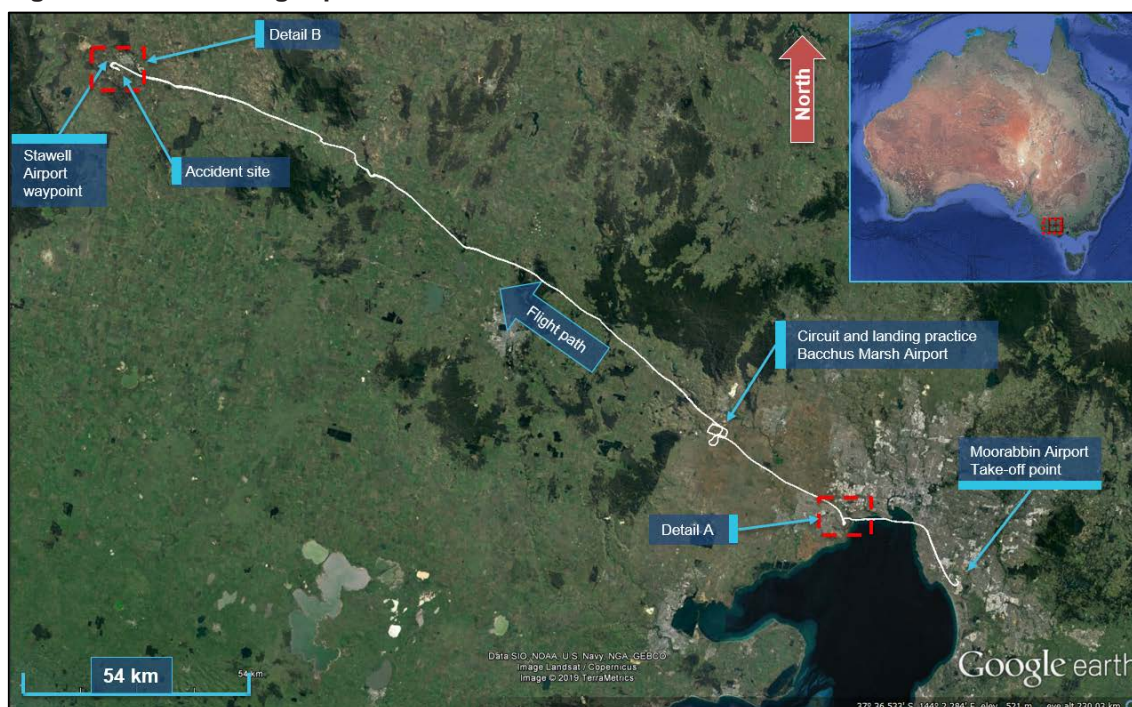
Figure 1: Aircraft's flight path and accident site location

Automatic Dependence Surveillance Broadcast and on-board flight and GPS data recorded the aircraft position and attitude throughout the flight (see the section titled Recorded information). The data showed the take-off and flight over the northern part of Port Phillip Bay, followed by the commencement of significant manoeuvring overhead a built-up area to the west of Melbourne (Figures 1 and 2).

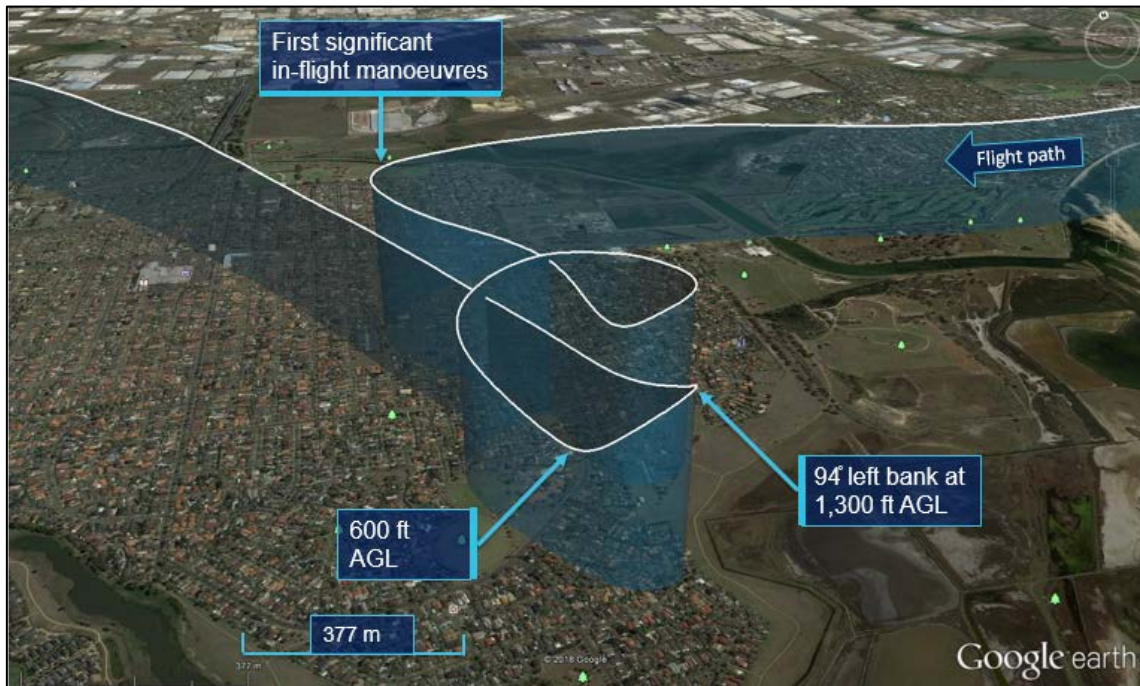
Figure 2: Detail A – Recorded data of the aircraft flight path over a built-up area

Figure 1 details the flight path of the aircraft in the area labelled as 'Detail A' in Figure 1. The data showed that the pilot conducted significant manoeuvres including steep climbs, descents and turns in excess of 90° angle of bank over a built-up area and at heights between 600-1,300 ft above ground level (AGL).

In discussing that segment of the flight, the pilot stated that a 360° turn was conducted over the house of someone the pilot knew in the area. The pilot did not recall conducting any aerobatics or significant manoeuvring at that time.

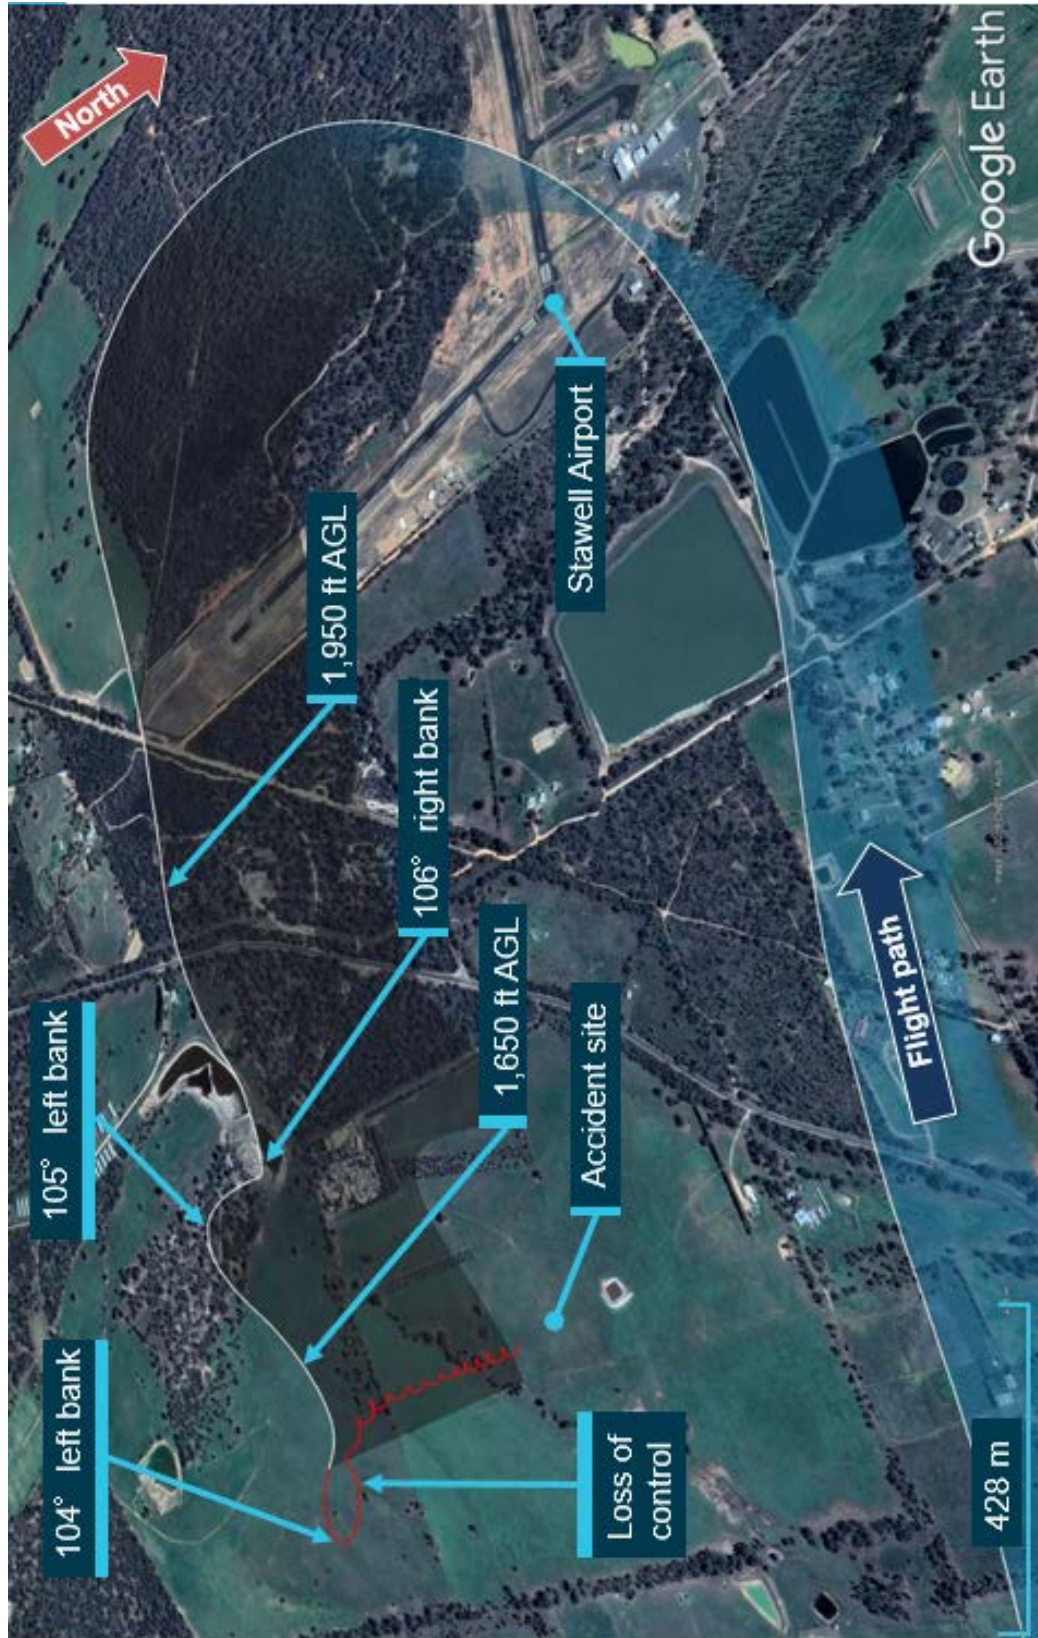
Figure 3: Detail B – Aircraft operation in the vicinity of Stawell Airport

At about 1240, three witnesses at Stawell Airport observed the aircraft overfly the airport before commencing a 180° turn back towards the south-east. Following that turn, the aircraft was observed to commence a number of significant manoeuvres including steep climbs and turns described as aerobatic in nature. The aircraft was then observed to abruptly enter a flat spin (see the section titled *Spins and spin recovery*) and descend out of view.

Analysis of the recorded data identified that, after passing overhead the airport, manoeuvres far in excess of the aircraft's performance limitations were conducted. Based on the magnitude of the recorded pitch and roll values, the manoeuvres were classified as aerobatic. Further data analysis established that while the aircraft was pitching and rolling out from a diving left steep turn, it experienced an accelerated aerodynamic stall² while rolling at an indicated airspeed of about 93 kt. The aircraft subsequently flick-rolled and entered a fully developed upright spin at an altitude of about 1,650 ft AGL. The aircraft maintained the spinning descent until it impacted terrain.

When provided with detail of the recorded flight data and other accounts, the pilot was unable to reconcile the difference between their recollection of the event and that of the witnesses and the recorded data. Figure 3 shows the aircraft track, manoeuvring and spin. The red portion of the flight track is the point at which the GPS lost signal and position data was no longer recorded. This

was likely due to a combination of the aircraft's rapid movements and the GPS antenna position. From that point onwards, position data was calculated using groundspeed, bearing and barometric altitude data.

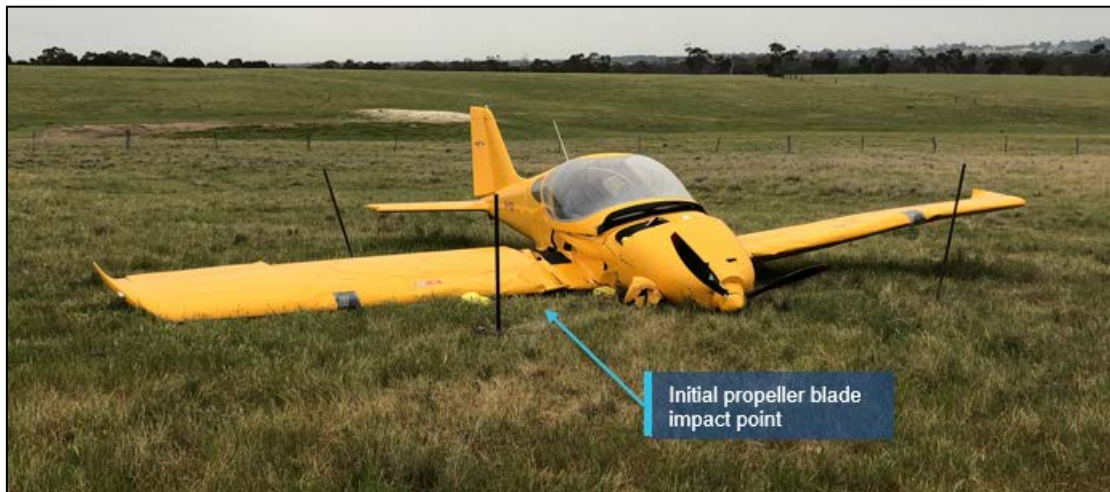
Figure 7: Aircraft accident site

- the aircraft was located in relatively flat and open farmland, about 1.7 km south-east of Stawell Airport
- ground impact marks indicated that the aircraft had impacted terrain in a relatively flat, upright, counter clock-wise spin
- the flaps were in the retracted position
- there was evidence of a significant amount of fuel at the accident site and the airframe fuel filter bowl was full of fuel and free of contaminants
- the propeller blades showed rotation damage consistent with engine operation at a low power setting at impact
- elevator trim was in a neutral position
- no pre-impact defects were identified with the flight controls or aircraft structure
- all aircraft components were accounted for at the accident site.

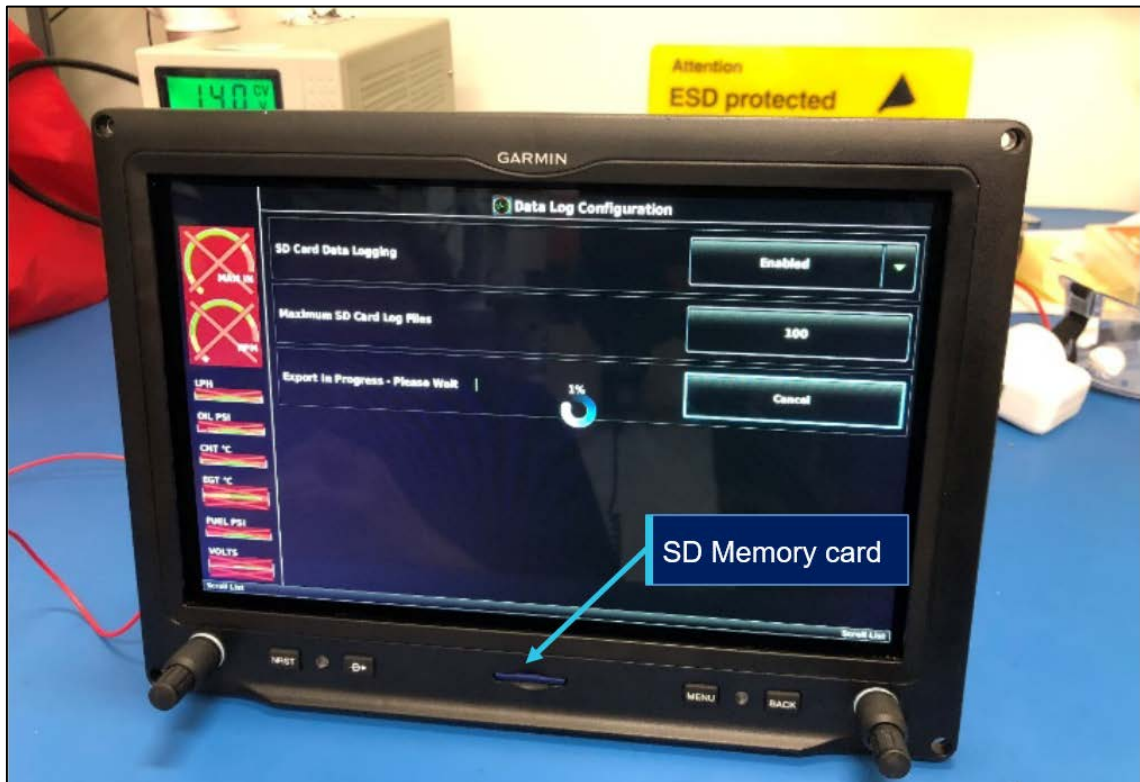
Figure 8: G3X avionics unit being downloaded, showing memory card position

The ATSB inspected the G3X unit and identified that it was visually undamaged. There was no SD card fitted to the unit. On return to Canberra, the unit was powered up with an SD card fitted (Figure 8). Data files associated with the accident flight were successfully downloaded from the memory module to the card.

The operator conducted a fleet-wide installation of SD cards to all aircraft capable of storing data.

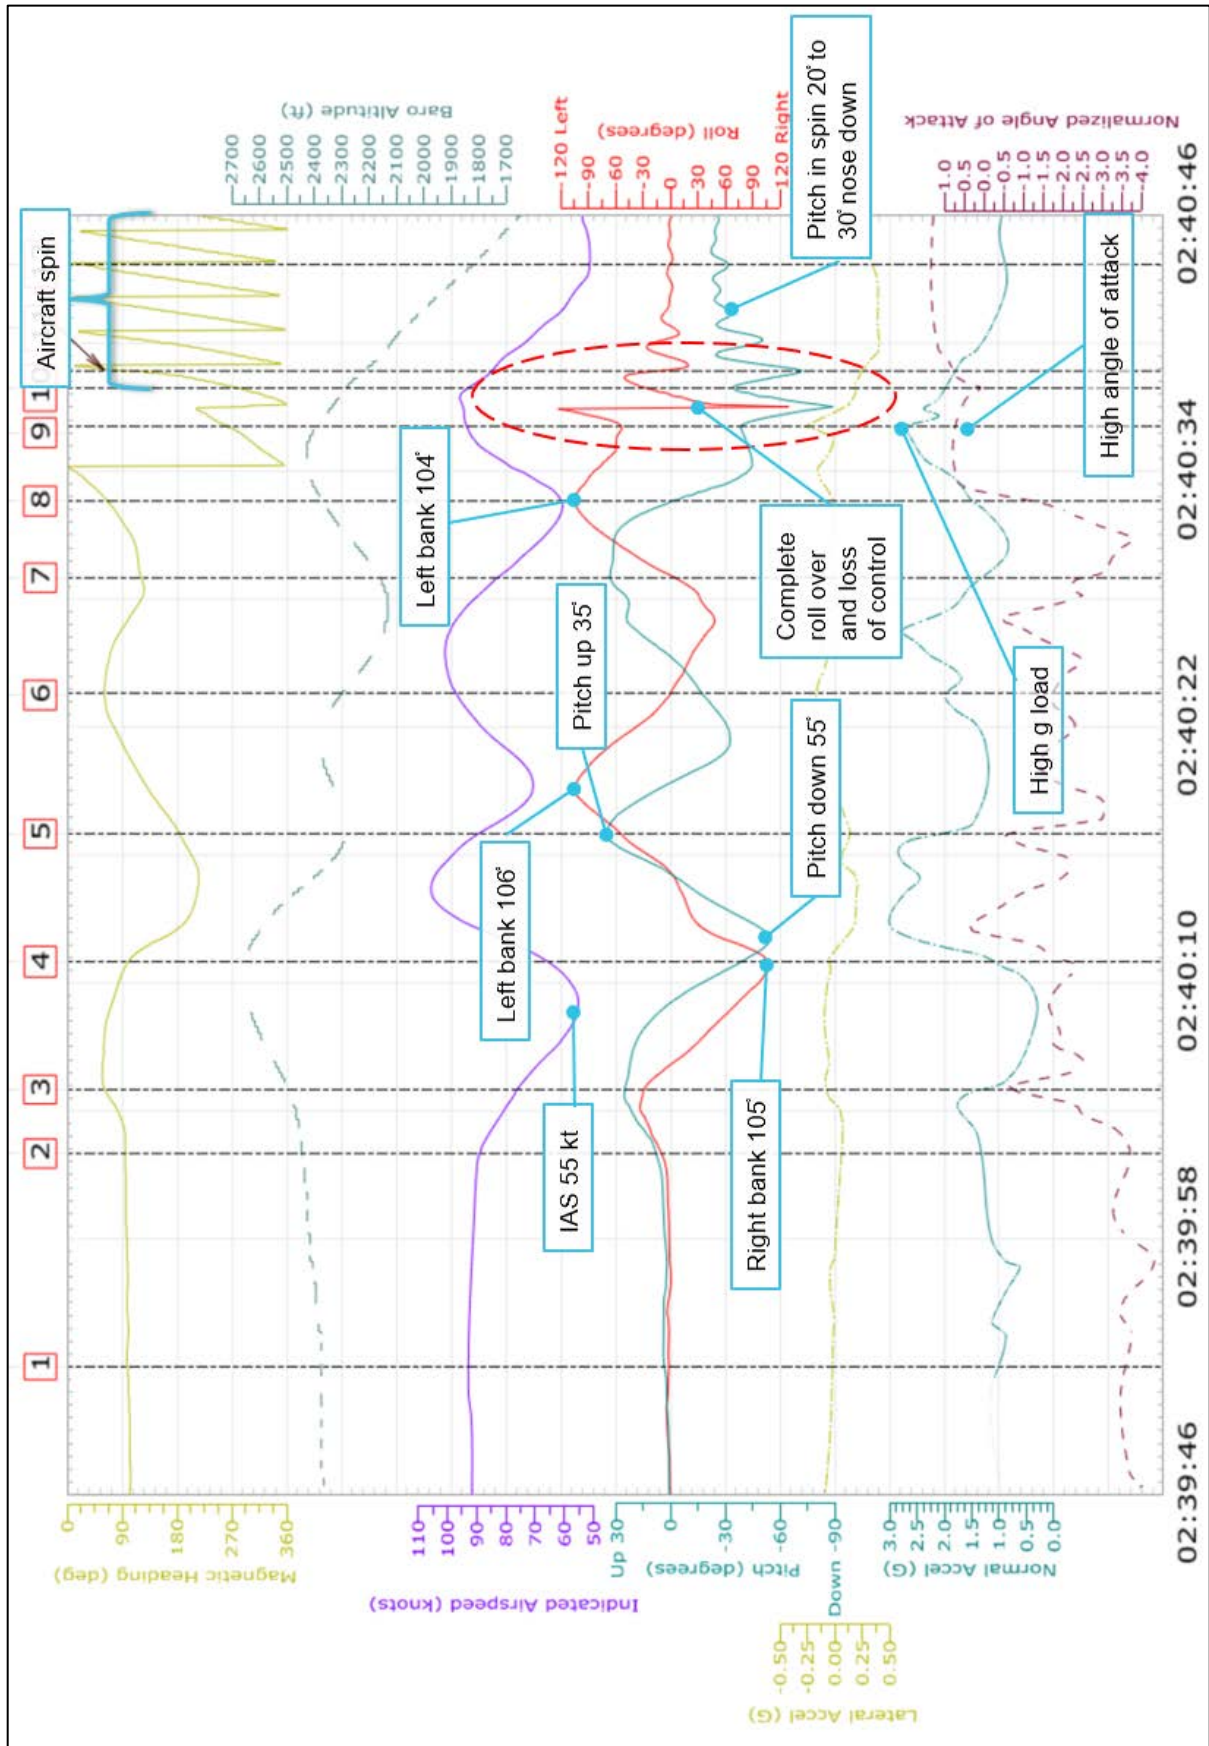
Figure 9: Last 60 seconds of recorded flight data parameters prior to the accident

Additional aerobatics were conducted mid-flight between Bacchus Marsh and Stawell airports, with one exceeding the aircraft's flight load limitations. The aircraft was then observed by witnesses to overfly Stawell Airport before again commencing significant pitch and bank manoeuvres. During one of these manoeuvres, the aircraft experienced an accelerated aerodynamic stall and entered into an upright spin at an altitude of about 1,650 ft AGL. This progressed into a fully developed spin that continued until the aircraft impacted terrain.
