# Loss of control and collision with terrain involving Diamond DA40, VH-YPQ

1 km south of Port Macquarie Airport, New South Wales, on 8 September 2017

**ATSB Transport Safety Report**  
Aviation Occurrence Investigation  
AO-2017-090  
Final – 30 June 2020

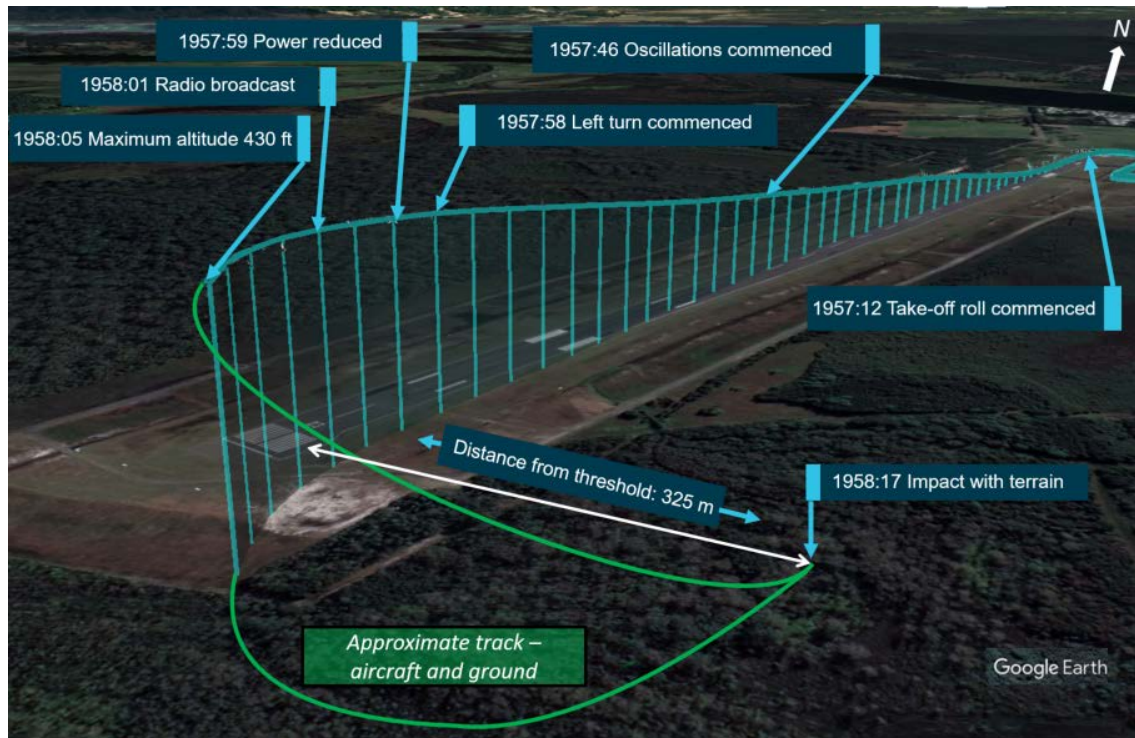
**Figure 1: Aircraft flight path and key events**

It was dark and the moon had just risen above the horizon when the aircraft commenced the take-off roll at 1957:12 Eastern Standard Time<sup>1</sup> (Figure 1). During the initial climb, about 20 seconds after lift-off, while still above the runway and passing 200 ft, the instructor noticed changes in the engine sound, felt acceleration changes and saw fluctuating indications on engine load and propeller RPM gauges, despite maintaining the power lever in the fully forward maximum power position.

The fluctuations increased over the next 20 seconds as the aircraft climbed. During that time, the aircraft pitched up to about 8 degrees, consistent with the normal attitude for initial climb and to achieve the best rate of climb speed, and the vertical speed increased to more than 900 ft per minute. The instructor assessed that the fluctuations were due to an engine problem and considered the options for landing.

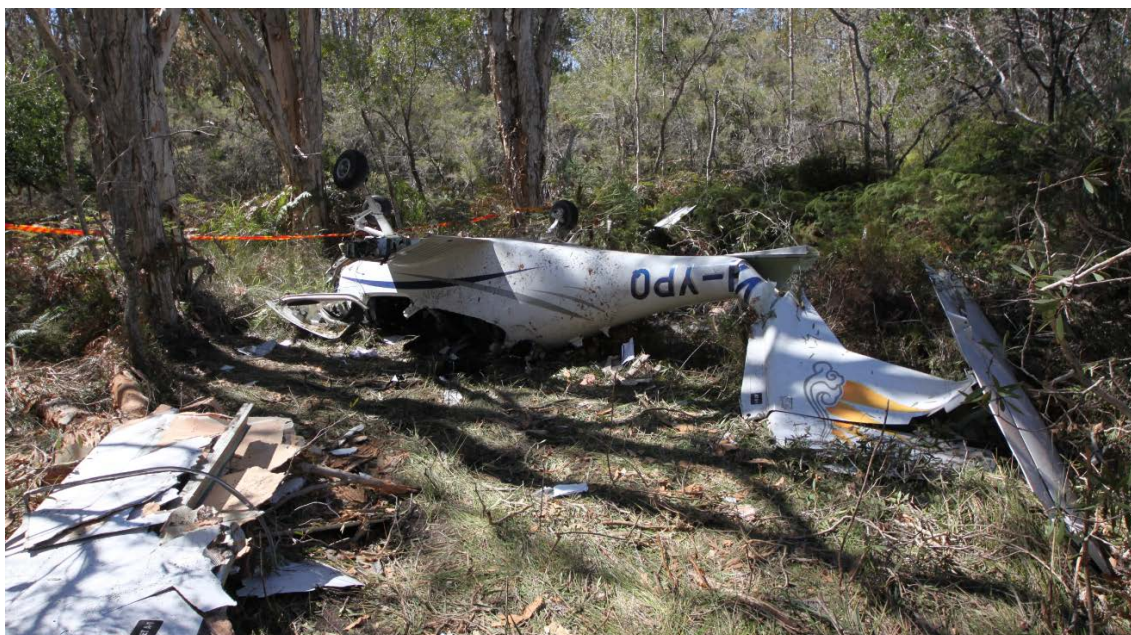
**Figure 3: Wreckage of VH-YPQ, which was partially disturbed during rescue of the occupants**

The aircraft initially impacted trees causing significant structural damage to the wings, after which it impacted terrain inverted and at a nose-down angle of about 25°. The cockpit was partially collapsed, with the airframe resting on the instrument panel and seat backs. Both wings and the tail detached during the impact sequence (Figure 3).

Examination of the aircraft wreckage found no pre-existing airframe issues. The flap actuator was found in the take-off position. The aircraft's fuel tanks were breached and there was evidence of fuel spillage. A small quantity of fuel was drained from the tanks and matched the characteristics of aviation turbine fuel. It tested negative to water content. Previous fuel records and the engine data both indicated that there was sufficient fuel on board the aircraft for the intended flight.

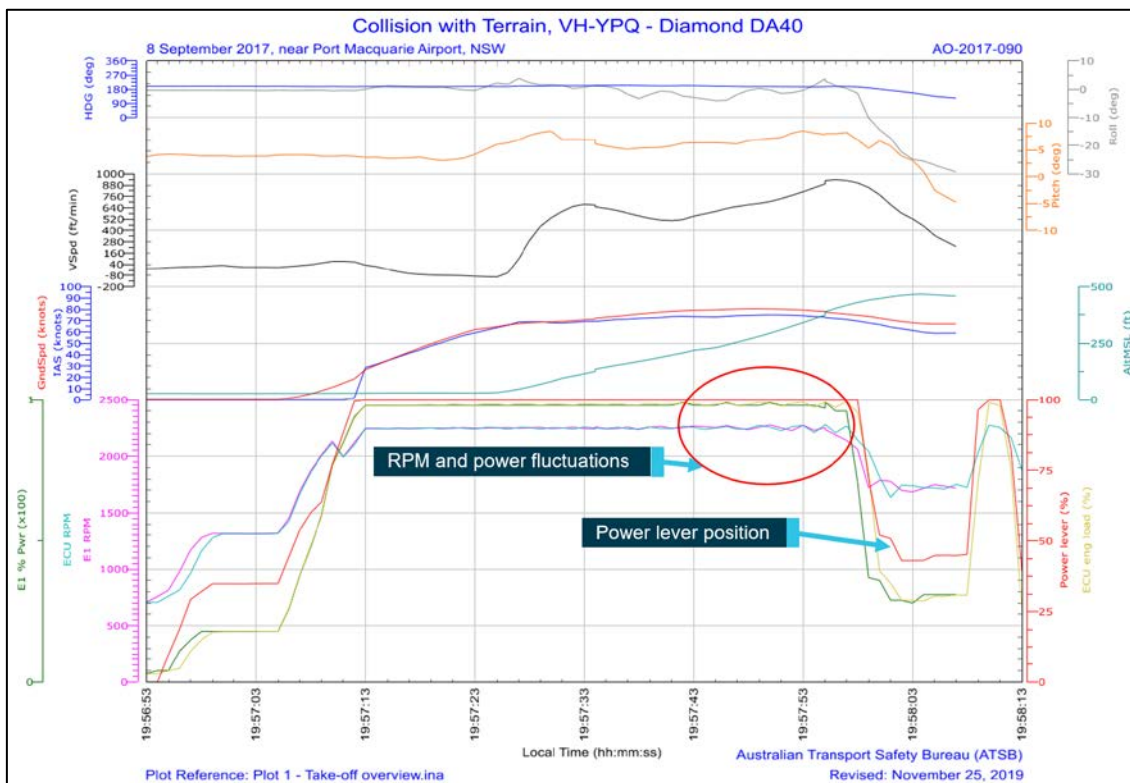
**Figure 5: Plot of selected engine and aircraft GPS data parameters**

The fluctuations continued to increase in amplitude over the next 10 seconds to a maximum variation of 73 RPM in 1 second (which equated to about 3 per cent of an average 2,250 RPM) as the aircraft climbed to 361 ft.

Image shows increasing fluctuations in propeller RPM and engine load, followed by a sequence of power lever movements with corresponding RPM and load variations.

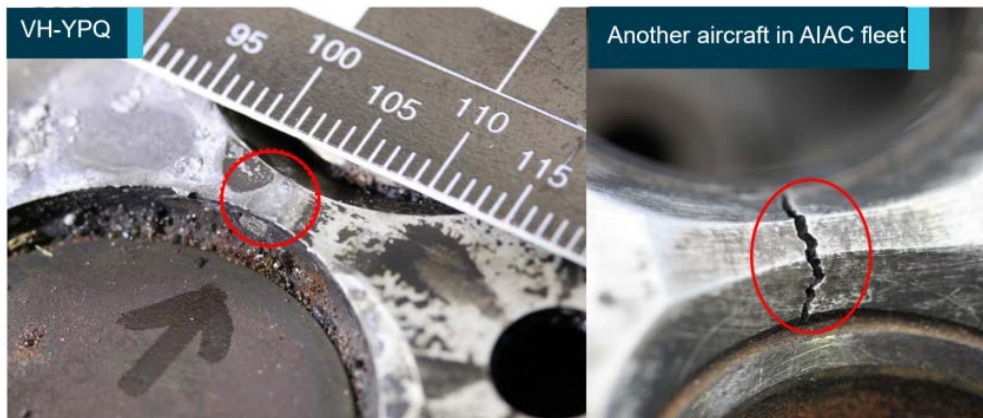
**Figure 7: Cylinder cracks in VH-YPQ and another aircraft**

After the accident and under the supervision of the ATSB, the operator examined the cylinder head fitted to VH-YPQ. Hairline cracks were identified in the cylinder head in the same location as VH-YPJ (Figure 7), however those cracks were assessed as insufficient in size to create engine problems at the time of the accident.

While not contributing to this accident, engine cylinder head cracking in the aircraft operator's fleet of DA40 NG aircraft had occurred before the service life of 1,800 hours was exceeded. A crack in an engine cylinder head may develop to a size that results in loss of compression or power, foreign object damage or engine failure.
