# Driveshaft failure and hard landing involving Overseas Aircraft Support UH-1H helicopter, VH-OXI

near Crawford River, New South Wales, on 7 December 2019

**ATSB Transport Safety Report**  
Aviation Occurrence Investigation  
AO-2019-070  
Final – 16 July 2020

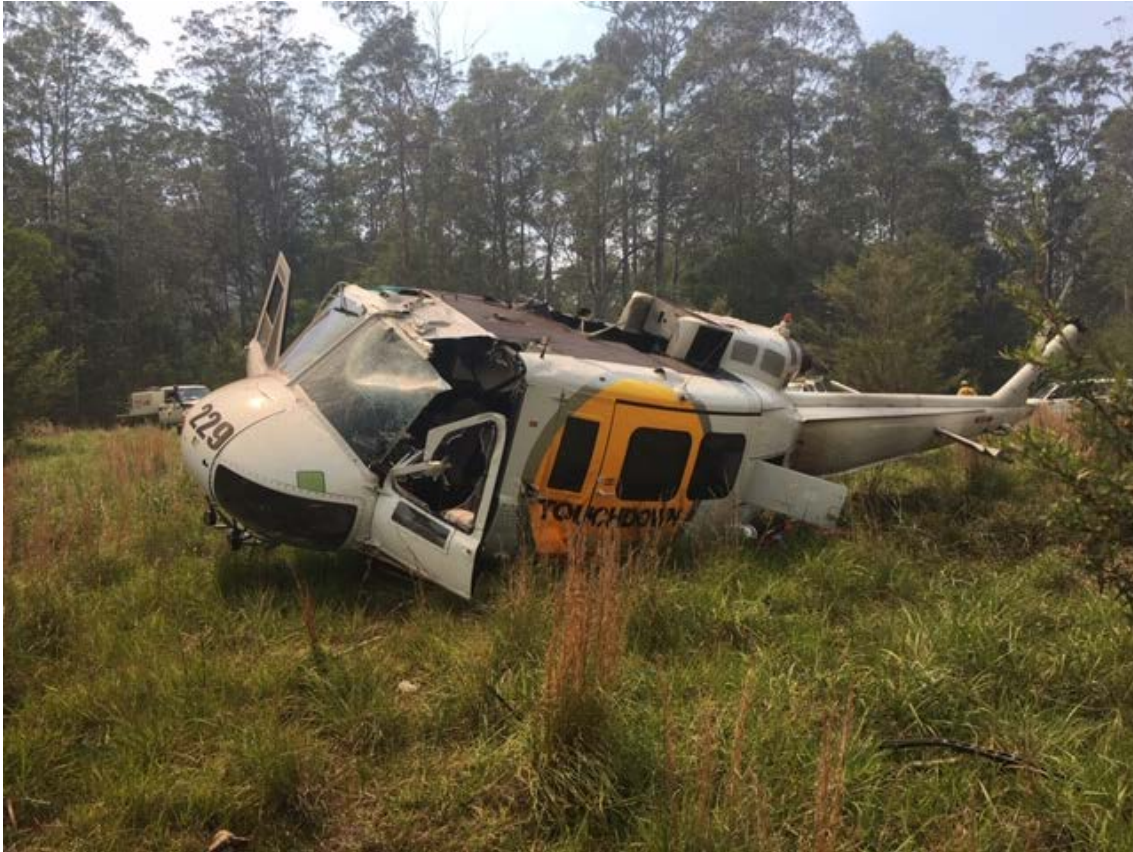
**Figure 1: Main wreckage site**

Rural Fire Service and National Parks personnel responded immediately and arrived at the accident site shortly after the pilot had exited from the wreckage (Figure 1). They extinguished a small grass fire that had been started by the helicopter. The pilot was transported to hospital by ambulance for observation and then released with nil injuries. The helicopter was substantially damaged.

When in a hover position, just prior to landing, the helicopter started to yaw right. Despite the pilot's attempt to stop the yaw, directional control could not be regained, which resulted in a hard landing. During the landing, the main rotor blades struck the ground, resulting in the failure of the main gearbox mounts and the forced ejection of the main gearbox, mast, rotors and KAflex® driveshaft from the airframe.

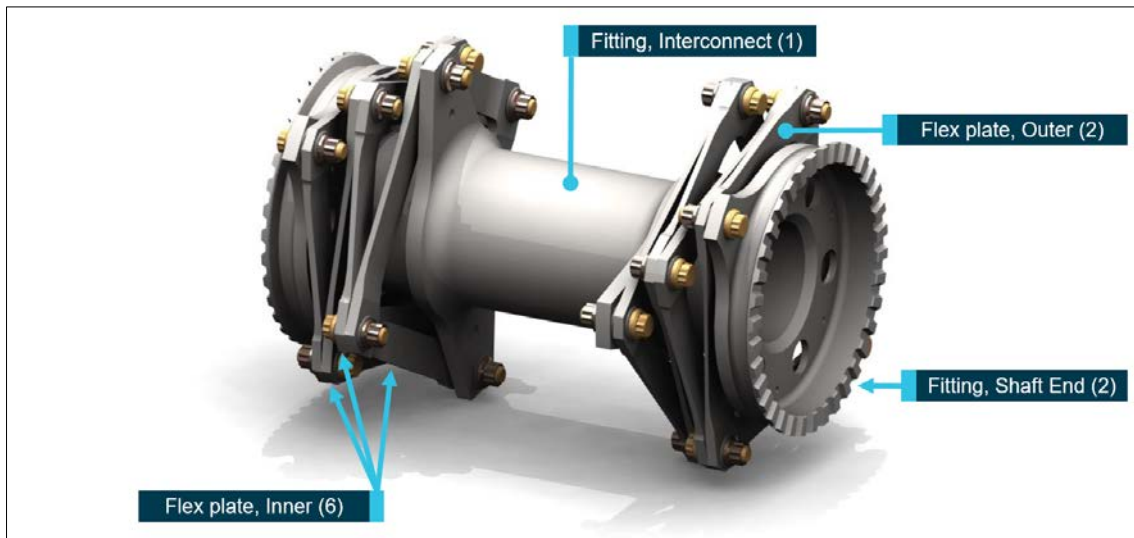
**Figure 2: KAflex® driveshaft – key parts identified with the number of each part fitted annotated in brackets**

The KAflex® driveshaft (part number: SKCP2281-103), which transmits the drive power from the engine output to the main gearbox input, was found to have fractured into multiple pieces. The driveshaft uses flexible plates (Figure 2) to accommodate relative movement between the engine and gearbox, and was designed with an integral failsafe feature for continued flight in the event of a single flex frame fracture. It will permit a limited continued power operation (20 minutes demonstrated during qualification), enabling pilots to safely land the helicopter.

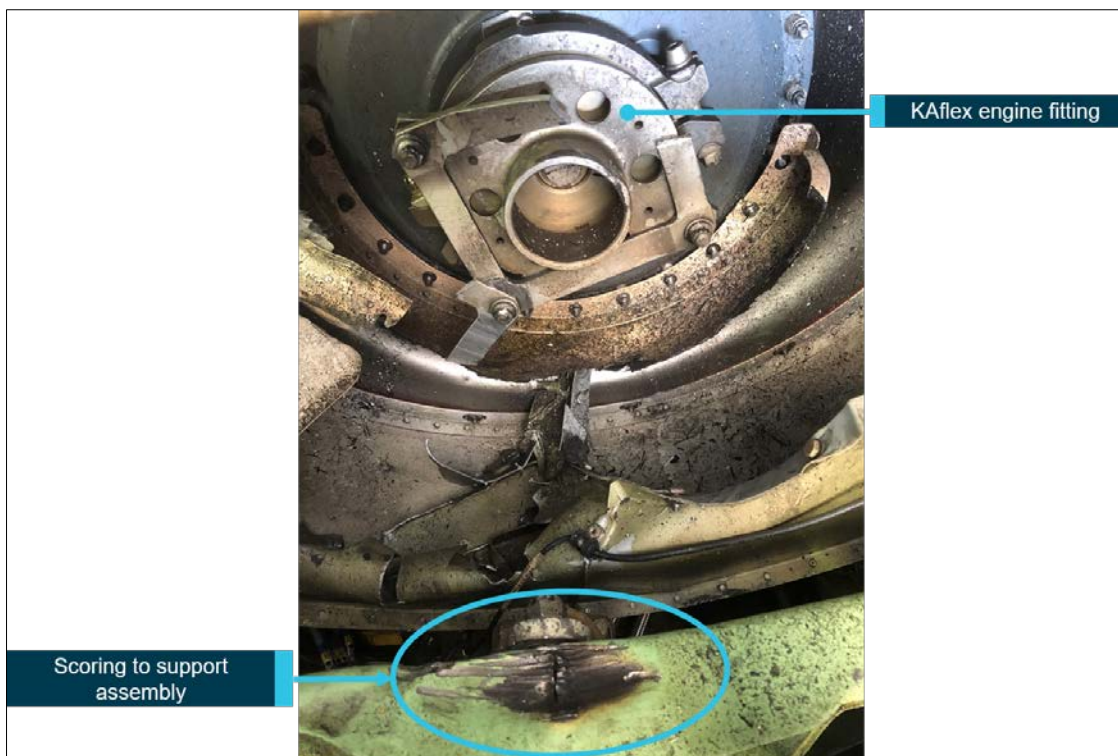
**Figure 3: Scoring to the rear transmission mount support assembly**

The visual inspection of the driveshaft noted a failure of one of the outer flex plate bolt holes, where the plate was bolted to the main gearbox-end fitting. In addition, there were five recessed washers missing from various fasteners. The rear transmission mount support assembly exhibited scoring below the location of the driveshaft gearbox-end fitting (Figure 3). Discoloration of a section of the failed outer flex plate was consistent with the scoring to the support assembly. The ATSB retained the helicopter's KAflex® driveshaft (serial number 2136) for materials examination.

An inspection of the airframe revealed the KAflex® driveshaft exhibited a fatigue failure of the outer flex plate at a bolt hole where the plate was fastened to the main gearbox-end fitting. The observed scoring marks to the rear transmission mount support assembly were consistent with the failed driveshaft flex plate striking it during operation. This indicated that the driveshaft failure started before the hard landing, and was consistent with the symptoms of noise and vibration reported by the pilot when overhead the Crawford River.

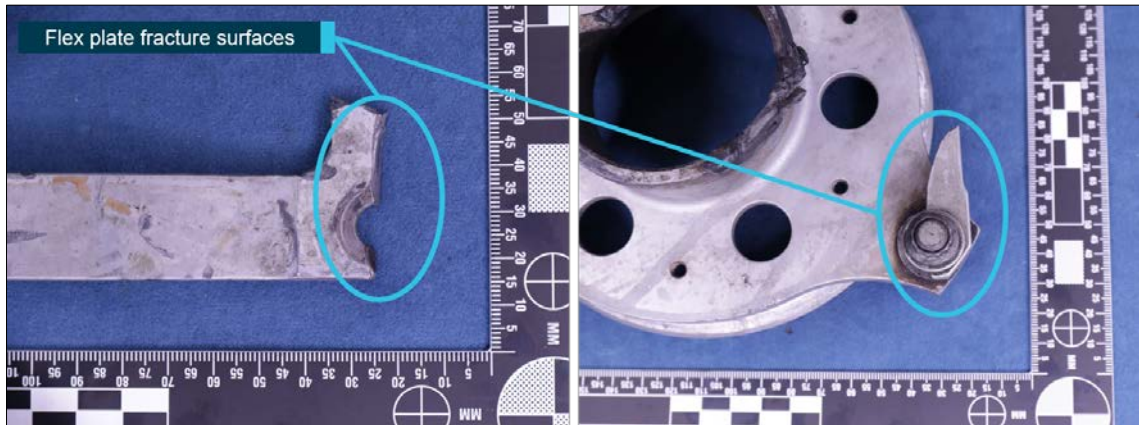
The flex plates from the driveshaft had fractured into multiple segments. The outer flex plate at the main gearbox-end fitting had fractured through the bolt hole, with a small section remaining attached at the join (Figure 4). Examination of the flex plate fracture surfaces revealed evidence of beachmarks, consistent with fatigue crack progression. The fatigue crack had propagated across about 90 per cent of the fractured surface. The surfaces surrounding the fatigue fracture exhibited evidence of surface corrosion and pitting (Figure 5).

**Figure 4: Fractured bolt hole (left) and small section remaining attached (right)**

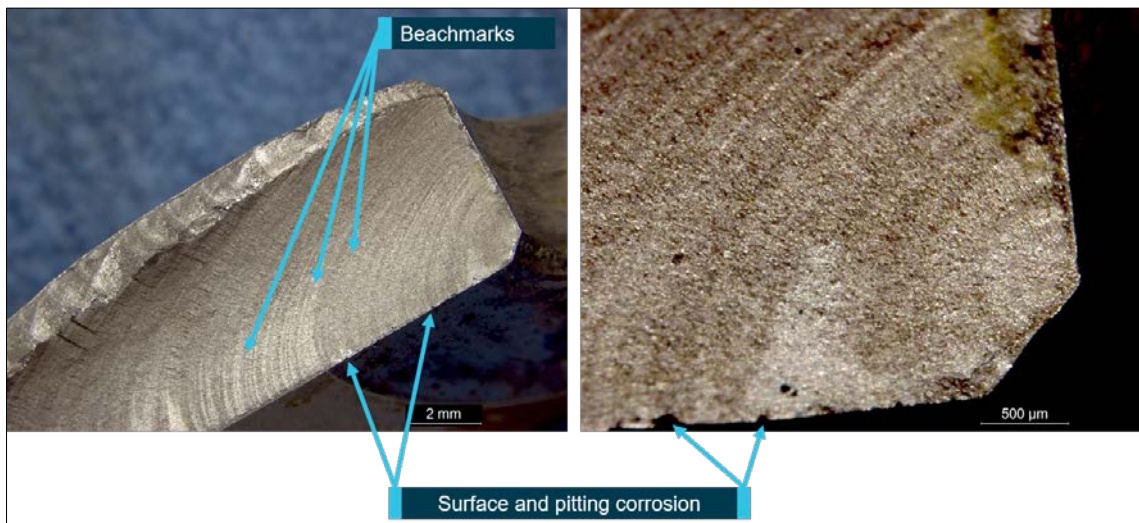
**Figure 5: Fatigue failure of flex plate**

- While conducting fire control operations, the pilot detected a 'buzzing' vibration through the airframe with an associated noise, which necessitated a precautionary landing. During the landing directional control could not be maintained, resulting in a hard landing.
- The helicopter's KAflex® driveshaft failed as a result of a fatigue failure of the outer flex plate attached to the main gearbox fitting.

The operator replaced the KAflex® driveshaft on their other UH-1H helicopter with a new driveshaft. They implemented a maintenance routine to monitor the hours flown and time-in-service of the new driveshaft, and included a scheduled retirement time of 5,000 hours.

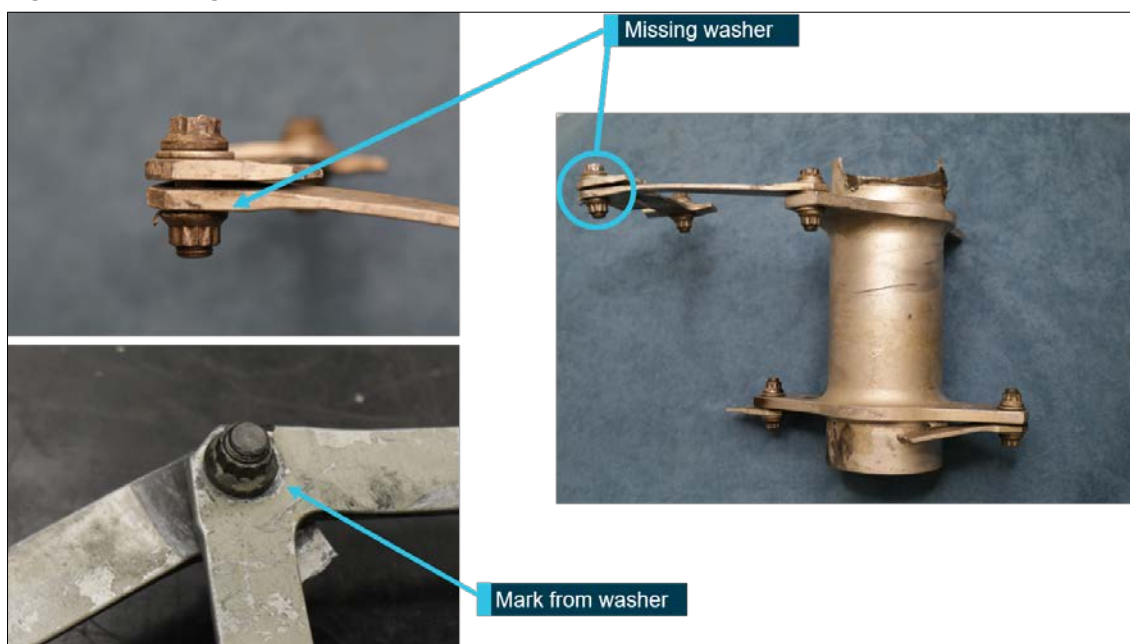
The five missing washers were from four fasteners, and in each of these locations the fasteners were loose and the flex plates free to move with respect to each other. Damage to the fasteners at these locations precluded any useful information with regard to torque values. A witness mark, consistent with a washer, was observed in all the locations. While some marks were more distinct than others, it was considered very likely that a washer had been present at each location at some stage in the life of the component. Figure 6 depicts the location of one of the missing washers.

**Figure 6: Missing washer**

Further inspection of the driveshaft debris revealed that five washers were missing from four fasteners, and that those joints were loose. Witness marks on the flex plates indicated that the washers were fitted at some previous time. The driveshaft was originally assembled in 1980, and had instructions that it was not to be disassembled, but did not have a service life history. While it could not be determined when or how the washers came to be missing, the loose joints would have resulted in excessive movement of the flex plates, which increased the risk of a driveshaft failure.

- The KAflex® driveshaft was missing five washers from various flex plate fasteners. This would have resulted in excessive movement of the flex plates, which increased the risk of a driveshaft failure.

The Civil Aviation Safety Authority inspected the driveshaft and then distributed an occurrence brief to all Australian operators of the UH-1 helicopters and variants with a copy of Airworthiness Bulletin 63-004: *Kamatics Corporation KAflex Drive Shafts – Bell 407*. This included the statement that the bulletin for the Bell 407 helicopters 'is considered equivalent information for all UH-1 rotorcraft.'
