Grounding of the bulk carrier *Orient Centaur*

Weipa, Queensland | 6 November 2017

ATSB Transport Safety Report
Marine Occurrence Investigation
MO-2017-010
Final – 14 November 2019

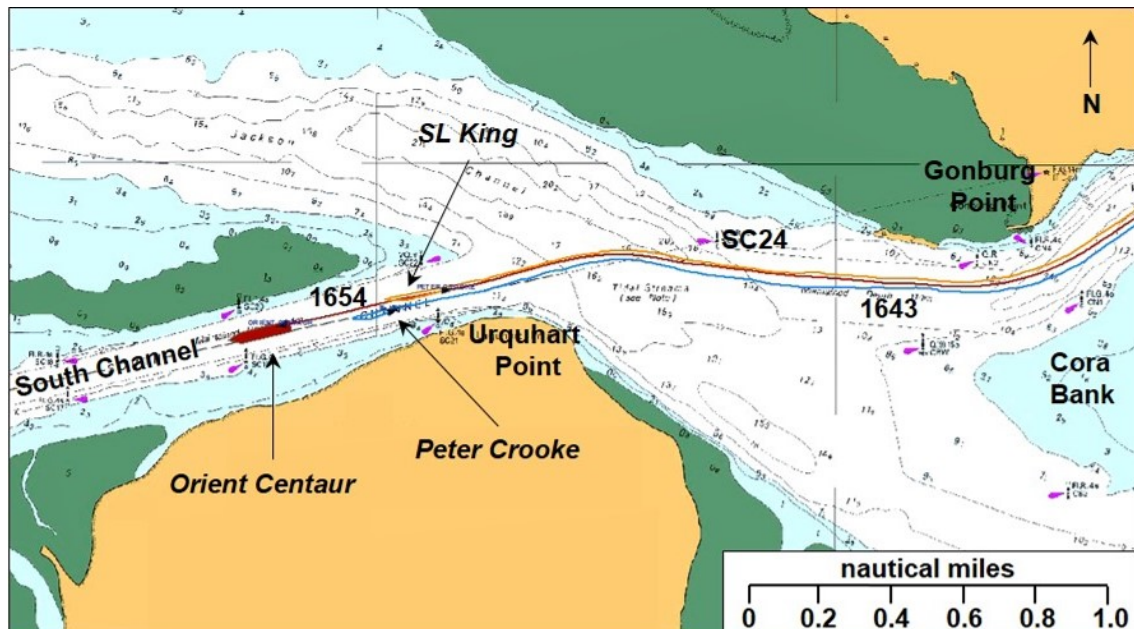
Figure 2: *Orient Centaur* passing Urquhart Point and entering the South Channel

At 1643, as the ship passed Gonburg Point, *SL King* was let go and stood by on the quarter, and the conning pilot ordered full ahead. Shortly after, as the ship passed beacon SC24, the conning pilot ordered port helm and started altering course into the South Channel. At about 1654, when the ship was steady in the South Channel, the conning pilot released the tugs as they passed SC22, and they headed back to their berth (Figure 2). The ship then proceeded outbound in the South Channel as planned, at a speed of about 8 knots.

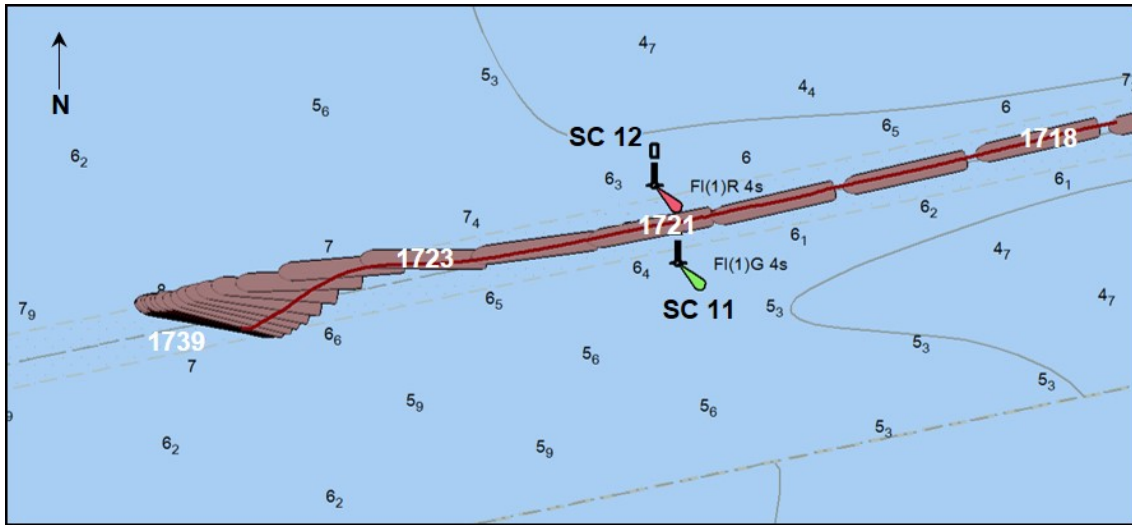
Figure 3: *Orient Centaur*’s main engine shutdown to the grounding at 1 minute intervals

At 1718, the main engine shut down, with the ship's speed at 8.6 knots (Figure 3). *Peter Crooke* was the first tug to respond to the call for assistance, and the comms pilot asked the tug master to attend the ship as soon as possible. The comms pilot then made several further radio calls to

Weipa VTS, stating ‘the ship had lost the main engine, taking a sheer, and was about to ground in the vicinity of SC12’.

The ship’s speed reduced to 8.3 knots as it passed beacons SC11/SC12, and it started to turn to starboard with an increasing rate of turn. The conning pilot ordered hard to port, but this had little effect. The ship continued to turn to starboard and at 1723 (Figure 4), the ship’s starboard shoulder grounded on the northern batter (bank of the channel) of the South Channel, at a speed of 6.7 knots, on a heading of 270°, and the rudder positioned amidships.

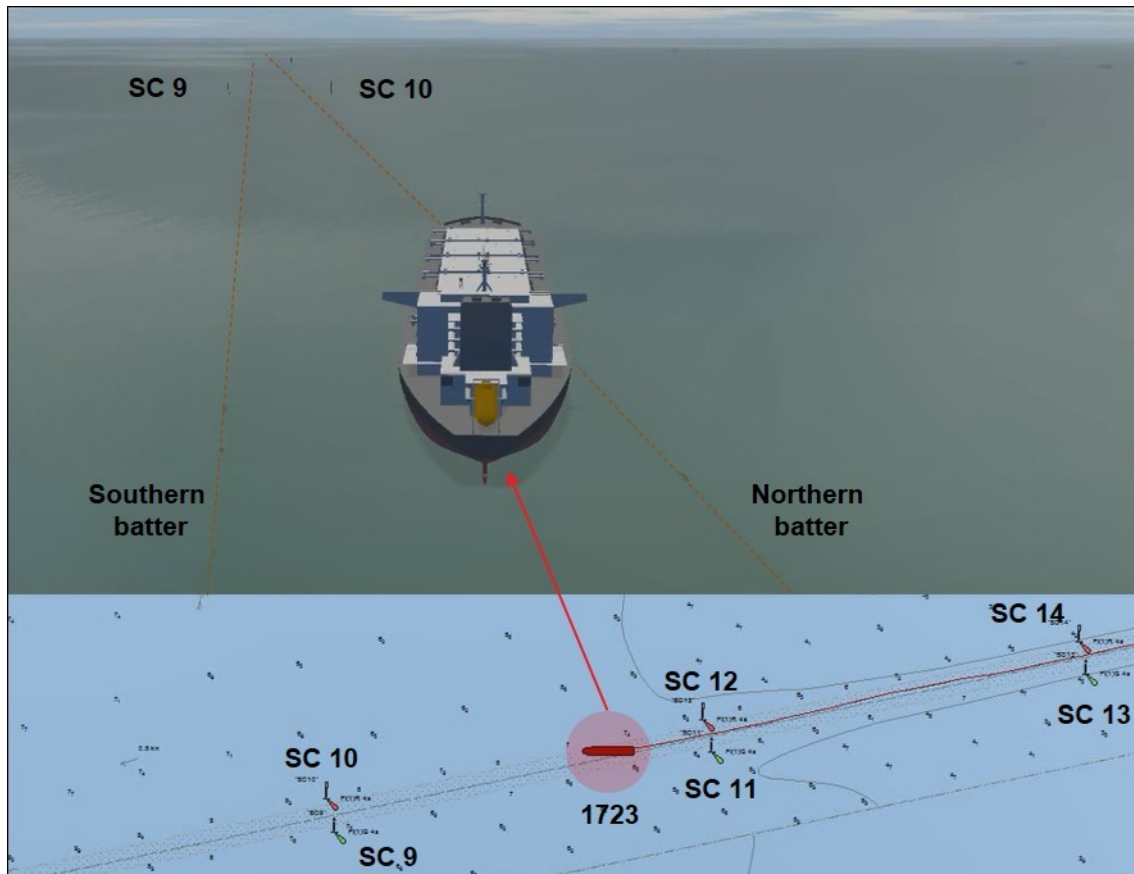
Figure 4: *Orient Centaur* aground in the South Channel at 1723

By 1739, the ship had come to rest with the starboard shoulder aground on the northern batter, on a heading of 279°, south-west of SC 12 with the port quarter across the channel and drifting towards the southern batter.

At 1745, the comms pilot managed to contact the RHM and provided a situation update. At the same time, the ship's crew activated their emergency procedures for a grounding. The ship's stern continued moving slowly across the channel, before coming to rest on the southern batter at 1759, on a heading of 289°.

- As the ship was transiting the South Channel, its main engine shut down due to a loss of cooling water associated with failure of the number 1 cylinder cooling jacket. Following the loss of propulsion, the ship's starboard shoulder grounded on the northern batter and its port quarter drifted across the channel to ground on the southern batter.

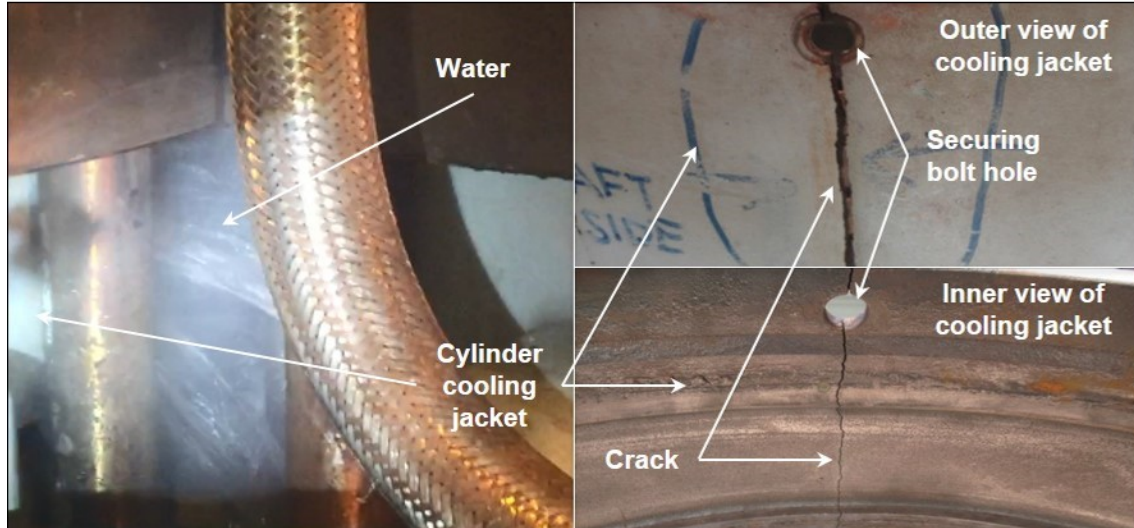
Figure 7: Cylinder cooling jacket failure and crack (after cleaning)

The crewmembers who were in the engine room at that time of the occurrence sighted water coming from a crack in the cylinder cooling jacket of the cylinder head of cylinder number 1 (Figure 7). The loss of jacket water triggered the main engine to shut down.

The engine manufacturer subsequently inspected the failed cylinder cooling jacket and identified that:

- the jacket had one vertical crack that passed through a securing bolt hole
- there were four bulges around the crack but no evidence of any impact marks
- the cooling space of the inner cooling jacket had heavy corrosion/rust and metal peeled off.

The loss of cooling water was the result of a crack in a main engine unit's cylinder cooling water jacket through a securing bolt hole, an area of inherent stress concentration. Furthermore, consistent with the engine manufacturer's service letter, it is possible that the effects of corrosion products found in the cooling water space contributed to the cracking due to increased stress in the area of the failure.

- water analysis on board weekly
- water analysis at shore every 6 months
- checking appropriate tightening of Cylinder Head every 8000 hrs
- proper overhaul of cooling jacket (replacement of o rings and cleaning) and use of original spares according to manufactures instructions, service letters and manual every overhaul
- checking securing bolts as per manufactures service letters every overhaul
- proper tracking of running hours monthly
- original spare cooling to be available on board at all times
- all cylinder jackets renewed within 1 year from incident
- maker guidance/recommendations and service letters are followed as per planned maintenance system schedule.
