Loss of control and collision with terrain involving Eurocopter AS350BA helicopter VH-BAA

Hobart Airport, Tasmania, on 7 November 2017

ATSB Transport Safety Report

AO-2017-109

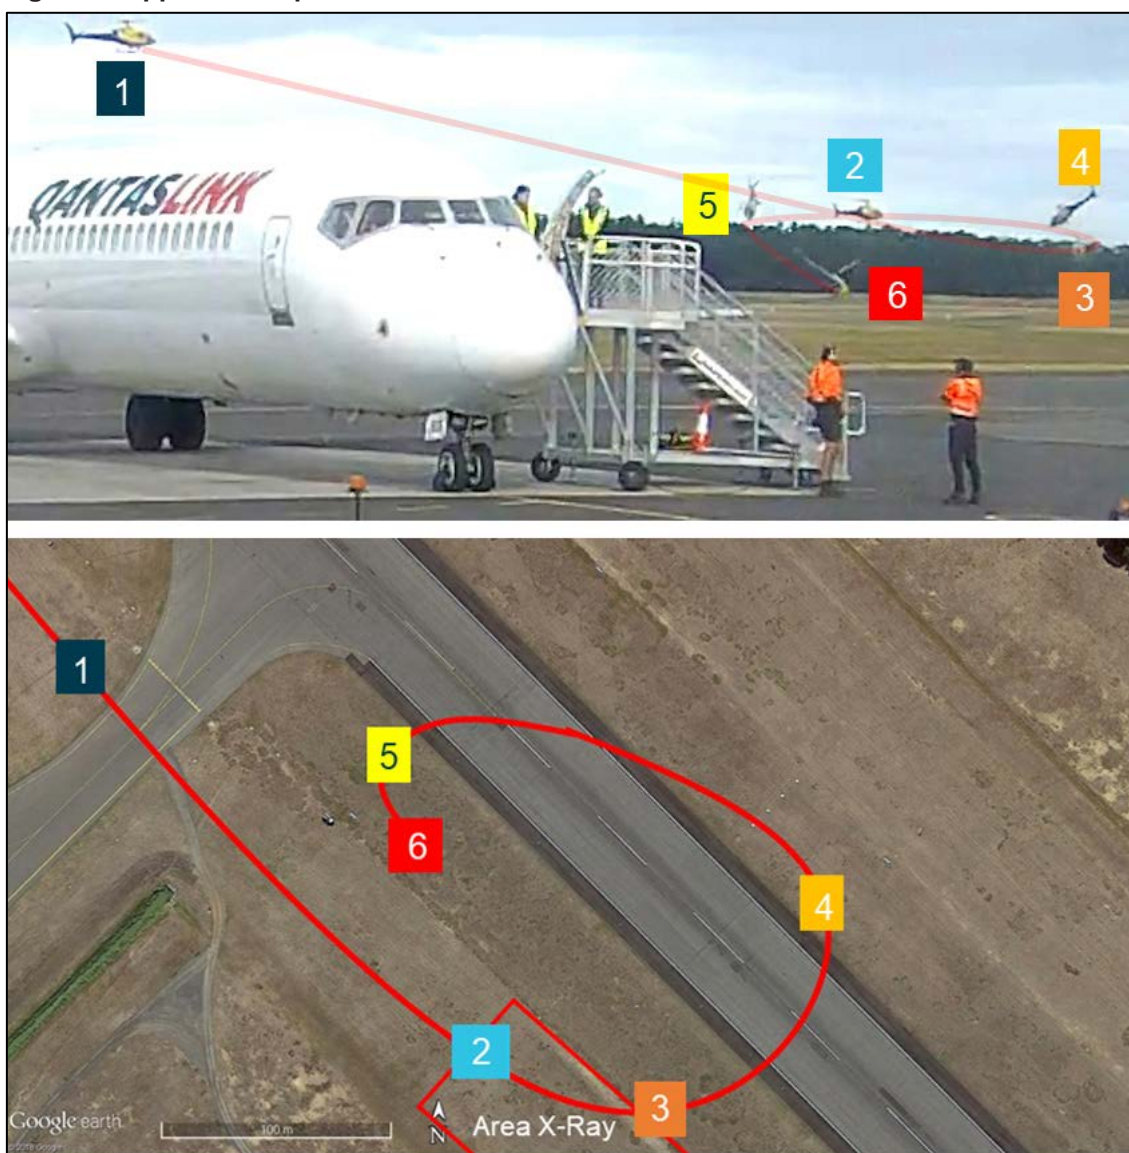
Figure 1: Approximate path of VH-BAA

#	Seconds	Aircraft behaviour
1	0	Heading about 120°. VH-BAA enters frame. Travelling around 20 kt.
2	12	Variations in pitch and yaw as VH-BAA slows to about 11 kt. Approach flattens, helicopter begins to yaw left.
3	18	Change of heading to about 040° after yaw to left. Comes to hover in tail wind, slowly drifting.
4	21	The aircraft climbs, pitches forward, crossing the runway, and continues to yaw left to a heading of about 300°. Yaw continues, aircraft turns left and pitches further forward to about 50° with left roll developing. Accelerates to over 20 kt ground speed.
5	28	Heading about 240°. Slides outwards in left turn. Pitch down now around 45°, roll around 50°.
6	30	Heading about 120°. Pitch down about 40°, roll increases to about 80°, helicopter impacts terrain.

At the end of the observed flightpath, the front left side of the cabin impacted the ground first. The CFI, seated on the left, was fatally injured, and the PUI in the right seat was seriously injured. The helicopter was destroyed.

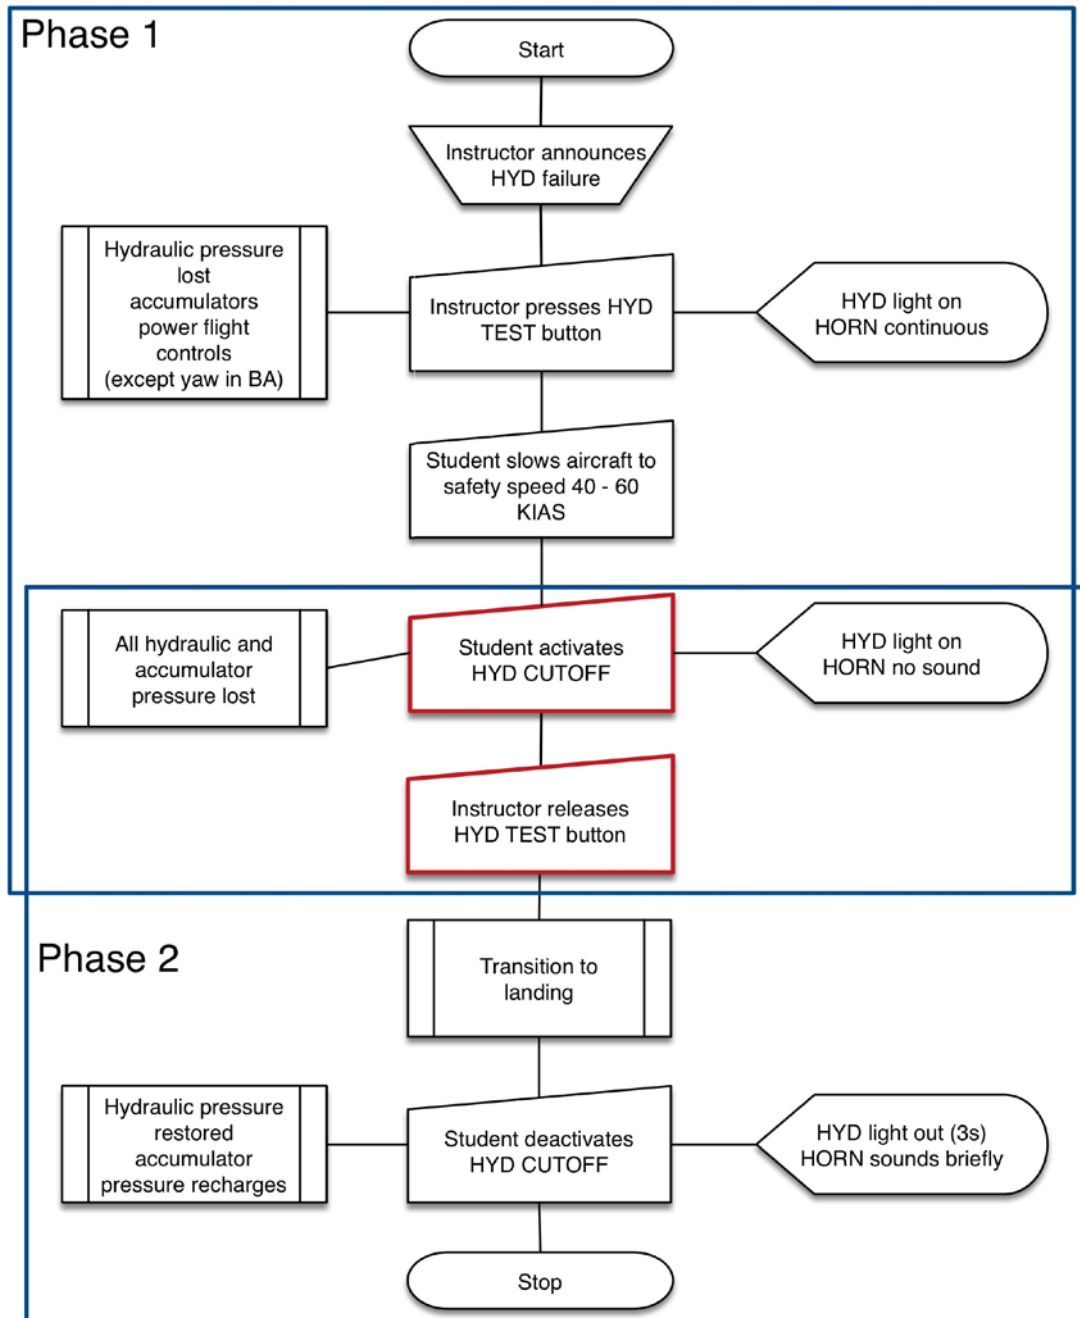
Figure 3: Hydraulic failure training procedure as taught

The instructor and the PUI advised that the flight school taught a different version of the hydraulic failure training procedure during the endorsement, and used it during the accident flight.

The procedure used had the student activate the HYD CUTOFF switch before the HYD TEST switch was released. This was a commonly-used procedure before the release of Supplement 7. An investigation into a similar accident in Canada ([A13Q0021](#)) related that flight instructors found this sequence accurately simulated a hydraulic failure. Figure 3 illustrates the procedure.

VH-BAA was not fitted with a yaw load compensator. Using this procedure on an AS350 equipped with a yaw load compensator will cause total loss of tail rotor control hydraulic assistance.

The procedure used to simulate failure of the hydraulic system did not match the requirements of the RFM, and overlapped the two phases of the procedure. It released the hydraulic test (HYD TEST) switch after activation of the hydraulic cut-off (HYD CUTOFF) switch. This introduced a hazard into the operation.

Distraction could lead to the HYD TEST switch being forgotten and remaining in. In this configuration, a pilot must activate two switches to restore hydraulics. This would lead to a failure to restore hydraulics when commanded via the HYD CUTOFF switch. Such an event would lead to delayed restoration, due to time taken to diagnose the problem and release the HYD TEST

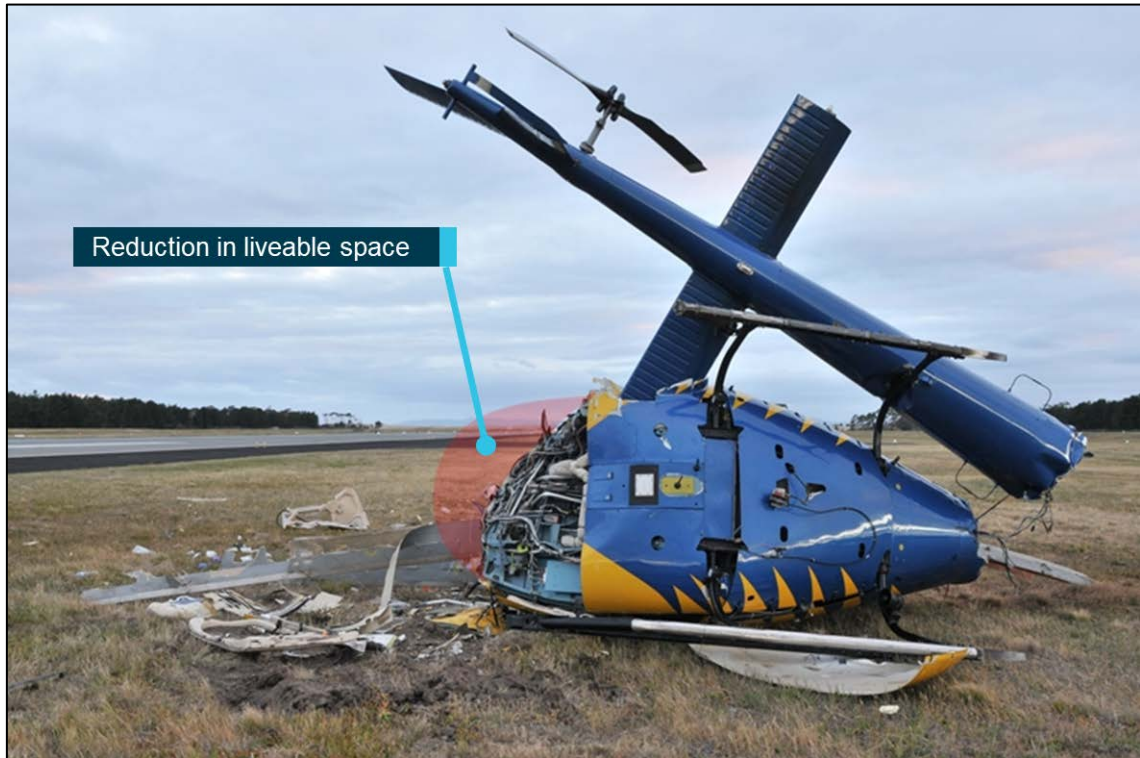
Figure 9: Accident site image

There was evidence that the engine was running for a period of time after the helicopter impacted with terrain, as indicated by burnt grass in the area of the engine exhaust, though there was no fire on site. Figure 9 shows the aircraft before removal.

Damage was indicative of significant impact on the front left side. The flexible steel legs of the skid gear, four-point harnesses, crash-resistant seats and light alloy frame of the cabin floor, all offer protection to occupants during accidents if the helicopter contacts the ground in a level attitude. The polycarbonate construction of the cabin offers very little protection to occupants if the collision involves contact with the canopy.

Investigation of previous AS350 hydraulic failure accidents identified that on initiation of the loss of control event the aircraft often rolled to the left, and initial impact with ground was on the left hand side. Consequently, the left seat occupant is likely to experience the highest impact forces during a collision. In this accident, the helicopter impacted the ground nose down while rolling to the left. As a result, there was significant disruption to the survivable space on the left side of the helicopter's cabin.

Both pilots were wearing seatbelts with upper torso restraints, and the seatbelts and seats held during the accident sequence. This kept the right-seat pilot within a disrupted but liveable space within the cabin, contributing to his survival.

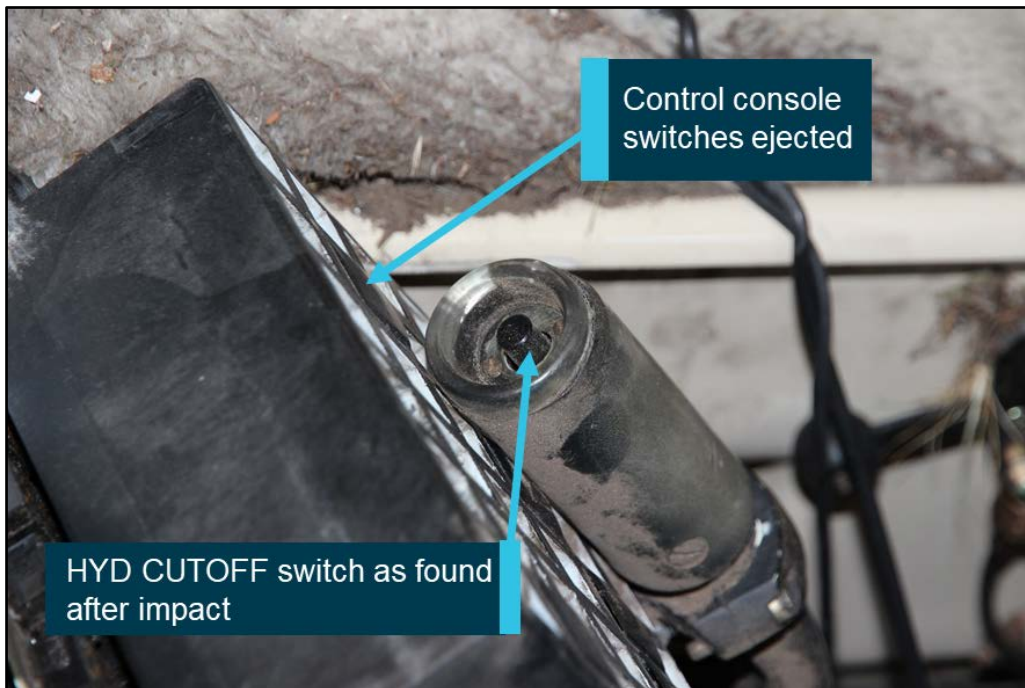
Figure 10: HYD CUTOFF switch and control console as found

The HYD CUTOFF switch and the HYD TEST switch were found in the correct position for restoration of hydraulic pressure at the time of impact (Figure 10). It is possible that one or both switches moved during the impact sequence. The HYD TEST switch unit was found outside of the aircraft, in the off (normal operation) position.

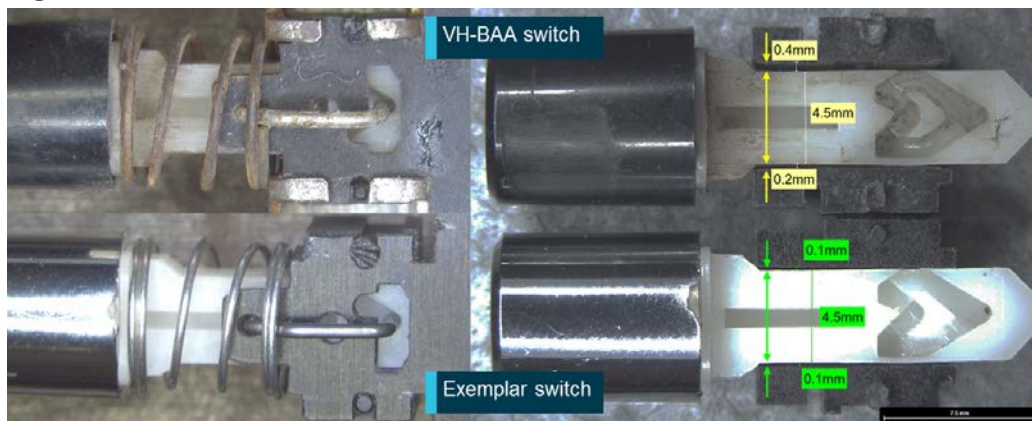
Figure 11: Corrosion, contamination, and wear in VH-BAA switch

Laboratory examination and comparative analysis of the HYD CUTOFF switch from VH-BAA was conducted with a new switch. They found that the switch fitted to VH-BAA at the time of the accident was susceptible to intermittent operation. The switch had a level of wear, corrosion, contamination and internal damage (Figure 11). Consequently, the mechanical latching and unlatching which cycled the internal contacts to ON or OFF could stick, and require additional effort to latch or unlatch.

It could not be determined if the intermittent operation was due in part to impact-induced damage.

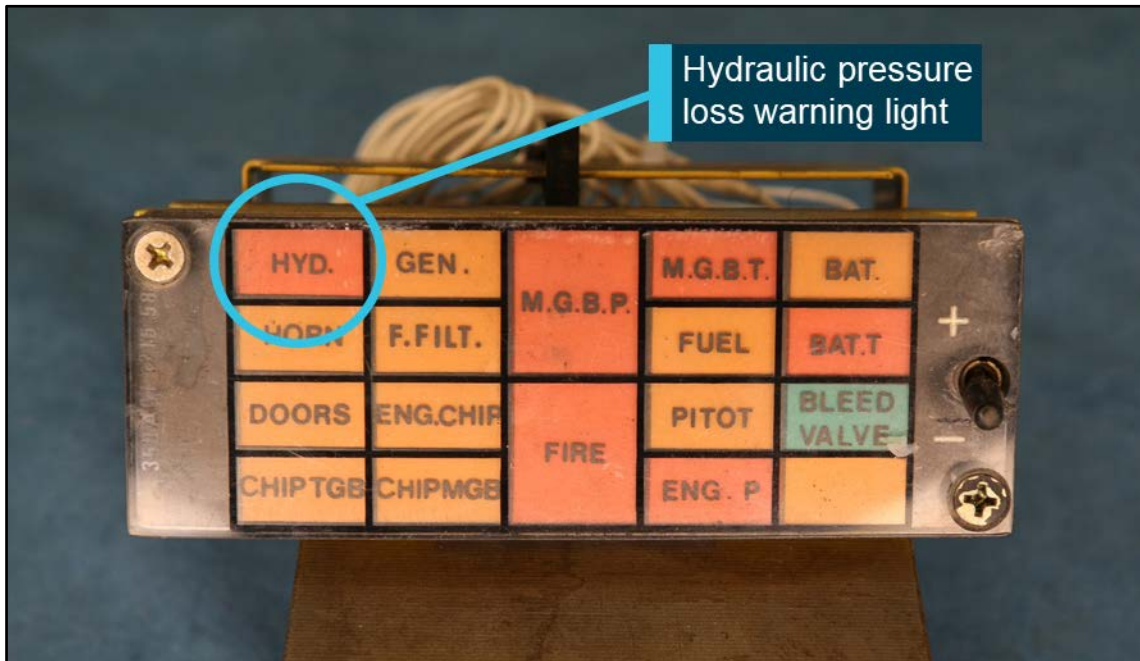
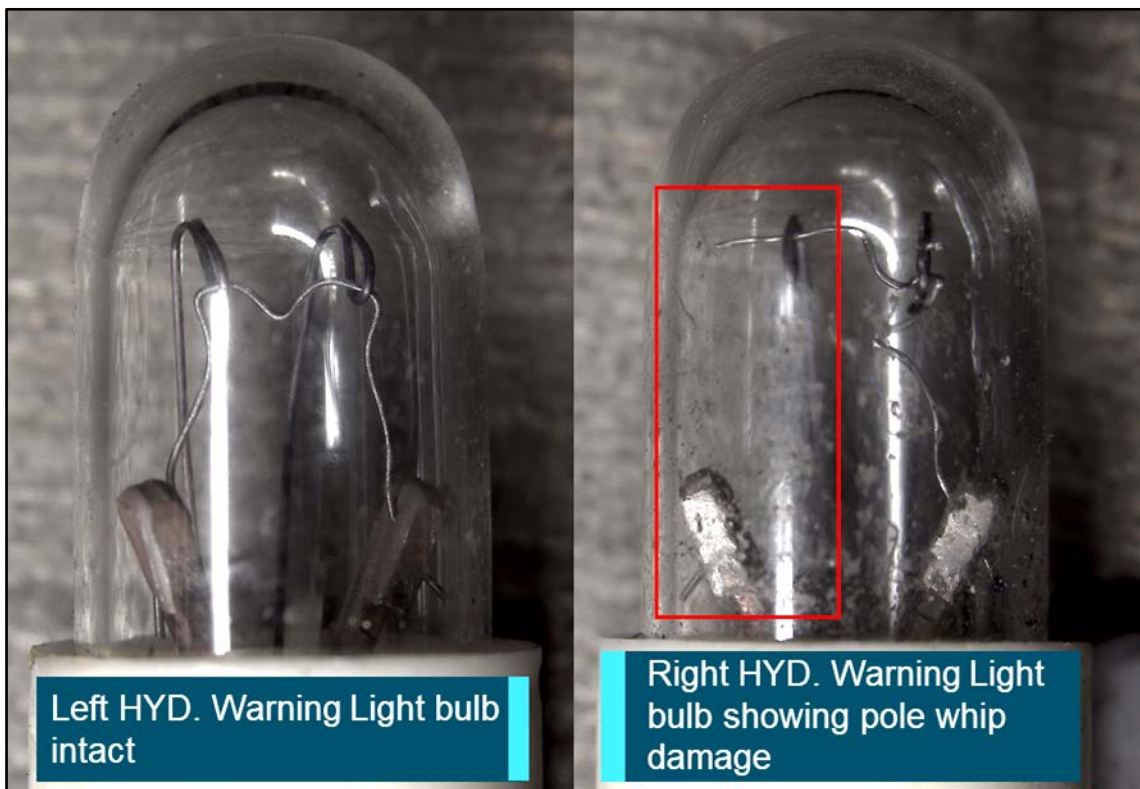
When the hydraulic system is inoperative, two incandescent bulbs light the red HYD warning light (Figure 12). Both of these bulbs were inspected for impact damage (Figure 13). The left bulb was intact and the right bulb exhibited pole whip damage (Carver, 1987). The pole whip created a brittle fracture between the terminal and the support post. There was some observed filament sag, which is consistent with an aged bulb exposed to high-impact forces. If the bulbs were illuminated at impact, provided the impact forces were sufficient, it is likely that the filaments would show evidence of stretch-type deformation damage. Therefore, it is considered probable that the HYD warning light was not illuminated at the time of impact.

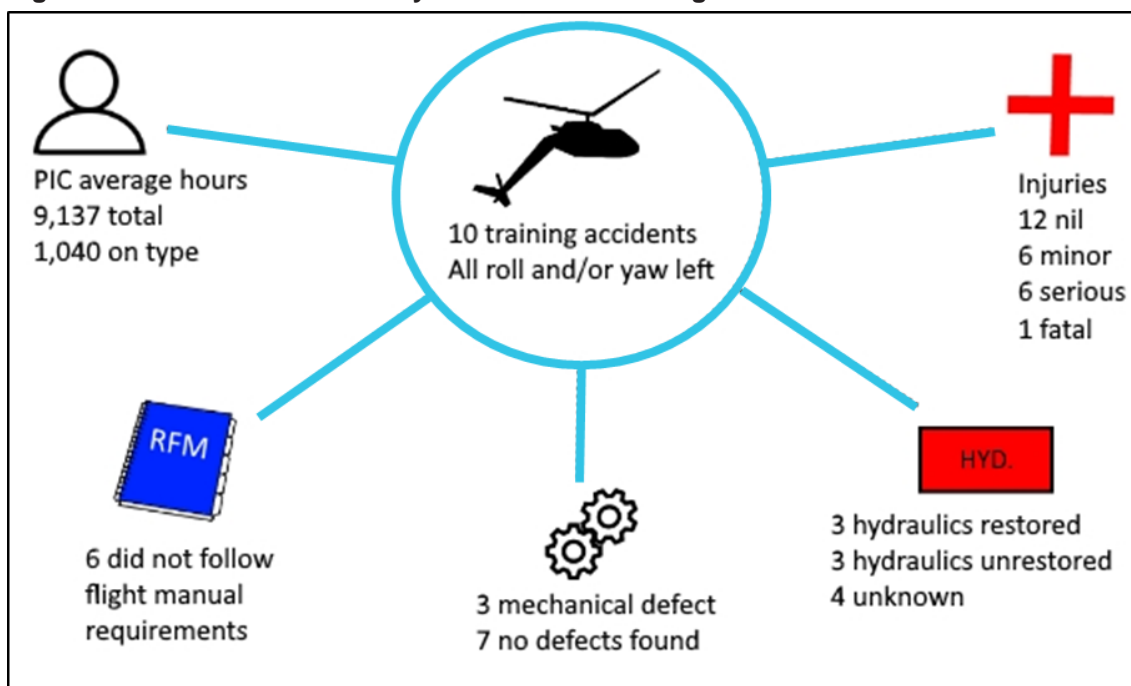
Figure 15: Overview of related hydraulic failure training accidents.

The ATSB reviewed 34 investigations of accidents involving AS350 series helicopter's hydraulic systems worldwide. Figure 15 collates the data from ten of the accidents that occurred prior to the accident in VH-BAA, involving simulated hydraulic failure during flight training. It indicates that loss of control accidents during training do happen to highly experienced pilots. Refer to Appendix A for a synopsis of the reports and the [Transport Safety Board of Canada's report A05F0025](#) for a list of AS350 loss of control events.
