Engine failure involving Saab 340B, VH-RXX

Near Merimbula, New South Wales on 29 August 2019

ATSB Transport Safety Report
Aviation Occurrence Investigation
AO-2019-046
Final – 13 August 2020

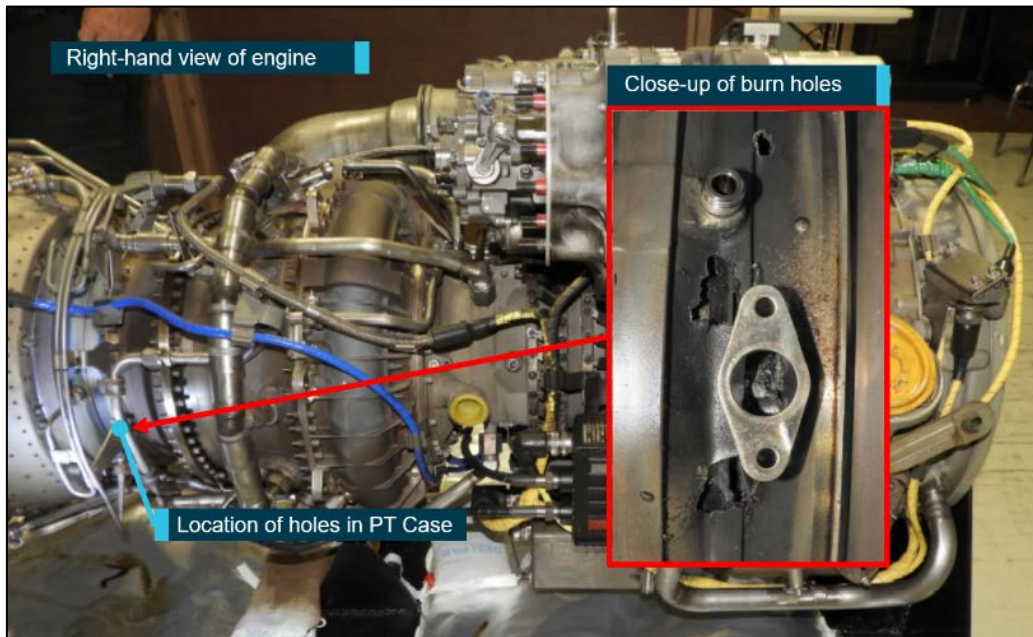
A post-flight visual examination of the engine revealed that there were several small burn holes³ in the power turbine (PT) case (Figure 1) and that the C-sump assembly and a section of the PT shaft were missing (Figure 2). The engine had previously undergone unscheduled maintenance for elevated oil consumption.

³ Burn holes are caused by hot gases above the melting temperature of the material. This is evidenced by the metal spatter around the holes and there being no direct path into the internal PT case.

Figure 1: Right-hand view of engine with burn holes indicated

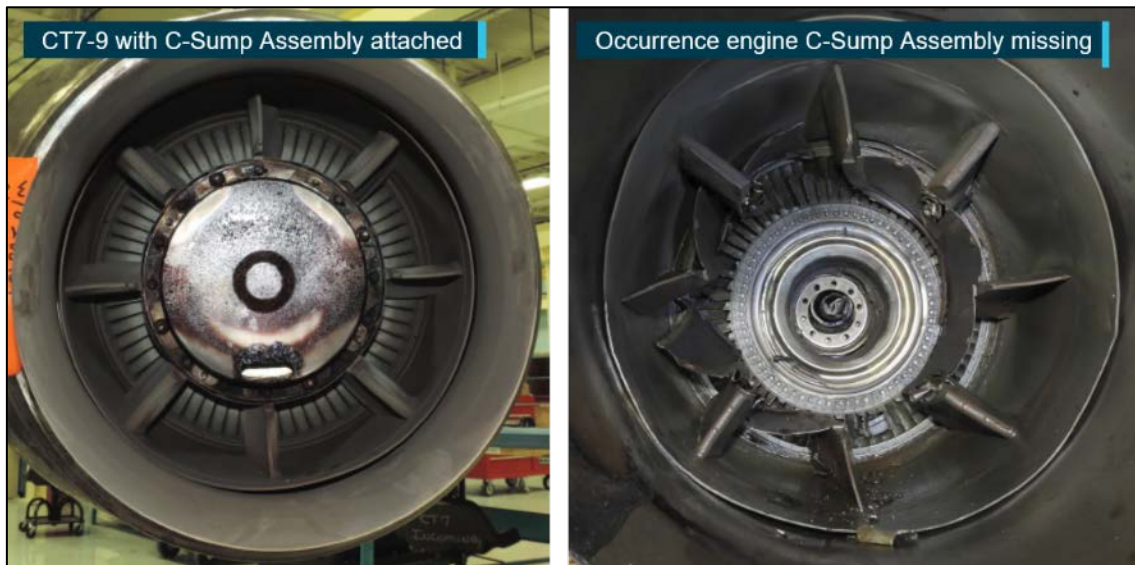
Figure 2: Rear-view comparison of undamaged engine (left) and the occurrence engine missing the C-Sump Assembly (right)

Conclusions of the analysis were that heavy coke build-up in the B-sump oil cavity resulted in the sump flooding⁷ and oil leaking into the B-sump air cavity. Due to the blocked B-sump air cavity oil drain tube, oil leaked into the CDLP air cavity. An oil fire then occurred in the CDLP air cavity and at the stage 3 outer diameter near the disk posts. This weakened the disk posts, and resulted in several blades being released. The resulting imbalance caused the separation of the section of PT shaft and the C-sump.

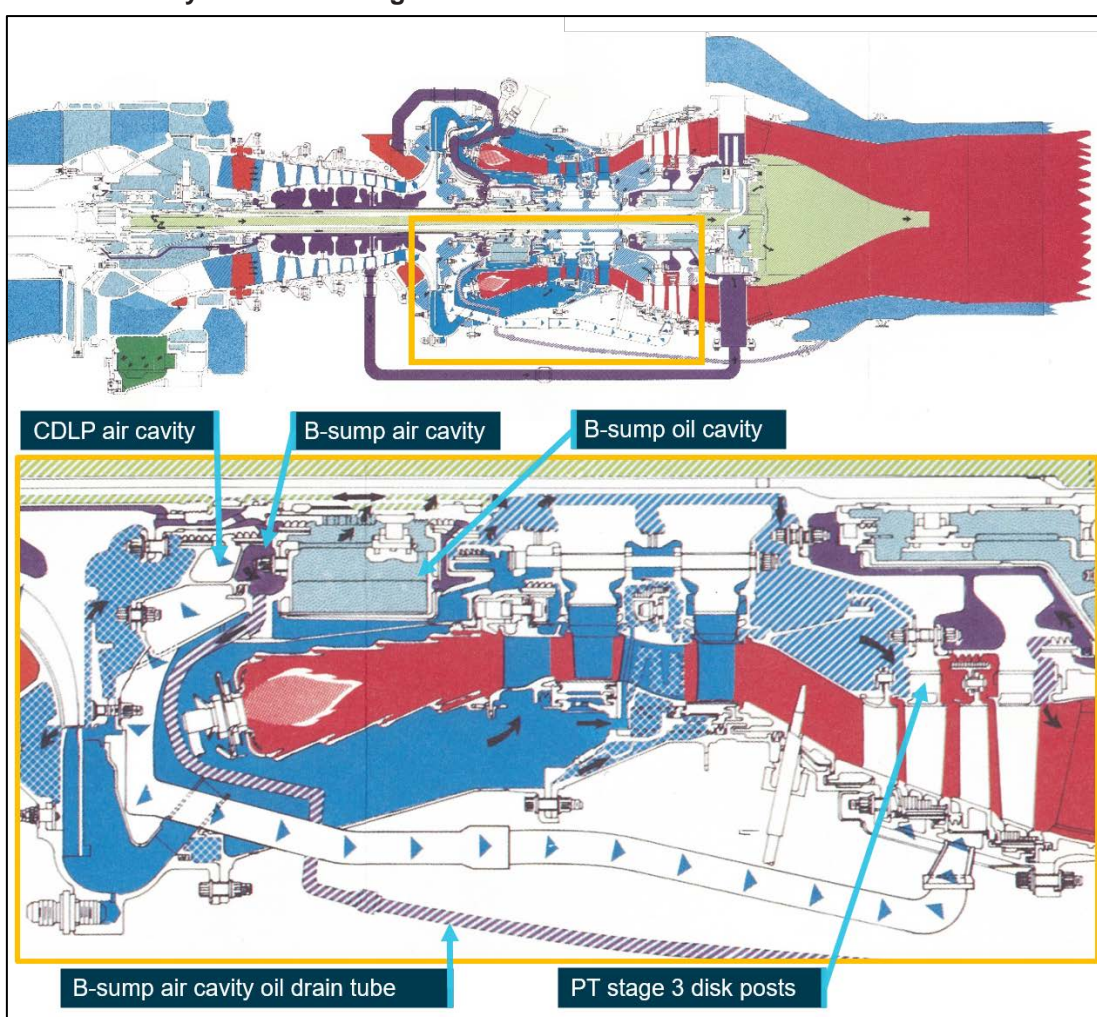
Located within the cold section module and part of the midframe assembly was the B-sump. This supplied oil to the bearing that supported the gas generator. A labyrinth seal⁴ separated the B-Sump oil cavity and the B-sump air cavity (Figure 3). During normal operation, it was possible for oil to leak beyond the labyrinth seal and accumulate within the B-sump air cavity. A drain tube incorporated into the cavity was intended to direct any oil from the B-sump air cavity into the exhaust gas path. Another labyrinth seal separated the B-sump air cavity from the compressor discharge leakage pressure⁵ (CDLP) air cavity. Oil was not intended to accumulate within the CDLP cavity.

Figure 3: Cross-section diagram of the CT7 – zoom showing the B-sump in relation to the CDLP air cavity and the PT stage 3 disk.

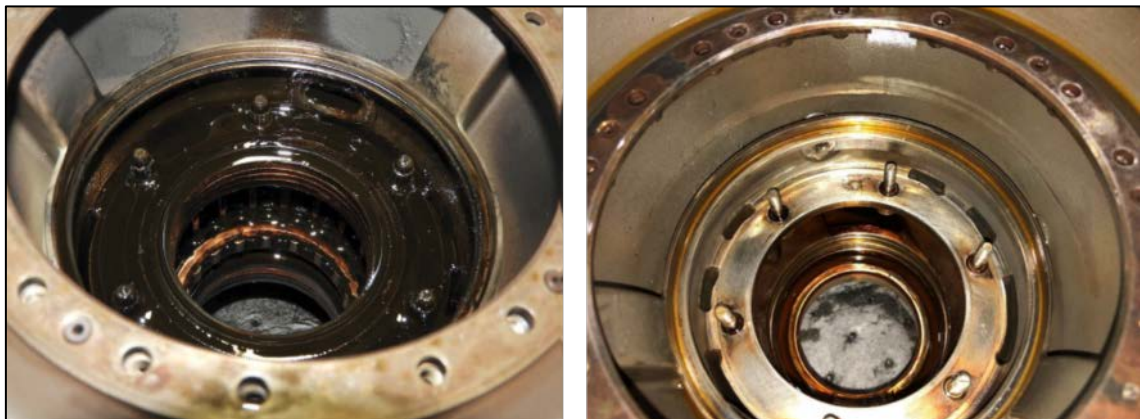
- the B-Sump oil cavity and the B-sump air cavity were heavily coked (Figure 4)
- the B-Sump oil drain was coked and blocked at the time of disassembly
- there was minor presence of coking and oil in the CDLP cavity
- a number of the power turbine (PT) stage 3 disk blades had been released. Examination of the remaining disk post tangs showed elongation and hardness values consistent with a creep condition as a result of exposure to elevated temperatures.

Figure 4: The coking within the B-sump of the occurrence engine (left) in comparison to the condition of a typical engine (right).

The B-sump component had only completed 1,481 flight hours since it was installed on the engine in May 2018. This represented only about 10 per cent of the typical time between major worksopes. The high level of coking found in the B-sump could only have occurred in that timeframe if:

- the component was not completely clean on installation following the major workscope
 - there was an accelerated formation of coking within the component
- or a combination of both.

- have completed a technical review and incorporated changes to the Maintenance Manual troubleshooting procedure to better identify a B-sump flooding condition.
- are ensuring licensed CT7-TP overhaul facilities are conducting the cleaning in accordance with the GE procedure. GE have also completed a review of the B-Sump cleaning procedure and developed enhancements which will be added to the next revision of the document.
