# Engine surge and high vibration involving Airbus A330, VH-EBR

44 km north-east of Gold Coast Airport, Queensland, on 15 April 2018

**ATSB Transport Safety Report**  
Aviation Occurrence Investigation  
AO-2018-033  
Final – 19 August 2020

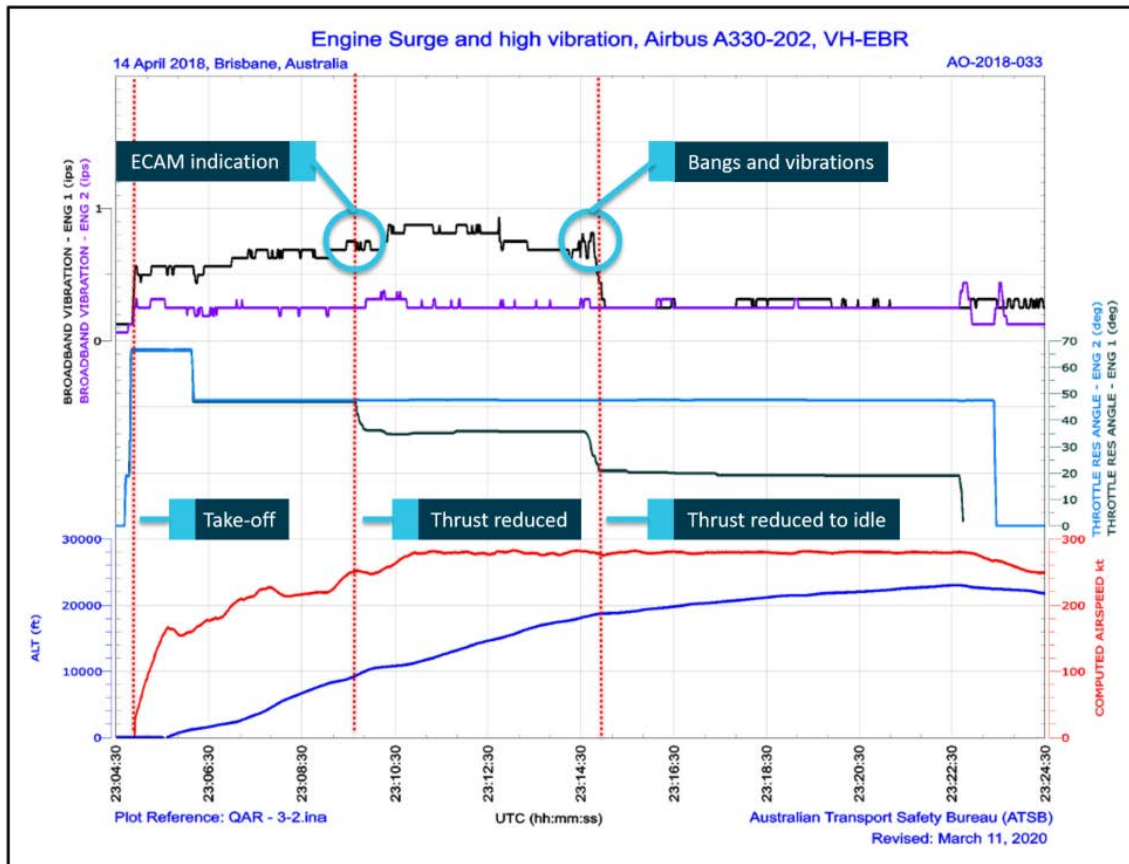
**Figure 1: Plotted data from QAR showing vibration levels and thrust lever positions during the occurrence flight**

Figure 1 shows a plot of the data that was obtained from the quick access recorder (QAR). During the take-off roll, the left engine vibrations (black line) increased to a higher than normal level for the CF6. The vibrations continued to increase, resulting in the ENG 1 N2 VIBRATION message displaying on the electronic centralised aircraft monitor (ECAM) at about 0909. The left engine thrust was reduced in response. About 5 minutes later, two left engine vibration spikes were recorded, consistent with the loud bangs and airframe vibration reported by the crew. The left thrust lever was then reduced to idle.

The ATSB also downloaded data from the previous five flights. The recorded data showed that on each of those flights, the vibration level of the left engine was higher than normal, but had not reached the limit to trigger the ECAM notification.

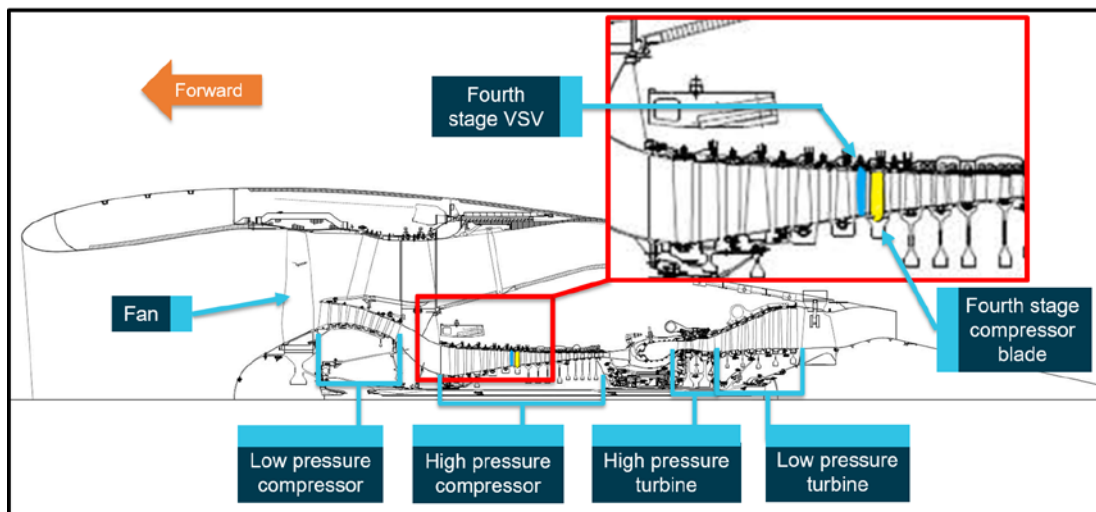
**Figure 2: GE CF6 cross-section showing a detailed view of the HPC**

A post-flight engineering inspection of the left engine identified metal fragments in the tail pipe and two missing fourth stage high-pressure compressor (HPC) blades. Figure 2 shows a cross-section of the GE CF6 engine, with the location of stage four of the HPC highlighted.

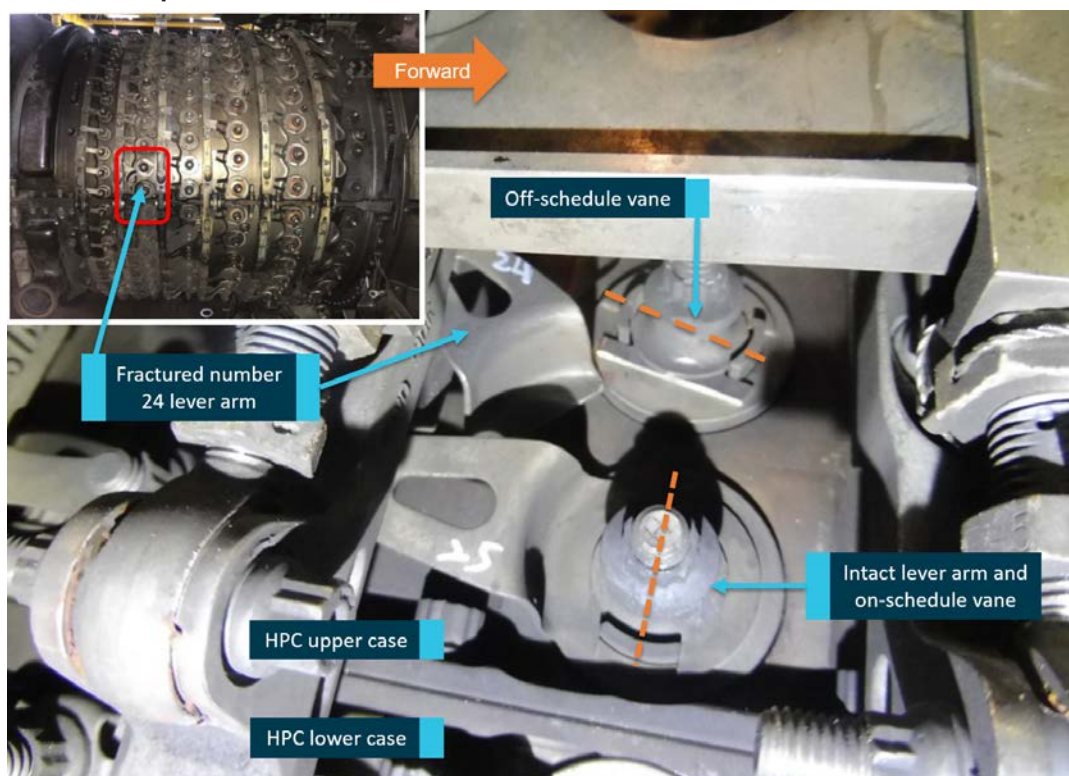
**Figure 3: Section of the fourth stage variable stator vanes showing the fractured number 24 lever arm and resulting off-schedule vane. Inset shows location on engine at 3 o'clock position.**

The inspection also identified that several variable stator vane (VSV) lever arms were bent and one was broken (Figure 3). The engine was subsequently shipped to an overhaul facility, where it was disassembled and inspected under the supervision of the engine manufacturer.

Once the lever arm was broken, the vane rotated freely, which disrupted airflow into the fourth stage compressor. This created vibratory aerodynamic loading of the blades, which resulted in the fatigue cracking.

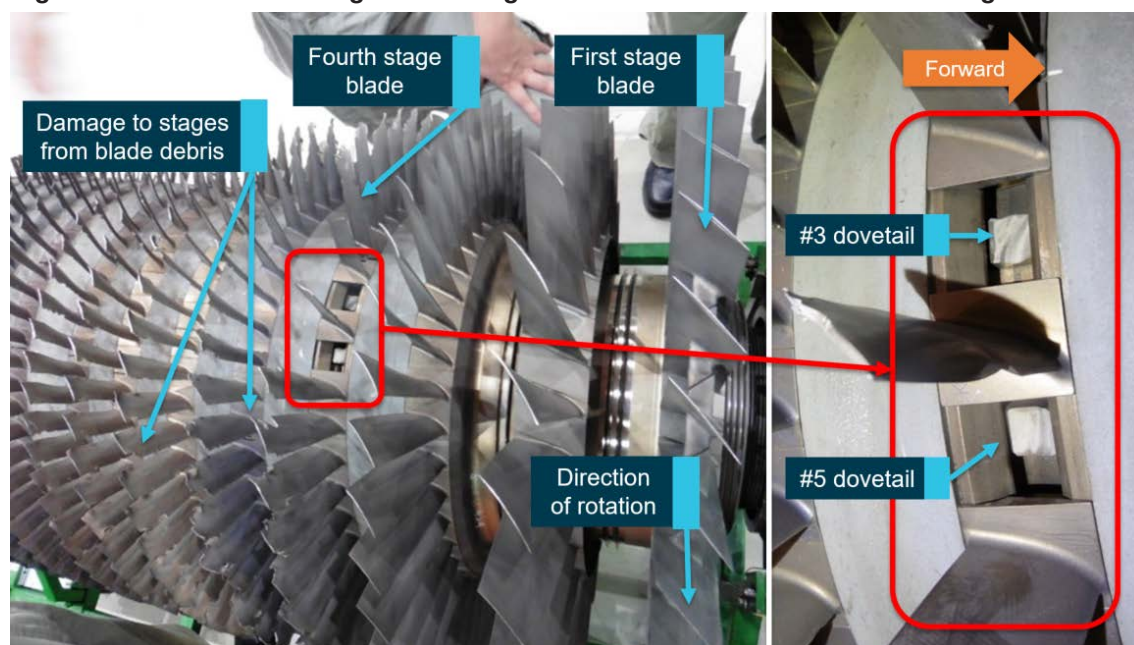
**Figure 4: Disassembled engine showing fractured dovetails within fourth stage**

- there was no damage to the first three HPC stages
- two of the fourth stage HPC blade assemblies, number 3 and number 5, had separated at the dovetail-mounting portion of the blade root (Figure 4)
- of the 50 fourth stage VSV lever arms, eight were distorted and the number 24 position was completely fractured
- the separated blades had damaged the rear face of the fourth stage vanes with the distorted lever arms
- the compressor and turbine sections downstream of the separated HPC blades were damaged from progression of the blade debris through the gas path.

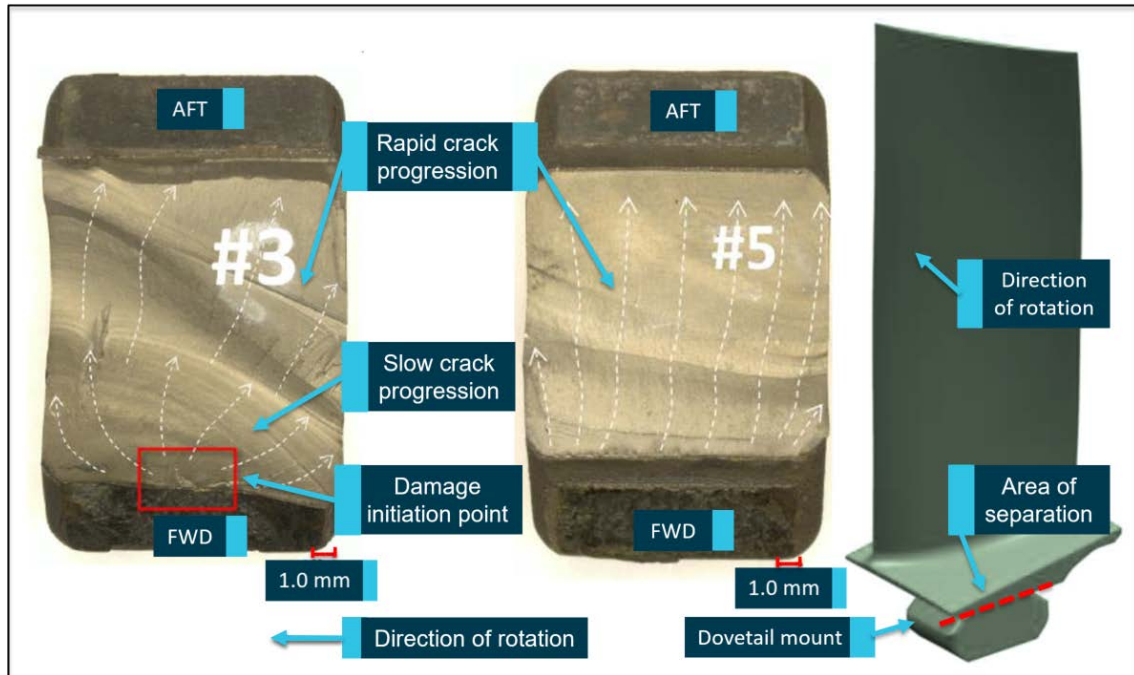
**Figure 5: Detailed view of fractured blades**

A laboratory examination by GE found that the blade fitted to the number 3 position failed due to the propagation of a high-cycle fatigue<sup>5</sup> crack that initiated in the blade root at the forward edge (in the direction of rotation). Other failures of the stage 4 blades have been reported previously, where the deterioration of the blade coating was identified as an important factor. There was no significant deterioration of the blade coating on this engine.

The blade in the number 5 position failed as a result of more rapid fatigue crack progression cracking (Figure 5). The examination found that this was due to secondary damage, likely from impact by the released number 3 blade. One other fourth stage blade was cracked.

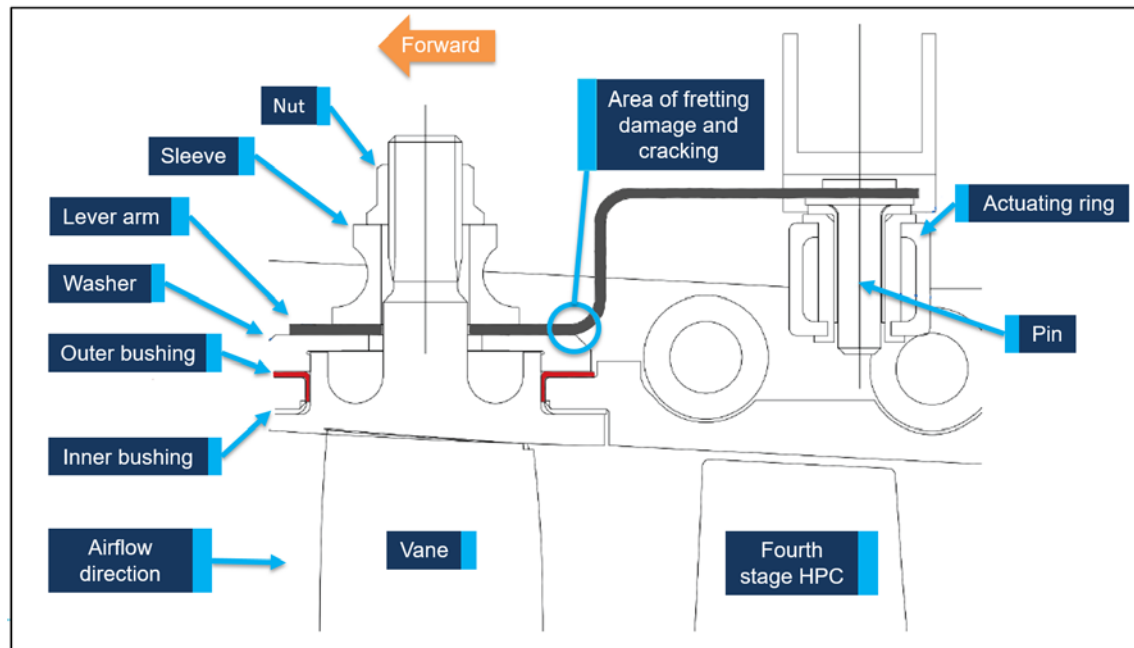
**Figure 6: VSV design and component locations, highlighting outer bushing and lever arm**

The VSV lever arm fractured as a result of fatigue crack progression that originated at an area of fretting<sup>6</sup> wear between the lever arm and washer (Figure 6 and Figure 7). The fretting on the lever arm was determined to have resulted from wear to the composite bushings fitted under the VSV lever arm. As the bushing wore, the VSV was allowed to tilt, placing a bending and twisting moment into the lever arm.
