Engine vibrations and in-flight shutdown involving Airbus A330, VH-QPI

Near Sydney Airport, New South Wales, on 1 June 2018

ATSB Transport Safety Report

AO-2018-046

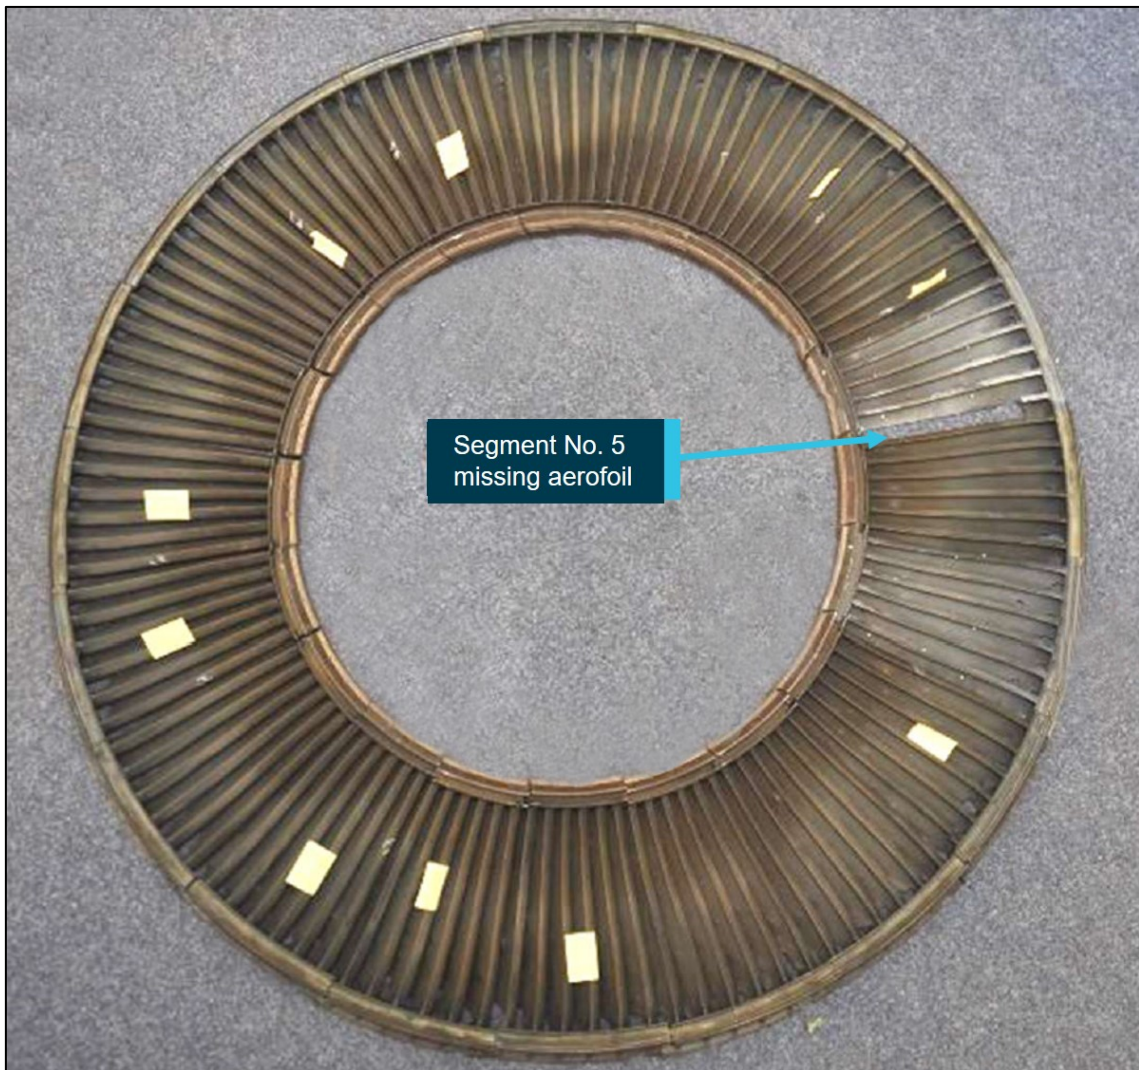
The No. 2 engine from QPI was disassembled and examined at the engine manufacture's repair facility. Examination of the engine's low-pressure turbine stages found that aerofoil No. 6 from the No. 5 segment of the stage four nozzle guide vane (NGV) was missing (Figures 2 and 3). The liberated aerofoil caused downstream damage to the stage four and five low-pressure turbine and the stage five NGV segments. Both turbine stages sustained loss of blade material consistent with impacts from the aerofoil and other liberated fragments. Additionally, while the low-pressure turbine case outer wall was perforated and showed signs of bulging, there was no loss of containment of the fragments via the outer case wall. No damage was found upstream of the stage four NGV assembly.

Figure 2: Low-pressure turbine stage four NGV assembly with segment No. 5 showing loss of aerofoil

Detailed examination of the stage four NGV assembly showed that another three segments exhibited cracks through the entire chord width of various aerofoils. The engine manufacturer identified that oxidation and deterioration of the aerofoil's chromide protective coating had occurred due to engine operating temperatures, stress and time. The deterioration led to the formation of intergranular oxidation in the NGV aerofoil material. As intergranular oxidation levels increased, cracks formed on the NGV leading edges, resulting in eventual failure of the No. 6 aerofoil.

In response to the aerofoil liberation in this occurrence, the engine manufacturer investigated changing the type of protective coating of the NGV segments from chromide to vapour-phased aluminide. The vapour-phased aluminide coating, in use on stage 3 NGVs, has lower instances of intergranular oxidation, and an absence of NGV material deterioration. SB 72-575 was issued in July 2019 to implement the coating replacement.

- replacing all NGV segments that exhibited cracking of the aerofoil leading edge
- introducing a requirement that only new segments were to be installed during overhaul (no multiple run segments)
- introducing a borescope¹¹ inspection program targeting the low-pressure turbine, stage four NGV assembly. The borescope inspection subsequently identified five engines with aerofoil cracking that warranted engine removal.
- revising the CF6 engine removal plan to reduce the time in service for those engines identified as at-risk of aerofoil liberation.

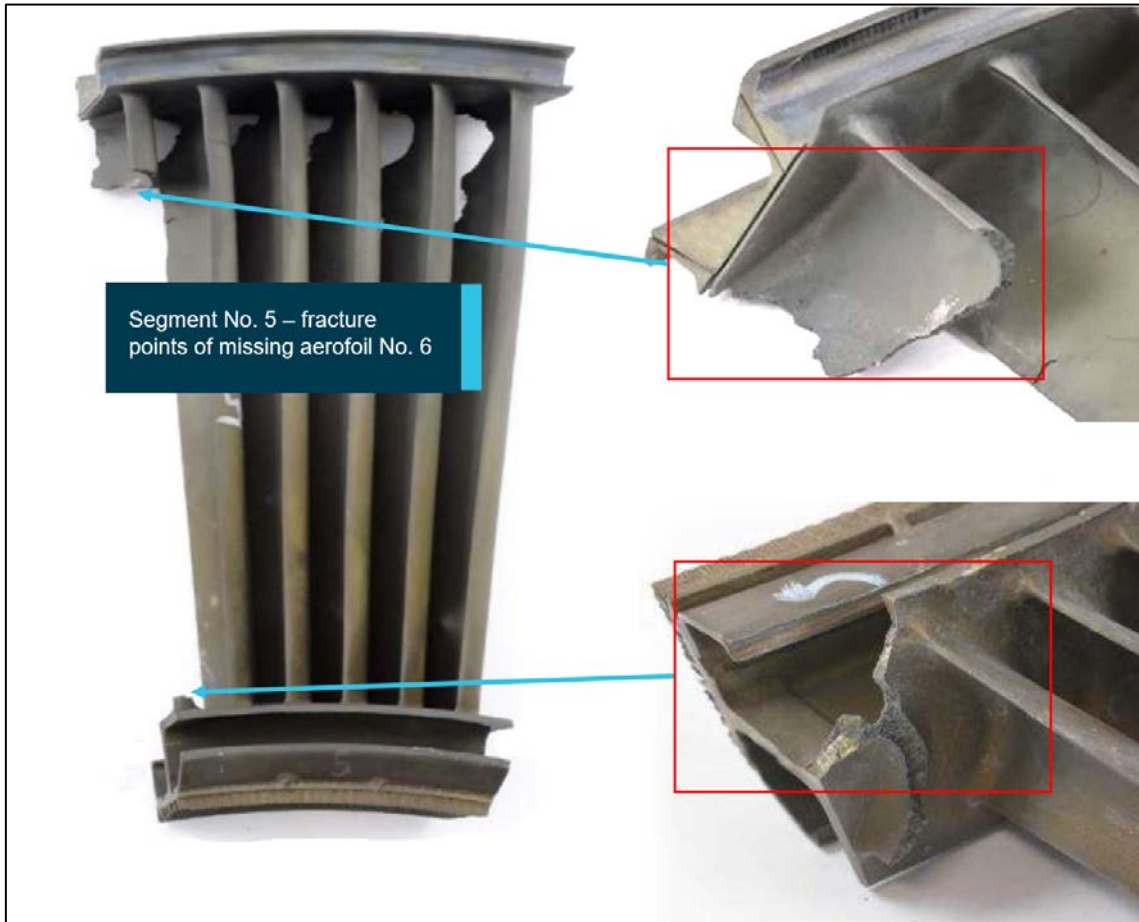
Figure 3: Segment No. 5 showing loss of aerofoil No. 6 and fracture area detail

The engine manufacturer also identified that the highest intensity of intergranular oxidation indications was concentrated in the leading edge of aerofoil No. 6, the highest stressed location in segment No. 5 of the stage four, low-pressure turbine, nozzle guide vane assembly.

Gas turbine engine, nozzle guide vanes (NGV) and turbine assemblies are subject to high mechanical loading and temperatures in a corrosive and erosive environment. Detailed technical examination identified that, following oxidation and deterioration of the protective coating on the stage four NGV, No. 5 segment, inter-granular oxidation developed in the base material of the aerofoils. This resulted in cracking of the highly stressed leading edge of the No. 6 aerofoil and its subsequent fracture and liberation.

Following this occurrence, the engine manufacturer changed the protective coating on the NVG segments from chromide to vapour-phased aluminide, citing better resistance to oxidation effects.

The operator also worked proactively by ensuring stage four, low-pressure turbine NGV segments that exhibited cracking of the aerofoil leading edge were removed from service, and that only new, not overhauled segments were fitted to the operator's engines. The operator also introduced a borescope inspection program that was successful in identifying other engines with aerofoil cracking and removed the affected engines from service.
