# Tail rotor pedal failure and collision with terrain involving Robinson R22 helicopter, VH-HHQ

near Kutchera Station, Queensland, on 22 June 2019

Aviation Occurrence Investigation

AO-2019-035

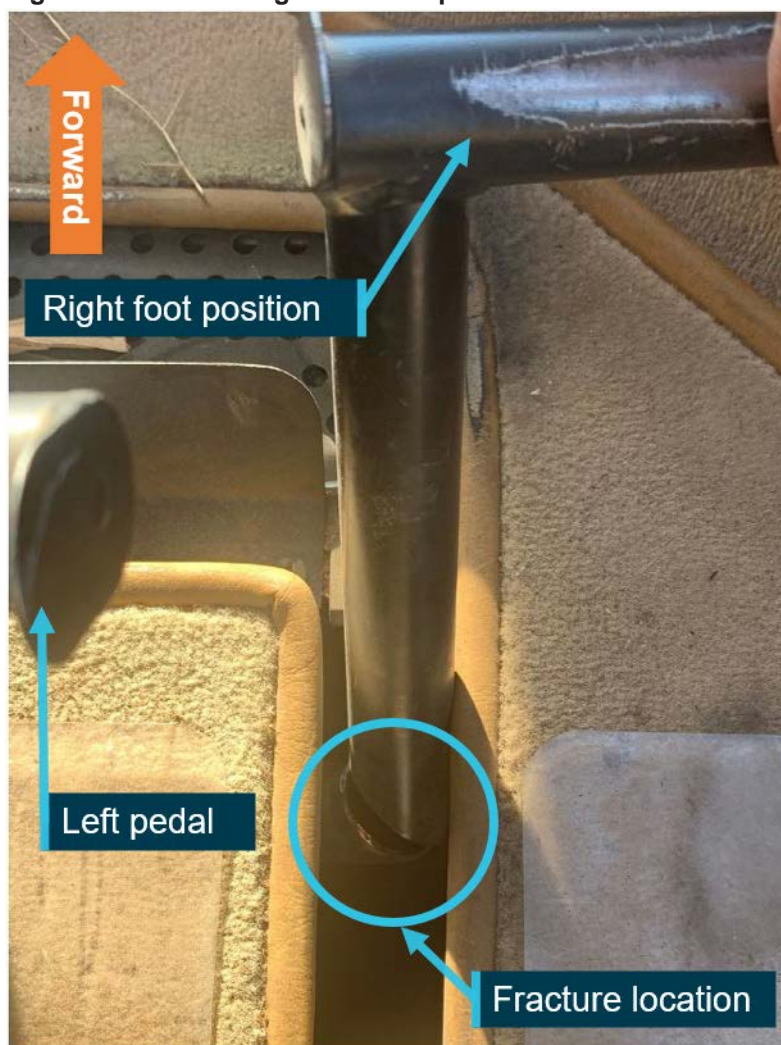
Following examination of the helicopter by the maintenance organisation, a significant fracture was noted on the right tail rotor pedal assembly at a weld located on a right angle join between two sections of thin walled tube (Figure 1). This join was between the vertical section of tube where the pilot places their foot, and the horizontal tube connecting to the tail rotor controls, and sits slightly below the cabin floor. The pedal was removed from the helicopter and sent to the ATSB's technical facilities in Canberra for further examination and testing.

**Figure 1: Fractured right tail rotor pedal as installed on VH-HHQ**

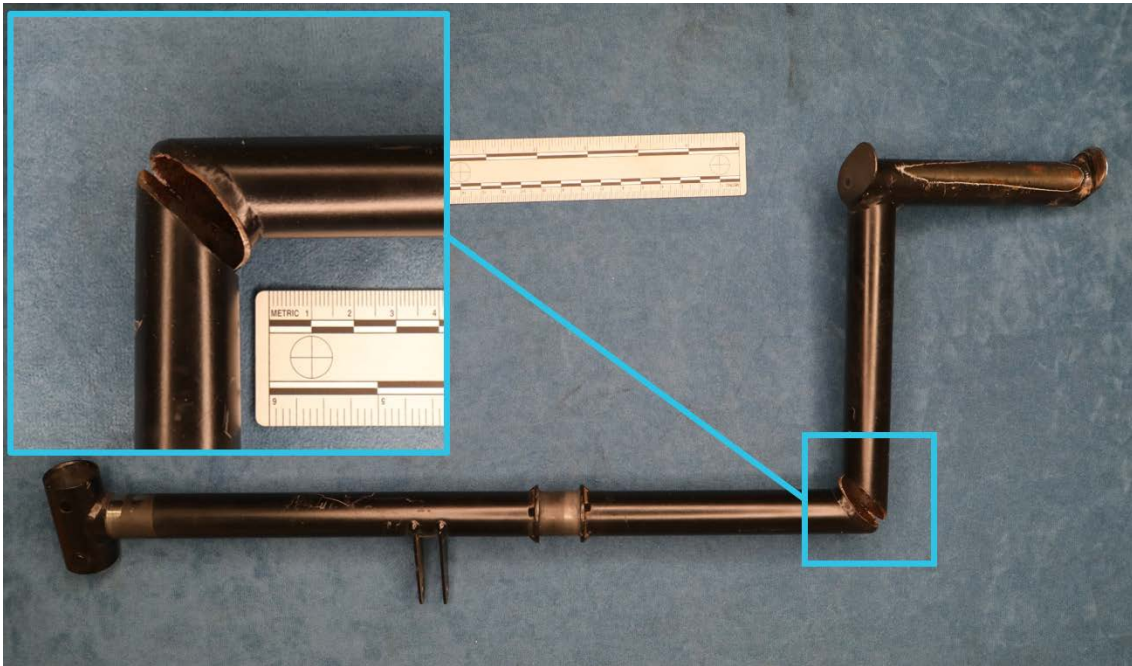
- The weld had fractured on the side of the pedal closest to the pilot seat (Figure 2).
- While the fracture was not through the entire section of the tube, the pedal assembly was no longer capable of maintaining loads and transferring pilot inputs.
- The pedal did not show any evidence of dints, scratches or other signs of mechanical damage.
- Wear, in the form of missing paint and a shiny smooth surface, was observed on the pedal surface in contact with the pilot's foot.

**Figure 2: Right tail rotor pedal as received by the ATSB, showing the location of the fracture**

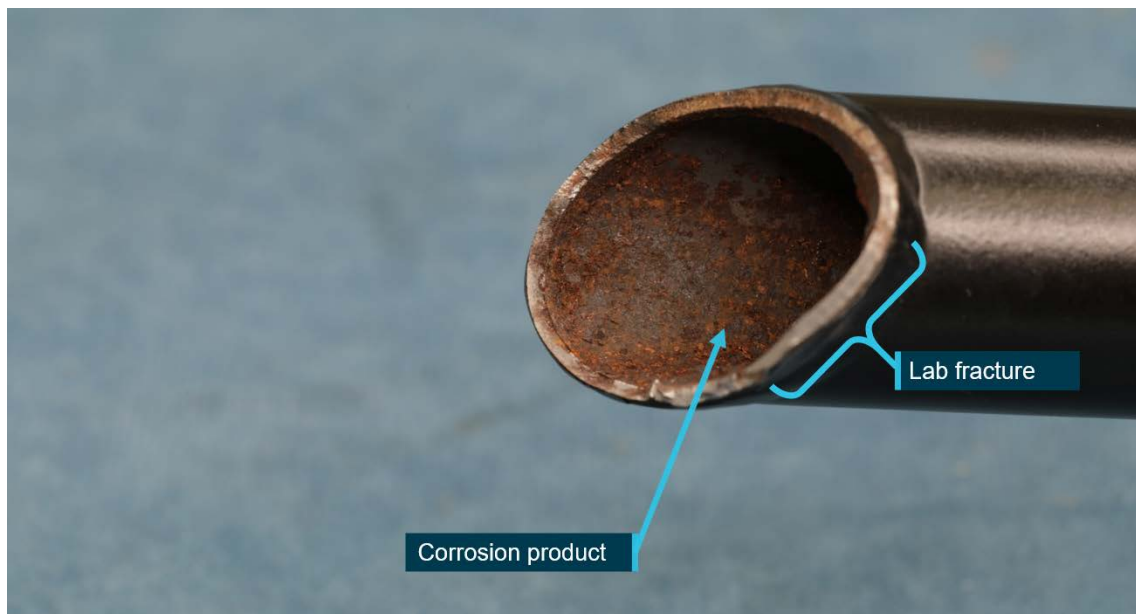
Following the initial examination, the pedal was fractured in the ATSB laboratory to separate and expose the two fracture surfaces. The majority of the fracture surface was discoloured and exhibited evidence of pre-existing cracking consistent with a fatigue failure (Figure 3). While the surface features were difficult to distinguish, the discolouration was indicative that the crack had been present for some period of time prior to the failure. While it appeared that the crack had initiated along the edge of the weld, no exact origin could be identified. However, the location of cracking was coincident with the location where the pilot input on the vertical tube was transferred to the horizontal tube, which is connected to the tail rotor push-pull tube assembly. As such, this area was subject to the largest torsional bending stress.

**Figure 3: Right tail rotor pedal fracture surface following fracture by the ATSB**

Following the examination of the fracture surface, it was then sectioned in the region adjacent to the likely origin for further inspection. The general fracture surface profile was consistent with a fatigue fracture. While the internal surface of the tube exhibited some evidence of pitting and general corrosion, there was no evidence that the crack initiated at one of these locations. Additionally, as the tubes were completely sealed, it was more likely that the corrosion product was the result of moisture ingress following the initiation of the fatigue crack.

As a result of this accident, the maintenance provider has advised that, although not required by the maintenance manual, the tail rotor pedal assembly will now be included with other components that are sent for magnetic particle inspection at every 2,200-hourly overhaul.
