Severe turbulence and loss of control involving a Cessna 210M, VH-SJW

30 km south of Darwin Airport, Northern Territory on 25 November 2019

ATSB Transport Safety Report
Aviation Occurrence Investigation
AO-2019-069
Final – 15 September 2020

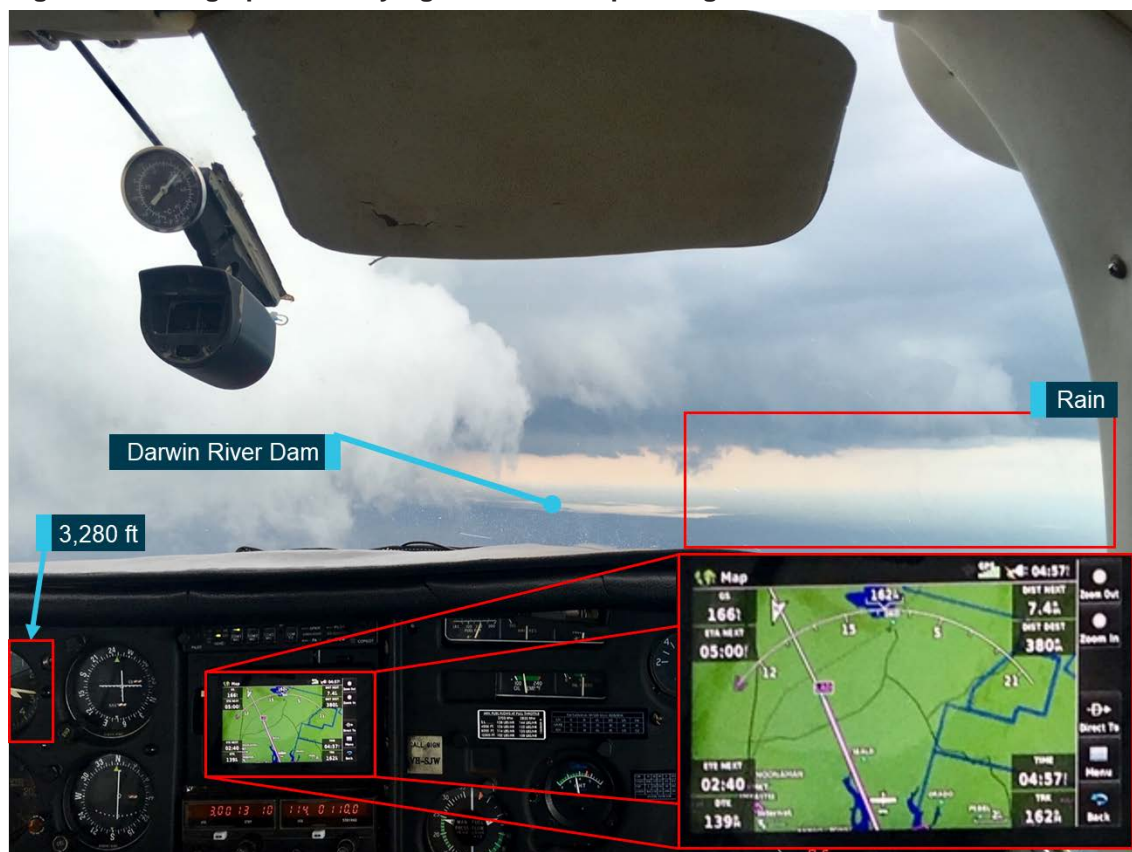
Figure 2: Photograph taken by right centre row passenger

The aircraft departed Darwin at 1418 and the pilot was cleared to depart via VFR route 4. The pilot had identified that the storm cell was about 5 NM left of the planned track, so requested a diversion of 5 NM right of track to provide a 10 NM separation from the weather. ATC approved the pilot's request. One of the passengers photographed the weather after they diverted (Figure 2).

About 10 minutes after take-off, the pilot reported maintaining an altitude of 3,500 ft. At about this time, and shortly after the photograph was taken, the aircraft was subjected to sudden severe turbulence.² The mobile phone used to take the photograph fell under the pilot's rudder pedals with the first significant drop in altitude. The pilot's checklist and an iPad were also loose in the cabin.

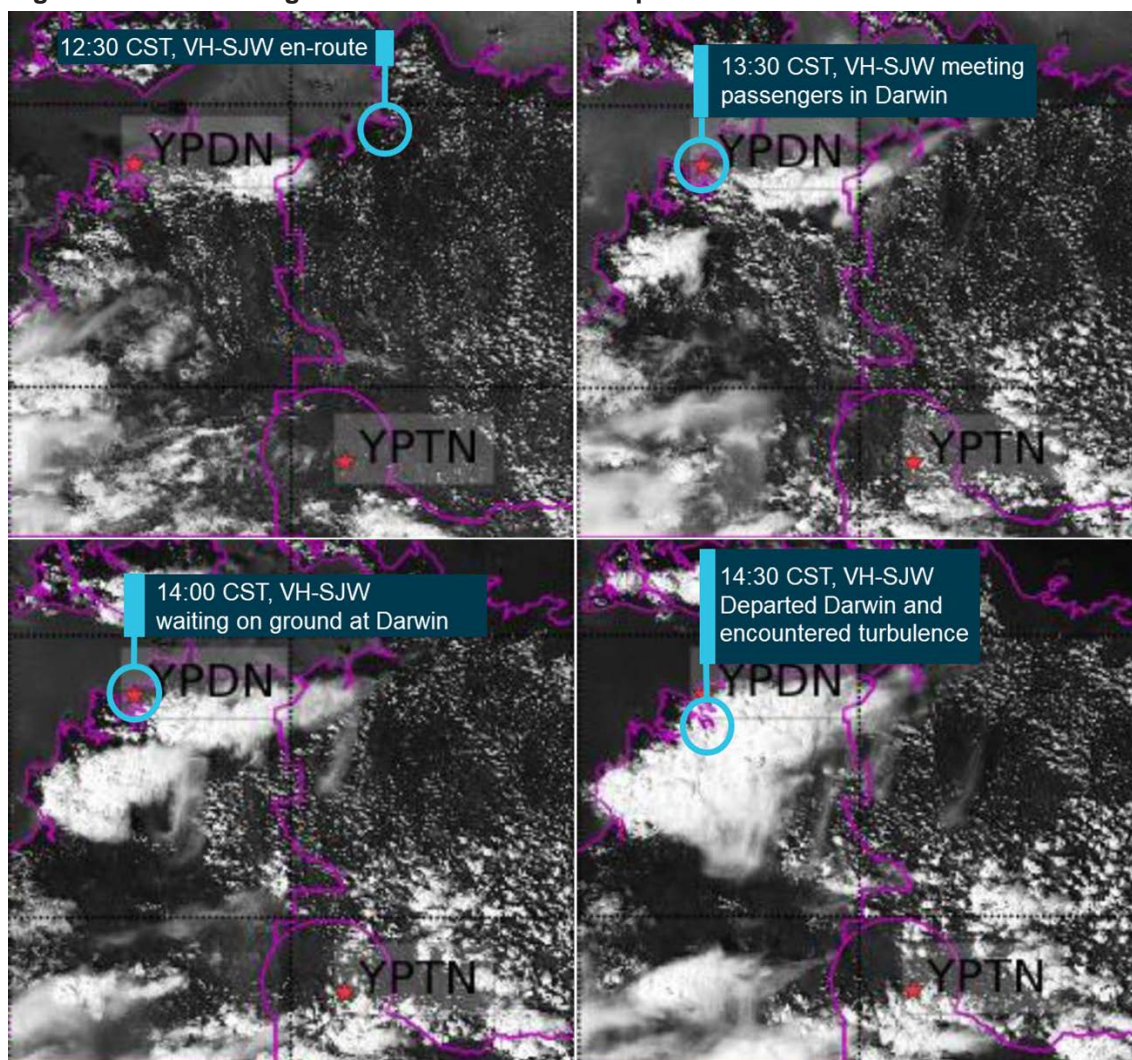
Figure 4: Satellite images of thunderstorm development at the time

Figure 4 shows satellite images that captured the build-up of thunderstorm activity on the day. In the first frame at 1230 Darwin (YPDN) is relatively clear of cloud. After VH-SJW arrives in Darwin, the next hour shows significant build-up of cloud on VH-SJW's intended track to Tindal (YPTN).
