# Controlled flight into terrain involving Cessna 182, VH-DJN

14 km south-south-west of Atherton Airport, Queensland, on 8 April 2019

**ATSB Transport Safety Report**  
Aviation Occurrence Investigation  
AO-2019-018  
Final – 17 September 2020

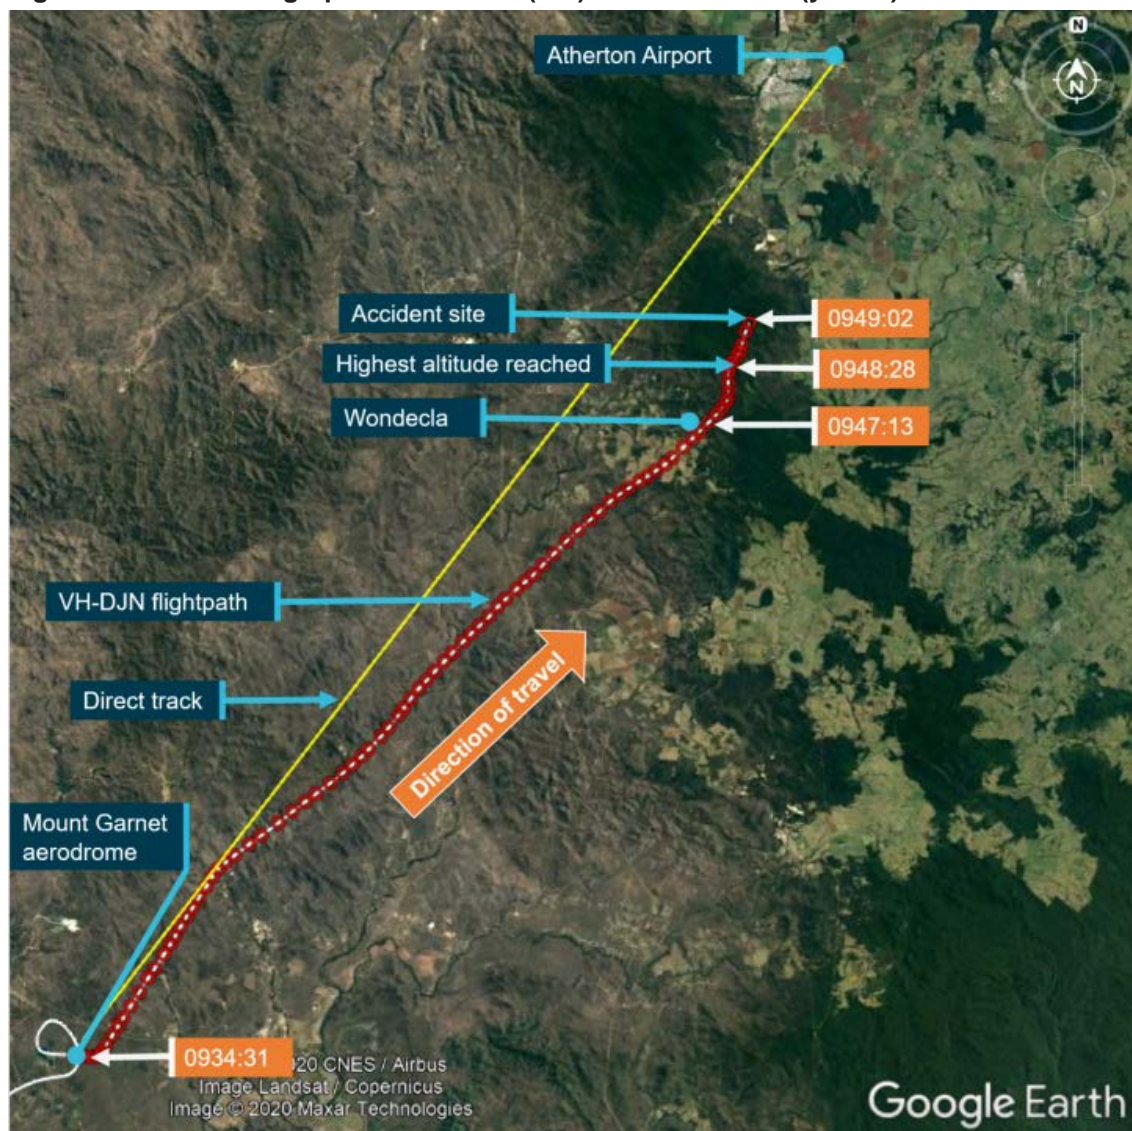
**Figure 2: Recorded flightpath of VH-DJN (red) and direct track (yellow)**

The aircraft took off from Mount Garnet at 0934:31, with the pilot as the sole occupant. Based on the aircraft's GPS data, it initially tracked directly towards Atherton Airport for about 4 minutes, before diverging east of the direct route (Figure 2).

The aircraft made small deviations right and left as it tracked north-east and passed overhead Wondecla at 0947:13 climbing through 4,144 ft. Over the next 30 seconds, the aircraft climbed to about 4,400 ft, which was the maximum height reached, before starting to descend. As the aircraft descended about 500 ft over the next 76 seconds, small changes in direction and two short climbs were made (Figure 3).

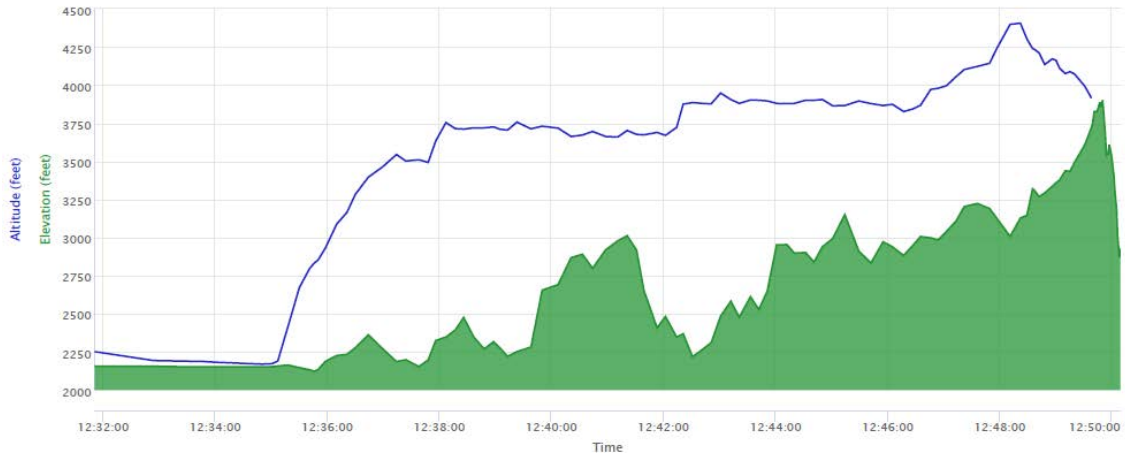
**Figure 3: Terrain elevation (green) and VH-DJN GPS altitude (blue) for the accident flight**

The aircraft's last recorded GPS position was at 0949:02 at an altitude of 3,916 ft and heading north-north-east. The terrain elevation at that position was 3,774 ft<sup>3</sup> and the terrain and GPS altitudes were each correct to within about 100 ft.

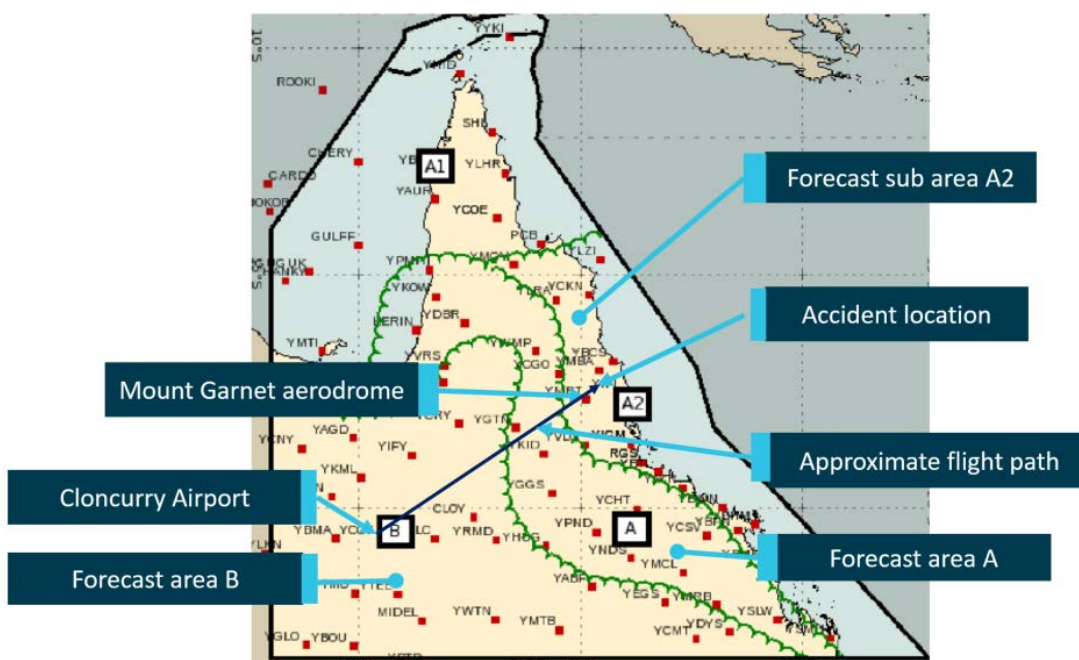
**Figure 5: Image from the graphical area forecast for area QLD-N issued at 0831 and valid from 0900 to 1500 EST**

Within the QLD-N area, for both validity periods, there were weather areas A and B and sub areas A1 and A2 within area A. About the first half of the flight from Cloncurry to Mount Garnet was in area B, the aircraft then entered area A and the final segment to Mount Garnet was in sub area A2 (Figure 5). The entire accident flight from Mount Garnet was within sub area A2.

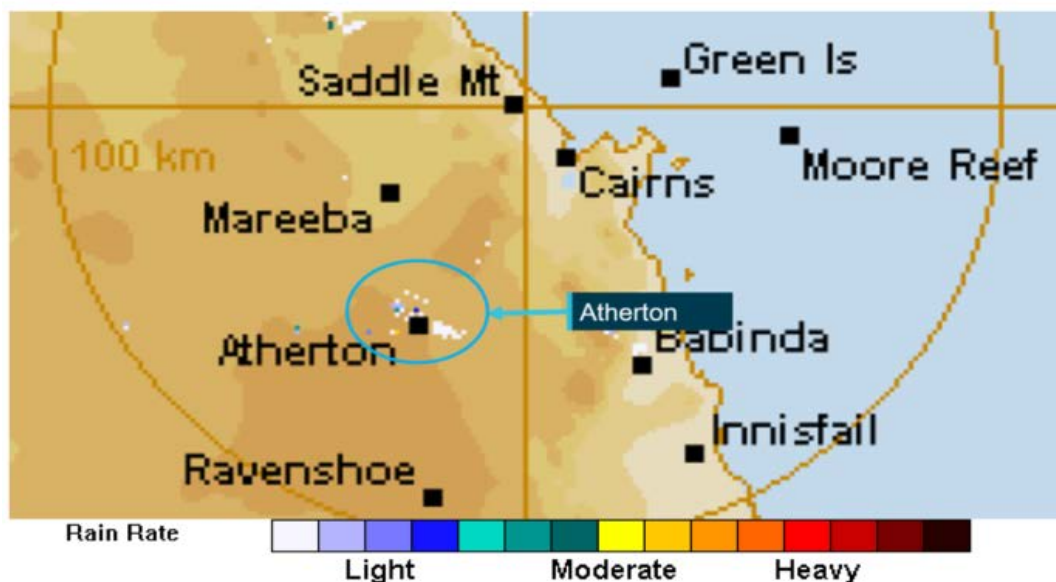
**Figure 6: Weather radar image from Cairns at 0951 showing light rain in Atherton**

Weather radar images from Cairns (Saddle Mountain) radar between 0934 and 0957 showed light rain in Atherton (Figure 6).

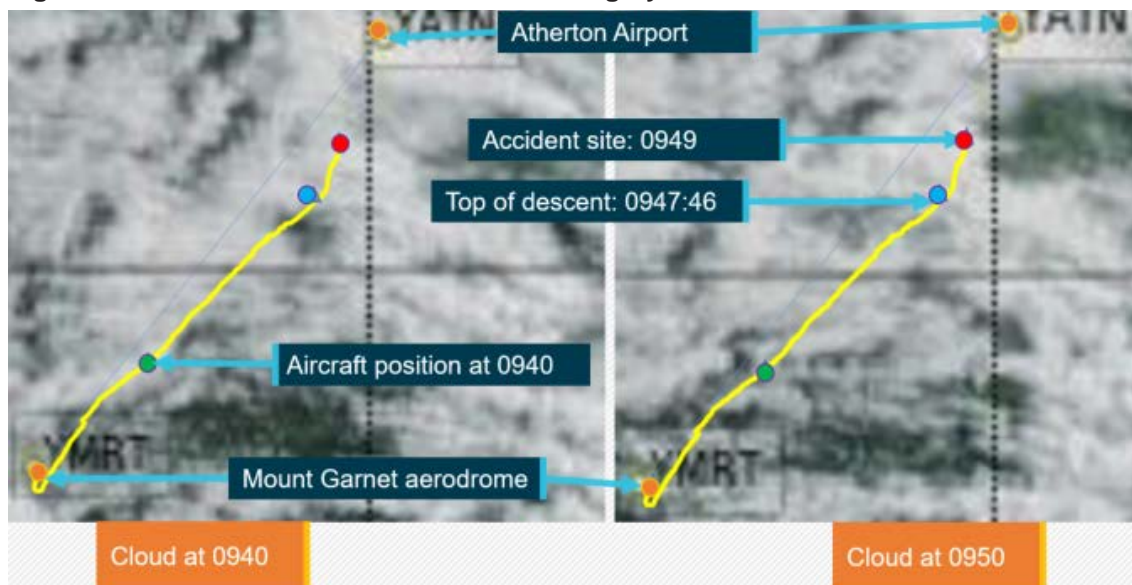
**Figure 7: Aircraft track overlaid on satellite imagery at 0940 and 0950 EST**

Satellite imagery showed scattered to broken cloud coverage at the time of the accident flight, moving from the south-east. Based on the cloud top infrared satellite temperatures, the cloud base was likely *at ground level* in the vicinity of the accident site. Figure 7 depicts the aircraft track overlaid on colour satellite images taken at 0940 and 0950. Within the limitations of the depicted cloud positions, these images show that the aircraft tracked along areas of more broken cloud until the top of descent. Between the top of descent and the accident site at 0950, the cloud appears as an unbroken cell.
