# Collision with terrain following an engine power loss involving Cessna 172M, VH-WTQ

12 NM (22 km) north-west of Agnes Water, Queensland | 10 January 2017

**ATSB Transport Safety Report**  
Aviation Occurrence Investigation  
AO-2017-005  
Final – 17 October 2019

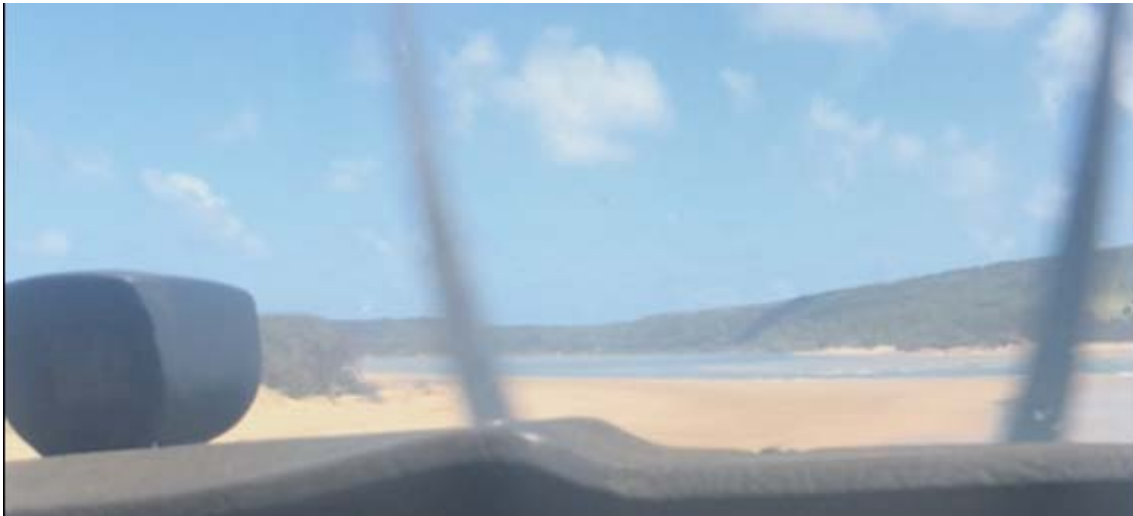
**Figure 4: A still image taken from the video footage 2 seconds after engine power loss (1037:36)**

Figure 4 shows the view of the remaining landing area at 1037:36, 2 seconds after the engine power loss. This shows an area of beach visible ahead, but does not show a further area of beach that was available for an emergency landing around a bend to the left (see Figure 2 and *Beach available for an emergency landing north of the landing area*).

*At the time this image was taken the phone camera was oriented to the left of the aircraft's heading. The image shows an area of sand on Middle Island beach, just prior to a bend to the left with further beach beyond. Source: Queensland Police Service.*

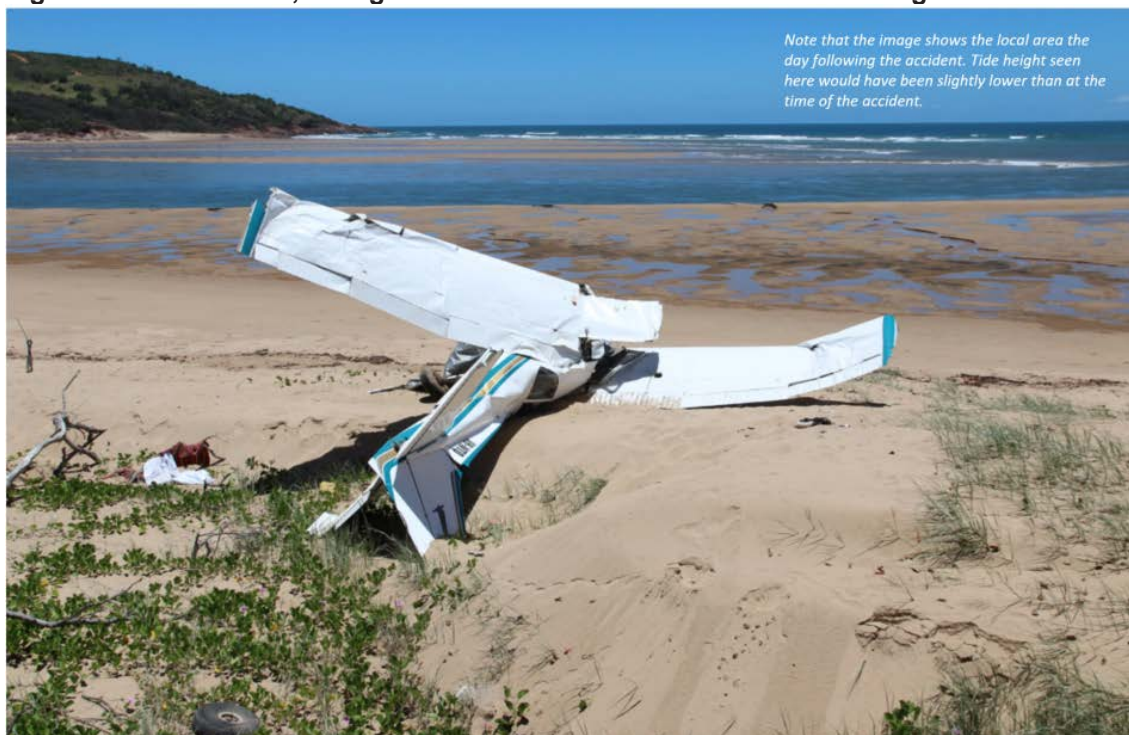
**Figure 5: Accident site, facing north-east with Bustard Head in the background**

One of the rear-seat passengers was fatally injured and the other three occupants sustained serious injuries during the impact. The aircraft was destroyed. Figure 5 shows the aircraft wreckage (see also *Wreckage and impact information*).

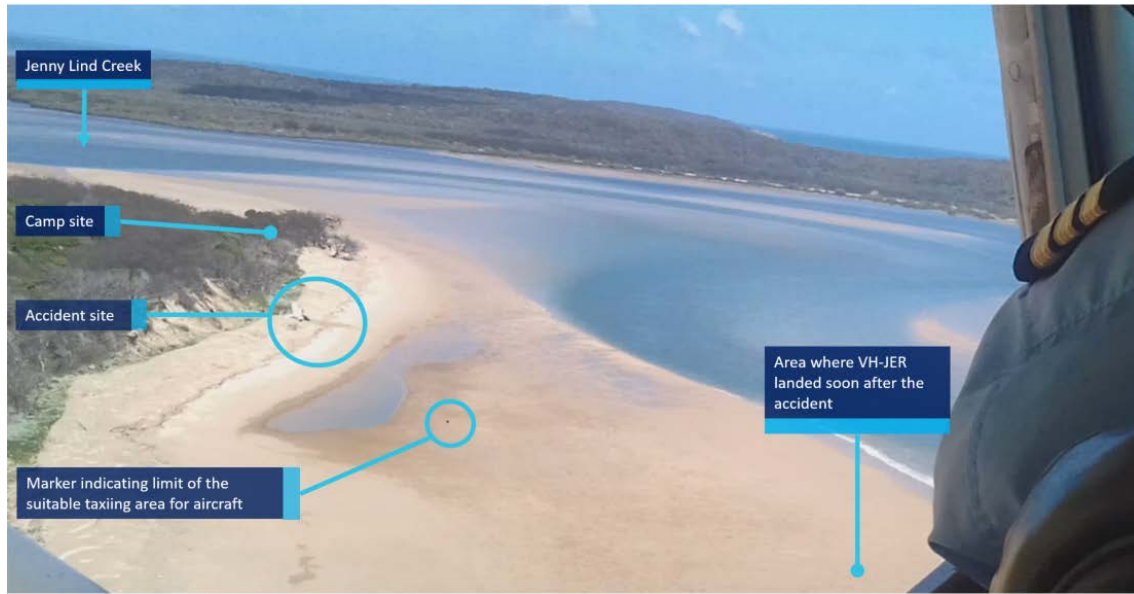
**Figure 6: Accident site, as viewed from VH-JER**

Following the impact, the aircraft cabin was inverted and the occupants were all held in place by their restraints. A significant amount of fuel was observed to be leaking from the aircraft's fuel tanks. The camp site employee, the chief pilot and other first responders extracted the occupants and moved them away from the wreckage to provide first aid. One of the rear-seat passengers was unresponsive, so the first responders provided cardiopulmonary resuscitation (CPR) but she could not be revived. A subsequent post-mortem examination determined that her injuries were not survivable (see also *Occupant injuries*).

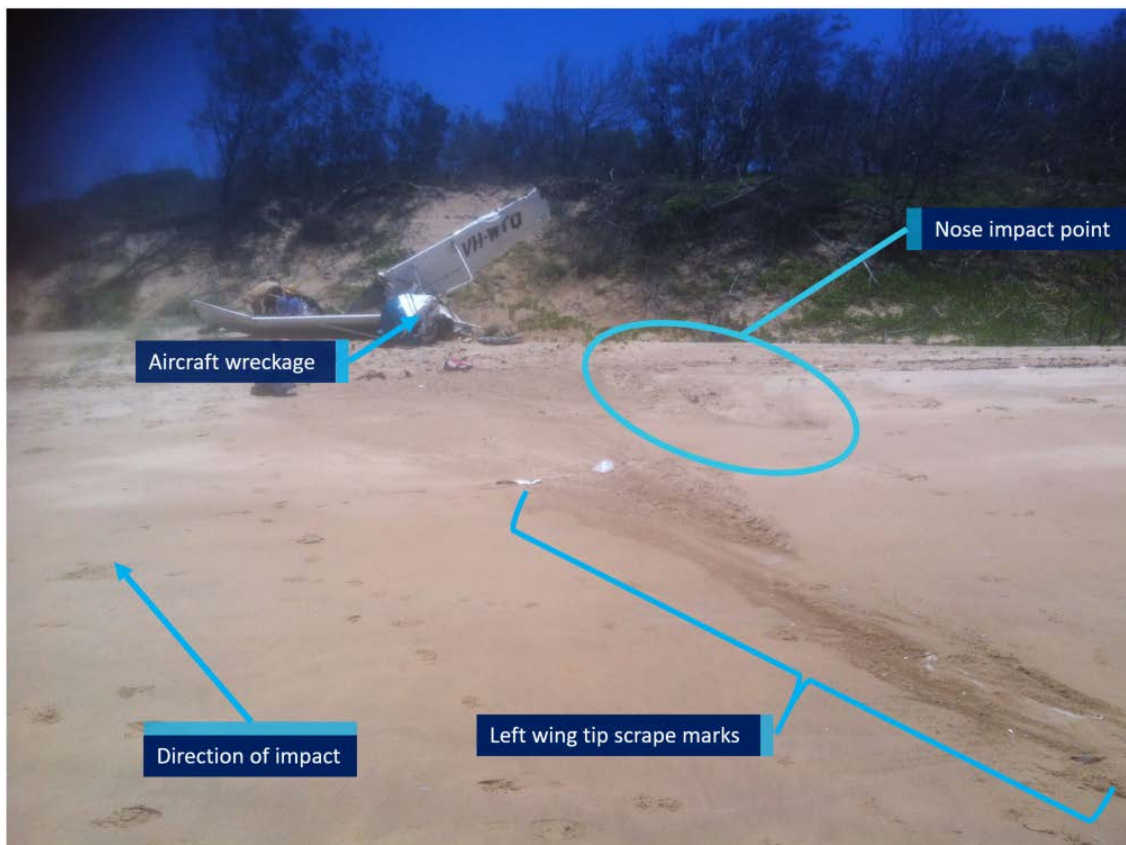
**Figure 8: VH-WTQ accident site showing impact marks**

The distance between the nose impact point and the main wreckage was about 5 m on a magnetic bearing of 210°. The wreckage distribution and distance from the impact point indicated that the aircraft impacted terrain in a significant nose-down and left-wing low attitude. The aircraft came to rest facing in the opposite direction to flight.

*This image also shows the sand dunes behind the beach, in the direction where the aircraft was headed prior to impact.*  
Source: Wyndham Aviation chief pilot.

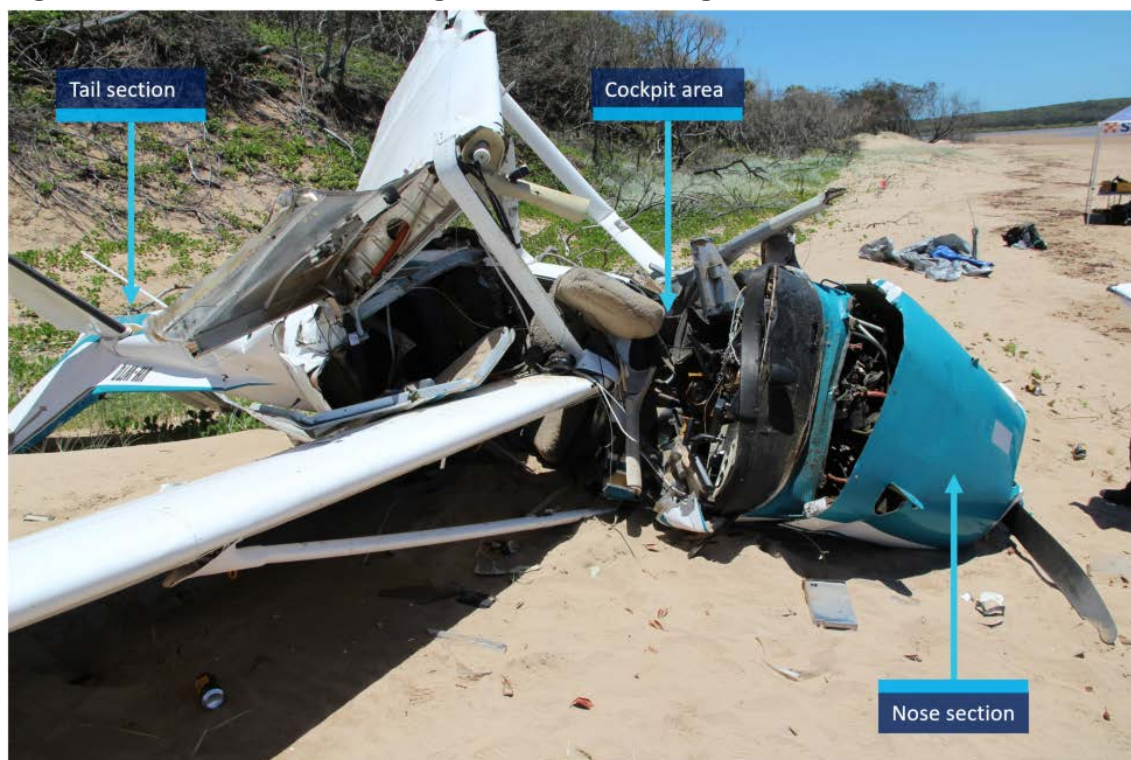
**Figure 9: VH-WTQ aircraft wreckage viewed from the right**

The aircraft was significantly disrupted by ground impact forces. The main fuselage structure had fractured at the rear of the engine firewall and just aft of the rear passenger seats. The cabin area was twisted and compressed and both wings had separated from the fuselage structure at the wing root (Figure 9).

The aircraft structure was examined for pre-impact defects, with none identified. All of the aircraft and its components were accounted for at the accident site. There was no indication of any fire.

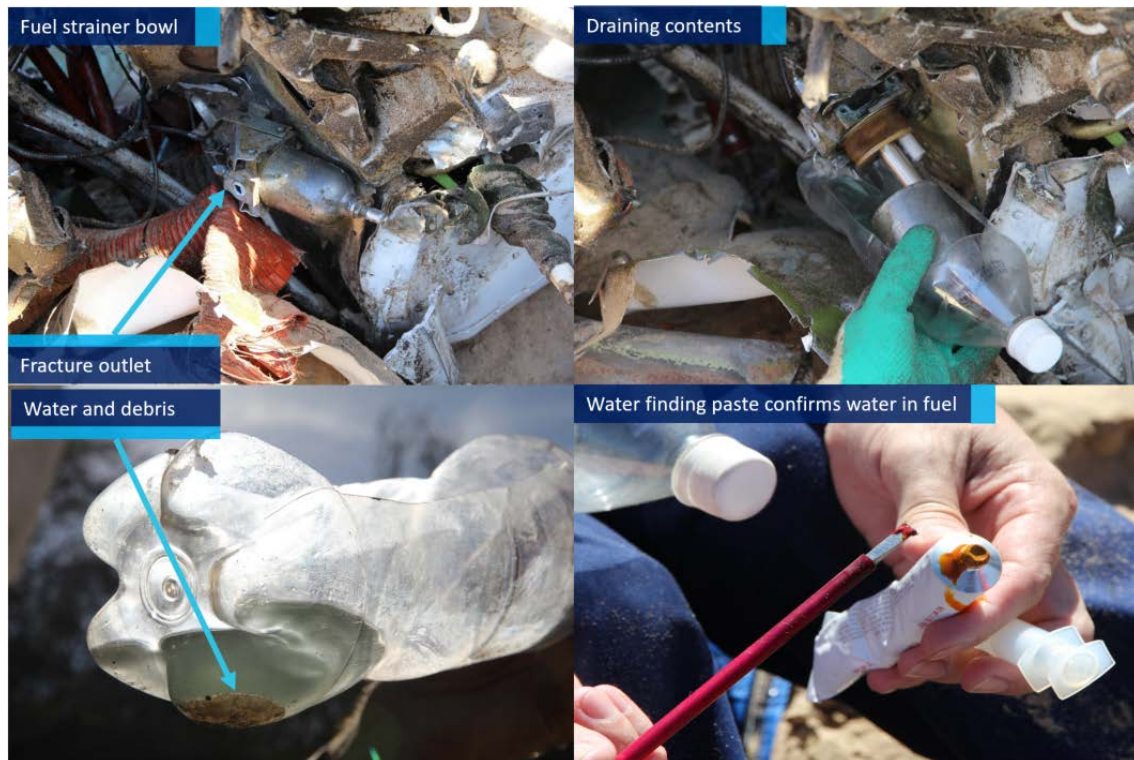
**Figure 10: Fuel strainer bowl and contents showing signs of water and debris**

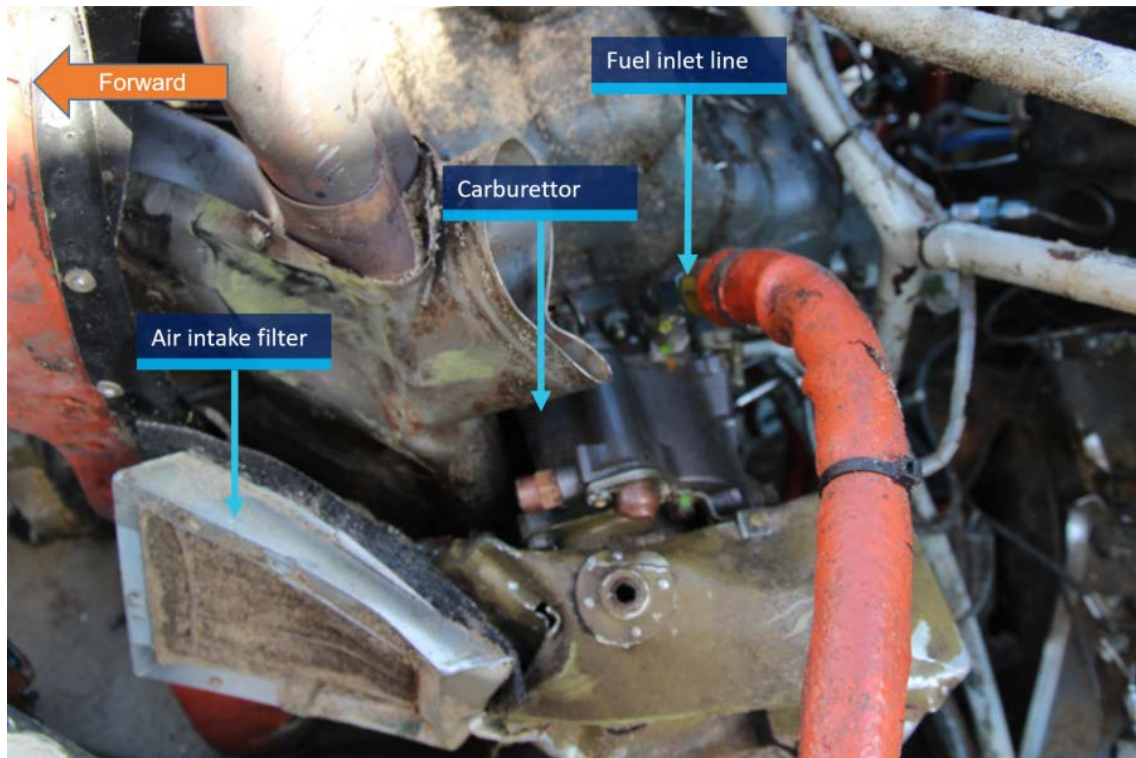
**Figure 11: Carburettor and air intake assembly**

The carburettor was oriented about 80° on its right side with the fuel inlet facing upwards. It was removed from the engine and inspected, with no defects noted.

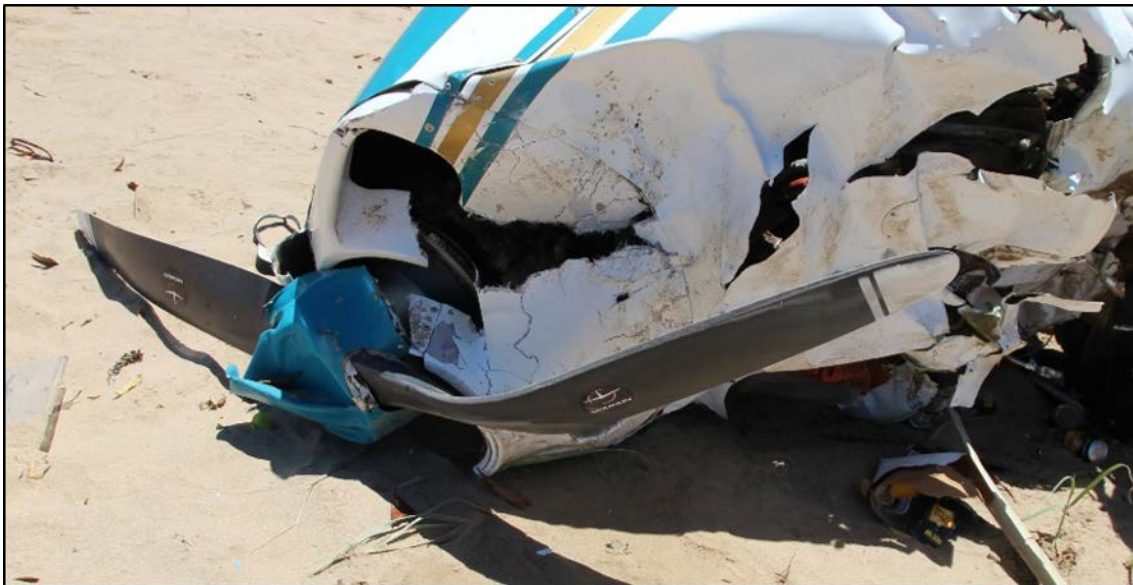
The propeller was examined on site for evidence of correct and secure fitment, with no issues identified. The propeller blades were examined for evidence of rotation damage at the point of impact. Only minor abrasion damage was observed on the blades with no other indications of rotation (Figure 14). That damage was consistent with very low or no power being delivered by the engine at impact.

**Figure 14: Propeller blades showing slight paint abrasion damage**
