In-flight break-up involving Airbus Zephyr unmanned aerial vehicle

Near Wyndham Airport, Western Australia on 28 September 2019

ATSB Transport Safety Report

AO-2019-056

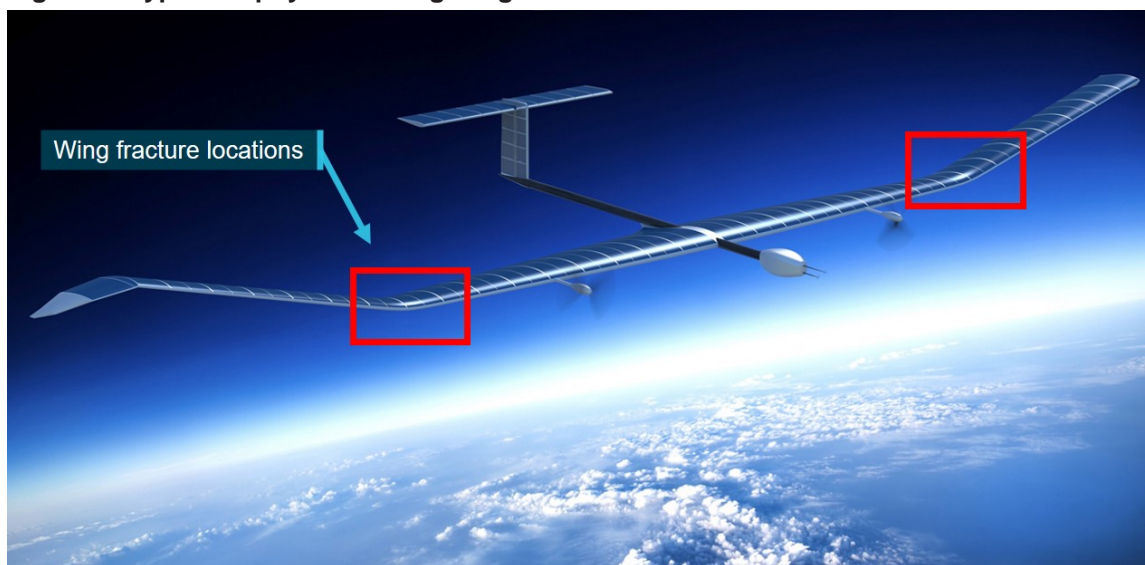
Figure 1: Typical zephyr - showing wing fracture locations

At about 2316, the UAV's airspeed increased further beyond Vne, which shortly thereafter, resulted in an in-flight break-up, with both wings fracturing at about mid-span (Figure 1). Coincident with the break-up, the crew noted that vision from the wingtip camera⁴ was lost. Shortly thereafter, both separated wing sections were observed in vision from the forward-looking camera mounted on the aircraft's fuselage.

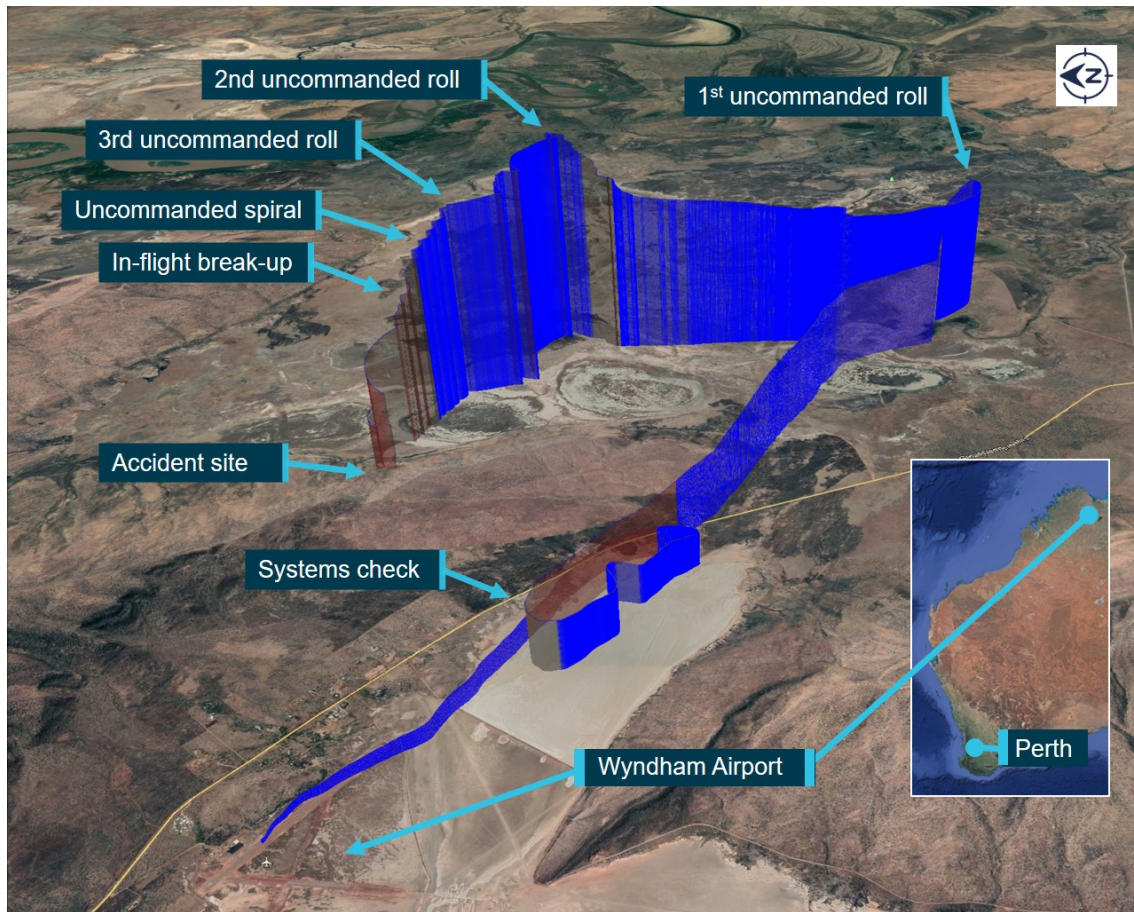
Figure 2: Flight path

The crew initiated the post-crash management plan and monitored the telemetry from the UAV until it was lost behind terrain, at 872 ft, about 5 minutes later. The accident site was located about 5.5 km east of Wyndham Airport and within the predicted cut-down zone (Figure 2).

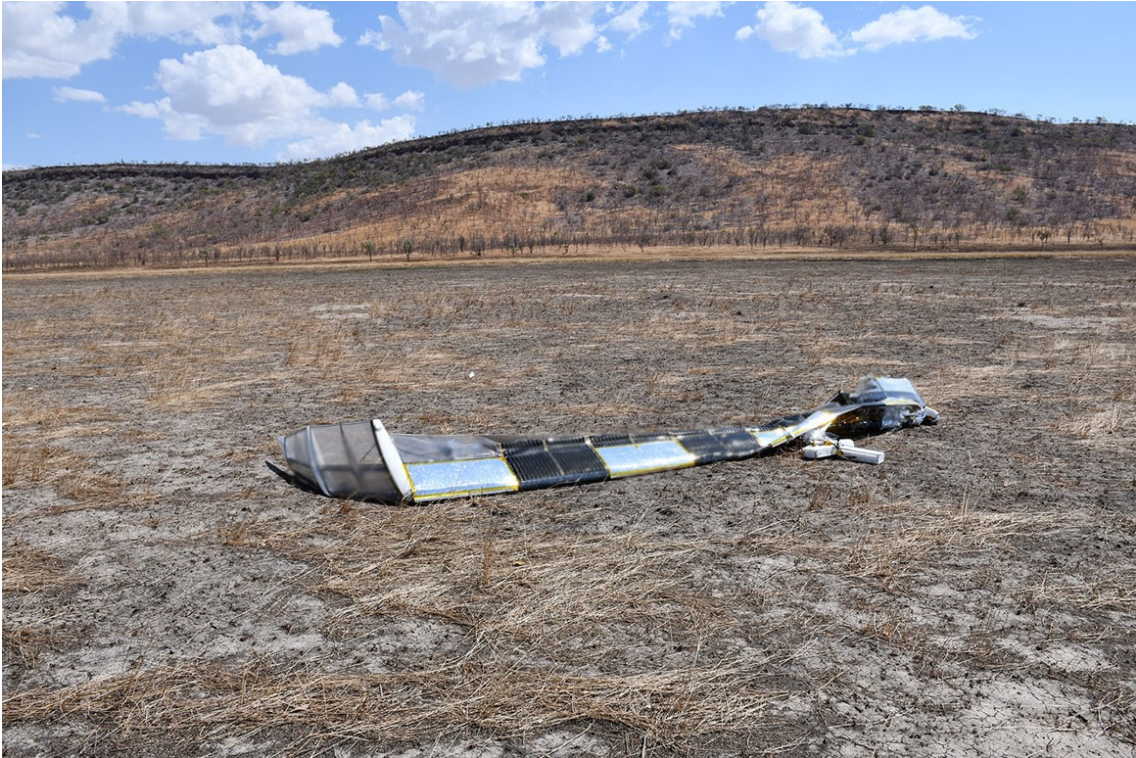
Figure 3: Right wing outboard section

The distribution of the wreckage was consistent with an in-flight break-up. The rudder was not located despite an extensive search. The recovered components were taken to a hangar at Wyndham Airport for examination. Examination of the wreckage identified that the wings failed about mid-span, due to overstress (Figure 3 and Figure 4). The aircraft batteries were tested and were all found to be within operational voltages.
