Overspeed and pitch up resulting in cabin crew injury involving Boeing 737, VH-VUE

42 NM ESE Adelaide Airport, South Australia, on 13 September 2017

ATSB Transport Safety Report
Aviation Occurrence Investigation
AO-2017-092
Final – 30 September 2020

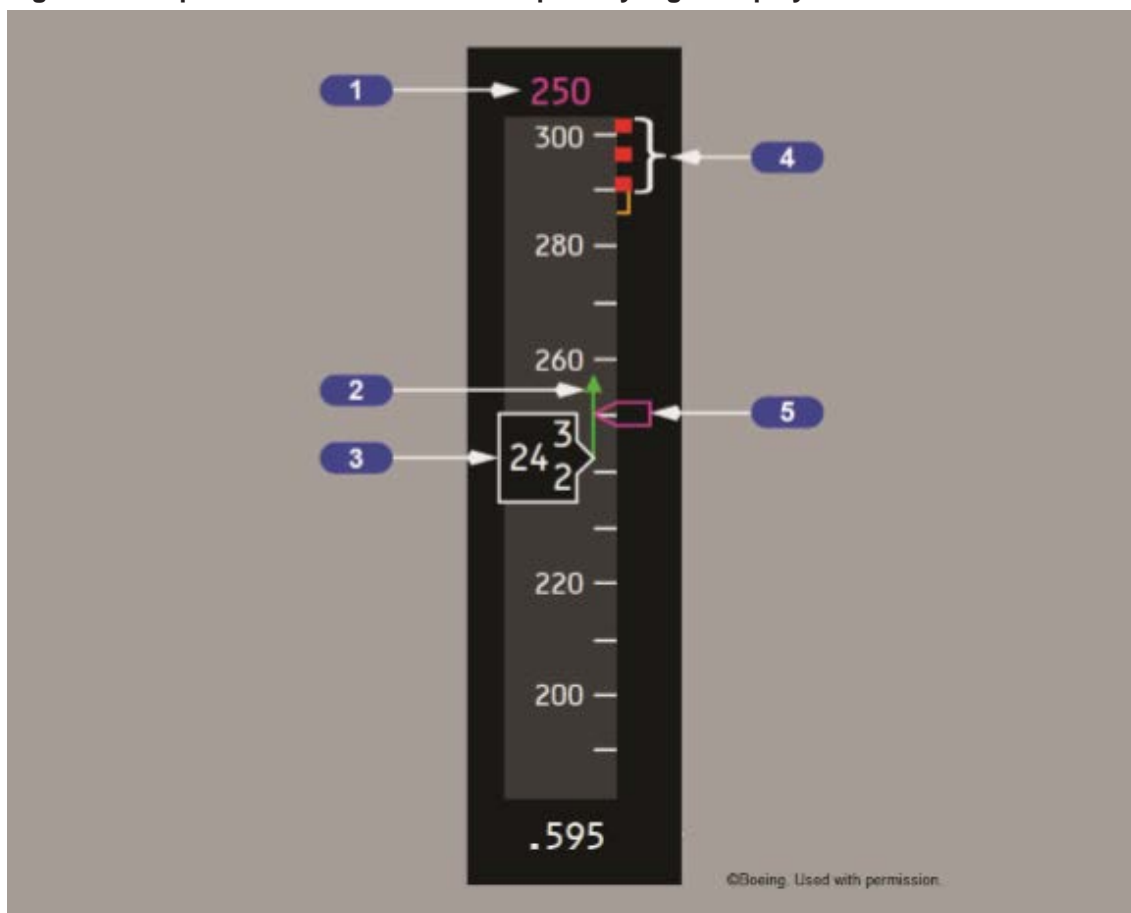
Figure 2: Airspeed indications on the 737 primary flight display

Prior to the autopilot disconnect, the flight crew observed the current indicated airspeed increase to near V_{MO} . The FO also observed the speed trend vector increase to within the lower band of the red bars, indicating that if not slowed the airspeed would exceed V_{MO} within the next 10 seconds. According to the captain's interview with the ATSB, the captain did not specifically look at the speed trend vector prior to pulling back on the control column in response to the sudden speed increase.

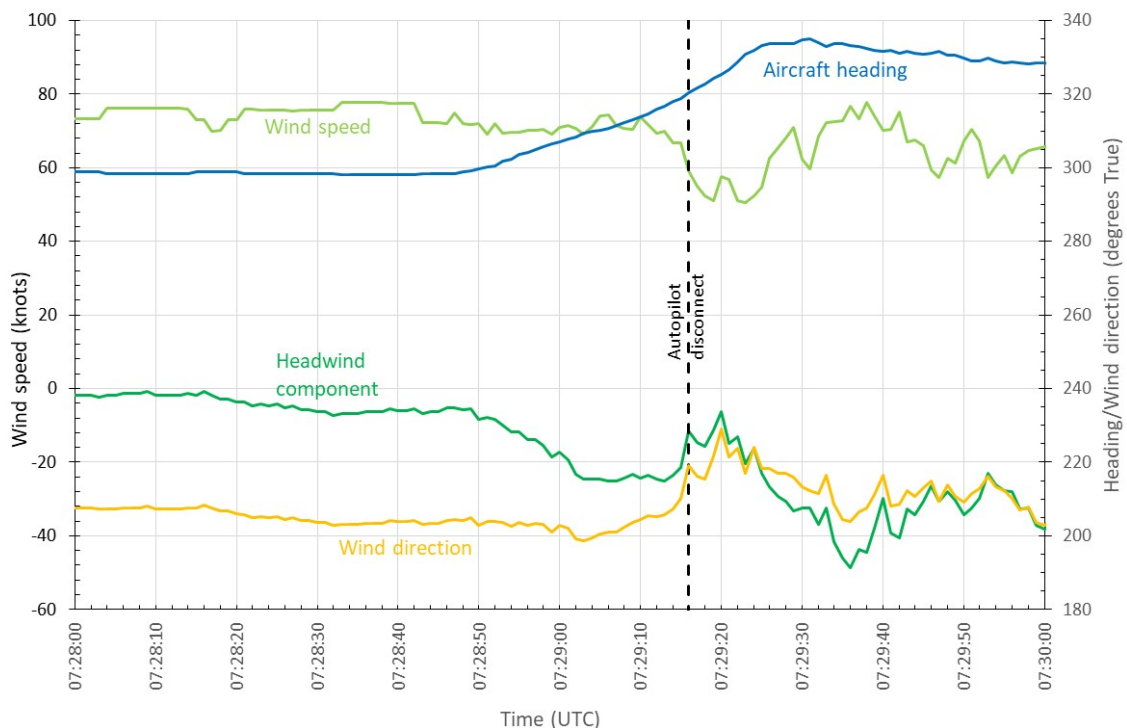
Figure 7: Plot of the calculated wind (light green), wind direction (yellow), headwind component (dark green), and aircraft heading (blue) during a two minute period around the autopilot disconnect.

Figure 7 shows the variation in the calculated wind vector and headwind components around the time of the autopilot disconnect. During that period, the wind component changed from almost no headwind component to a tailwind of about 25 kt, where it stabilised for about 10 seconds. Immediately before the overspeed, tailwind dropped by about 13 kt in around 2 seconds. This appears to have been due to a combination of a decrease in the wind strength and a change in the direction of the wind.

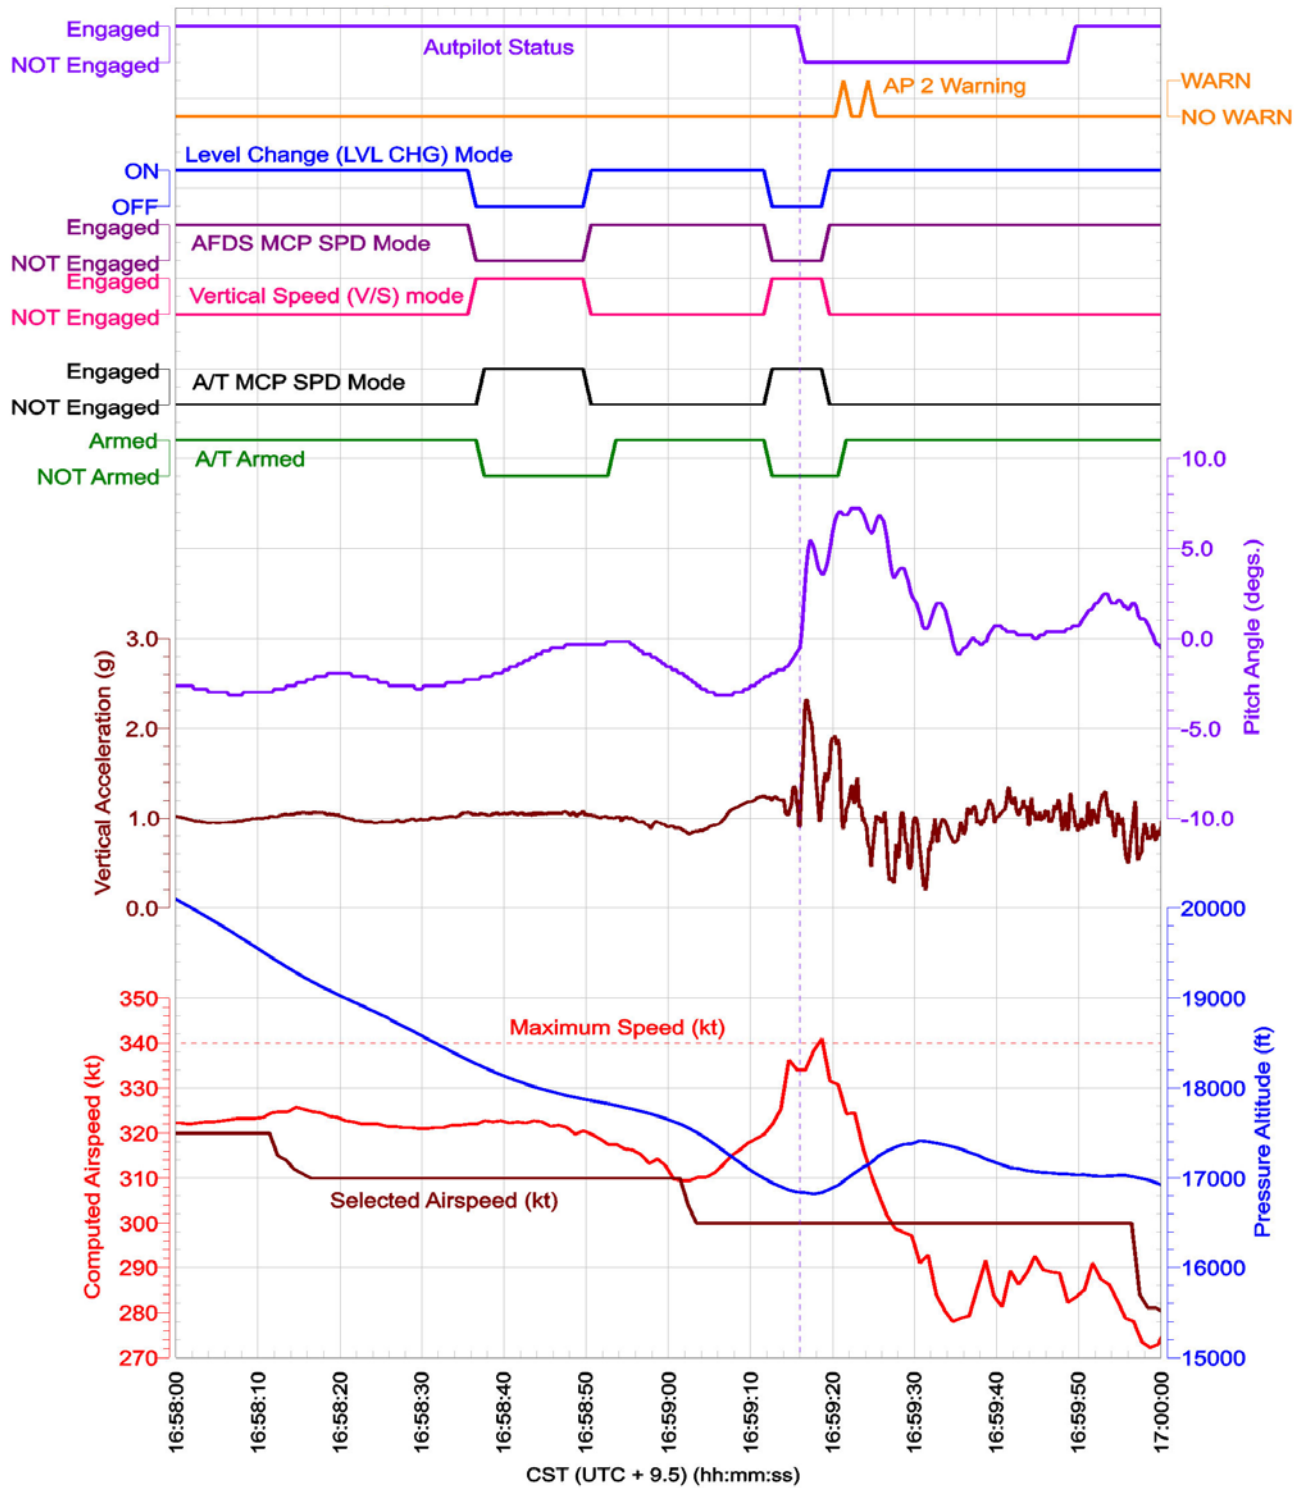
Figure 8: Recorded data parameters including autopilot modes, pitch angle and vertical acceleration

- At 1659:16 (vertical purple dotted line in Figure 8 and Figure 9), the captain suddenly pulled back on the control column, with a maximum 49 lb backwards control force. This caused the autopilot to disconnect and resulted in a large increase in the aircraft pitch attitude.

- At 1659:19, the airspeed peaked at 341 kt, before declining quickly to around 280 kt.

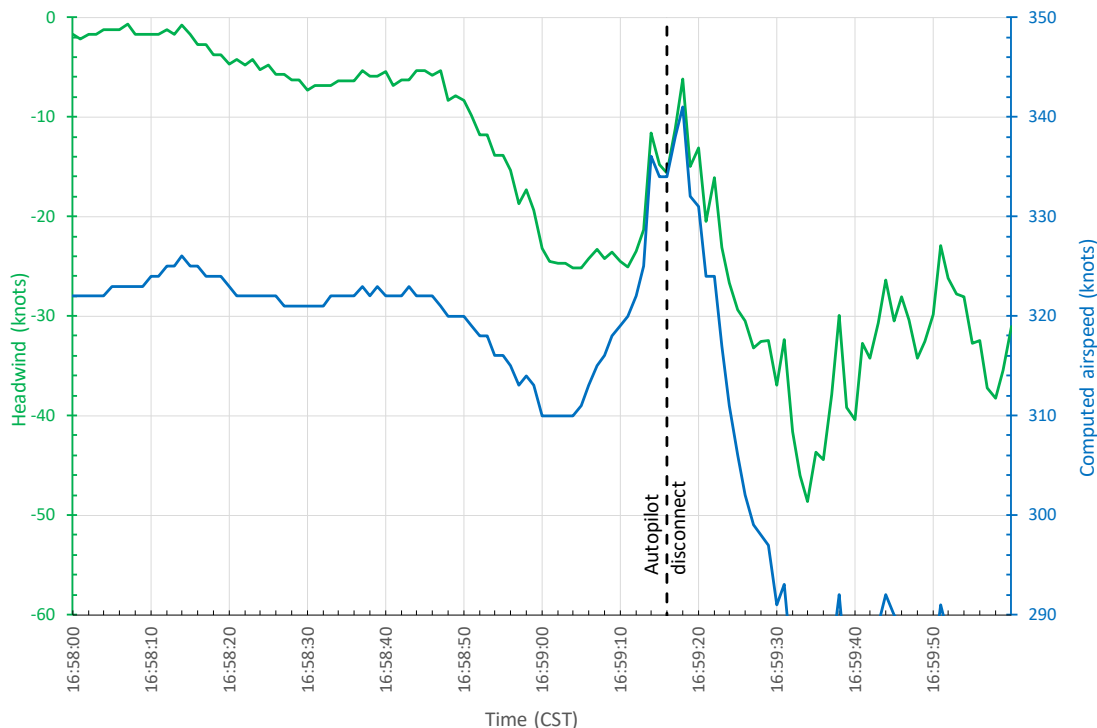
Figure 10: Comparison of the calculated headwind changes (green) and the computed airspeed (blue) in the two minute period around the autopilot disconnect.

change in the headwind component. The second rise in computed airspeed about 2 seconds later was also consistent with another change in the headwind component. This is consistent with a windshear encounter during the descent into Adelaide.

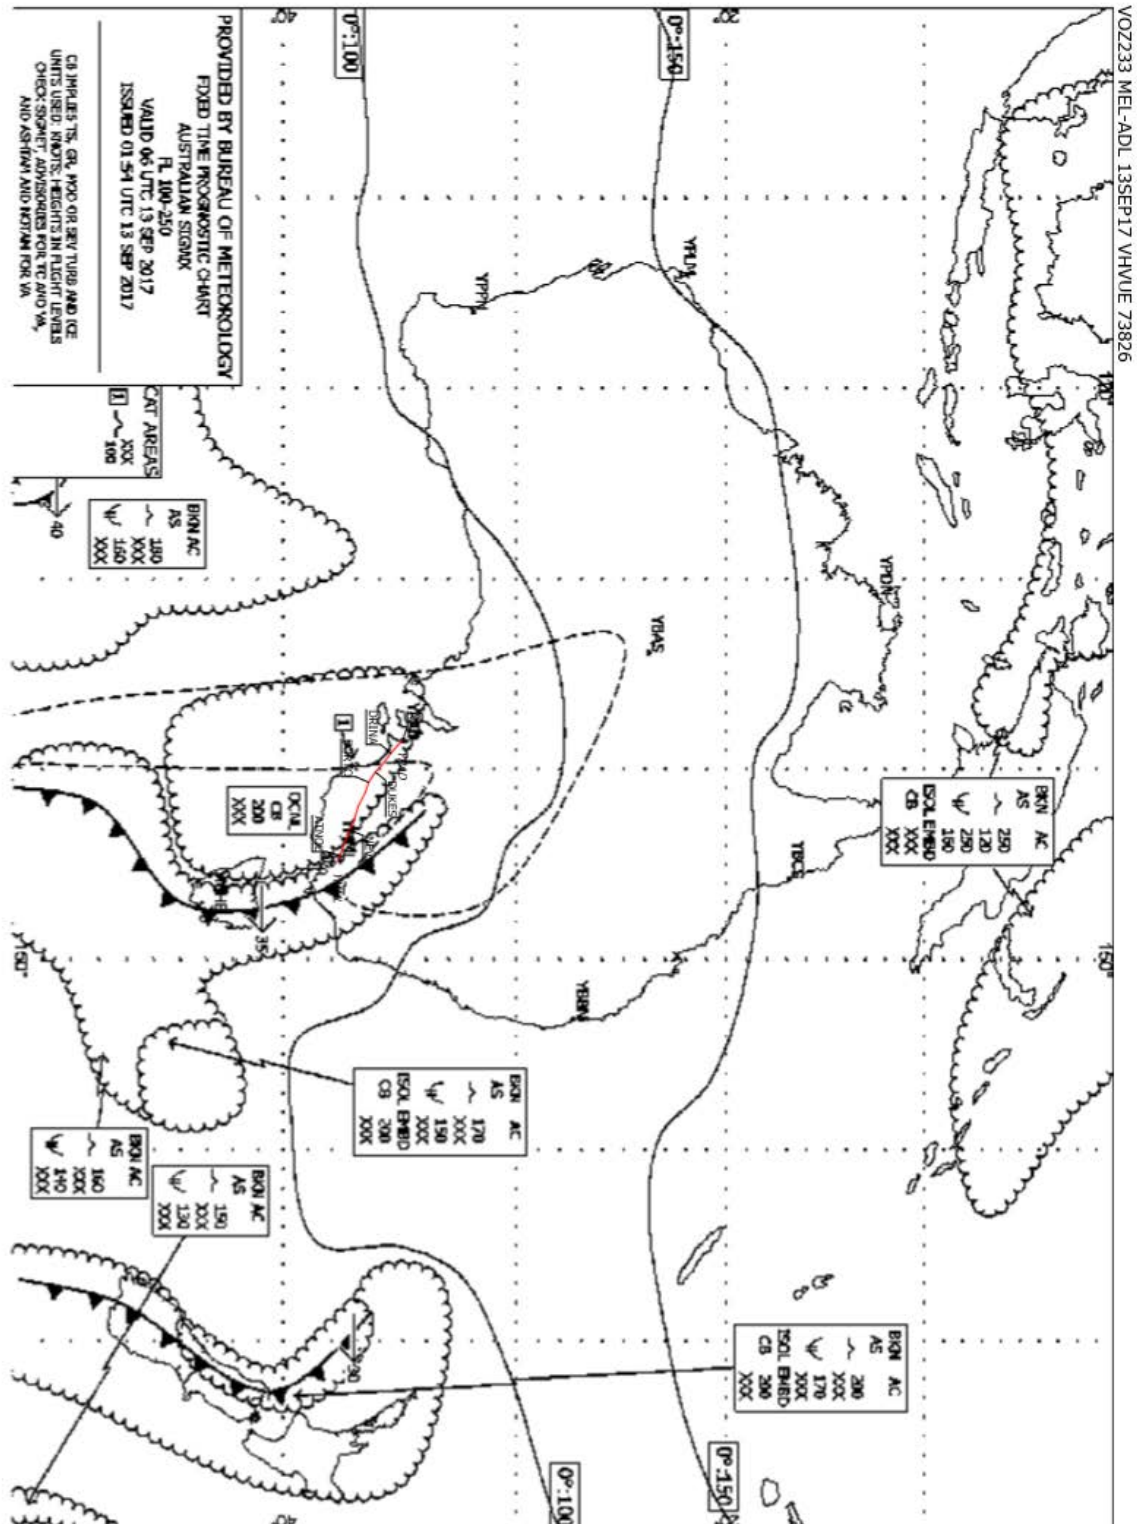
The significant weather charts (shown in *Appendix C – Significant weather chart*) forecast an area of moderate clear air turbulence from FL 100 to FL 250, which covered the planned route from around 95 NM (175 km) east of Adelaide. The aerodrome forecast for Adelaide was for westerly winds of 20 kt with gusts up to 30 kt, together with intermittent periods of reduced visibility in rain showers and small hail, and broken cloud at 2,500 ft.
