# Rotor RPM decay and hard landing involving Robinson R44, VH-HGX

5 km south of Ayers Rock Airport, Northern Territory, on 17 January 2018

**ATSB Transport Safety Report**  
Aviation Occurrence Investigation  
AO-2018-006  
Final – 7 October 2020

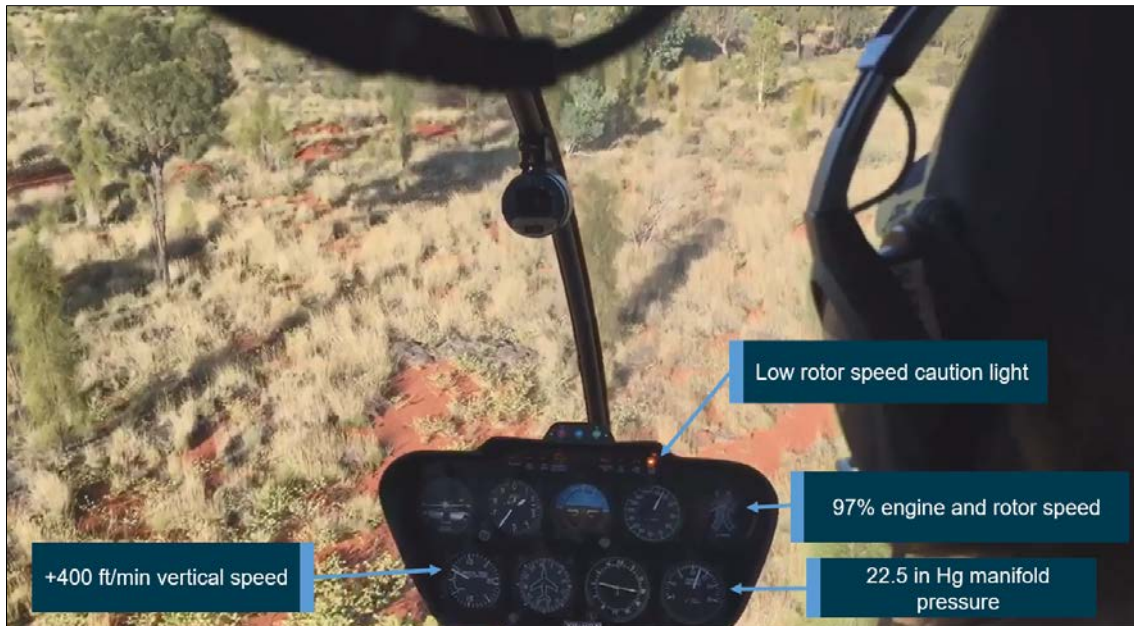
**Figure 1: Activation of low rotor RPM warning**

About 3 seconds after take-off, and just prior to passing overhead the first trees in the departure path, the helicopter's low rotor RPM warning horn and caution light activated (Figure 1). This indicated that the rotor RPM had decayed from 101–102 per cent (normal operation) to 97 per cent. The engine and rotor RPMs were matched and decreasing. The engine manifold pressure (MAP) was at 22.5 in Hg<sup>7</sup> and the airspeed at 25 kt; both were increasing. Based on estimates from a combination of the helipad surveillance video and passenger video of the flight instruments, the low rotor RPM warning occurred at approximately 37 ft above ground level (20 ft climb above take-off height).

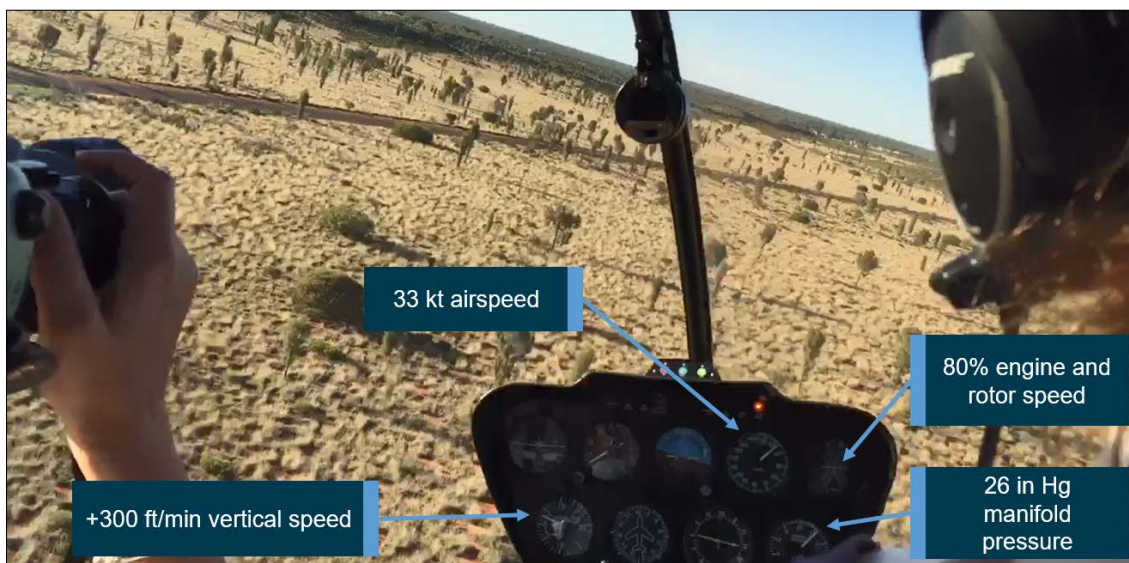
**Figure 2: Rotor RPM decay**

About 15 seconds after take-off, the engine and rotor RPM had decayed to 80 per cent, with a MAP of 26 in Hg, airspeed of 33 kt, height of about 87 ft above ground and vertical speed of 300 ft/min (Figure 2).<sup>8</sup> The onset of vibrations became noticeable in the final seconds of the passenger video of the departure, which ended about 17 seconds after take-off. The helicopter continued to turn left onto a southerly track, instead of following the planned scenic flight departure pattern to the west.

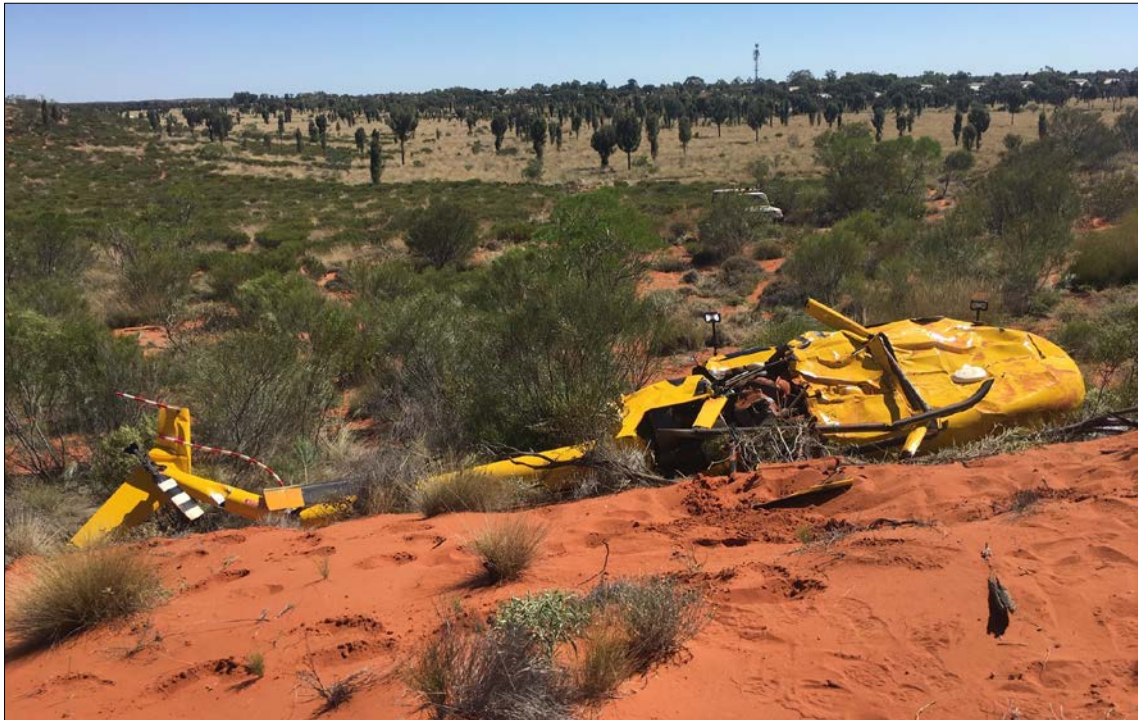
**Figure 3: VH-HGX wreckage**

During the descent, the rotor RPM was too low for the pilot to be able to arrest the helicopter's rate of descent to a safe vertical speed, resulting in a hard landing. The landing area was a small knoll with a steep bank, which resulted in the helicopter rolling over. The pilot and two passengers were seriously injured, and the remaining passenger experienced minor injuries. The helicopter was substantially damaged.

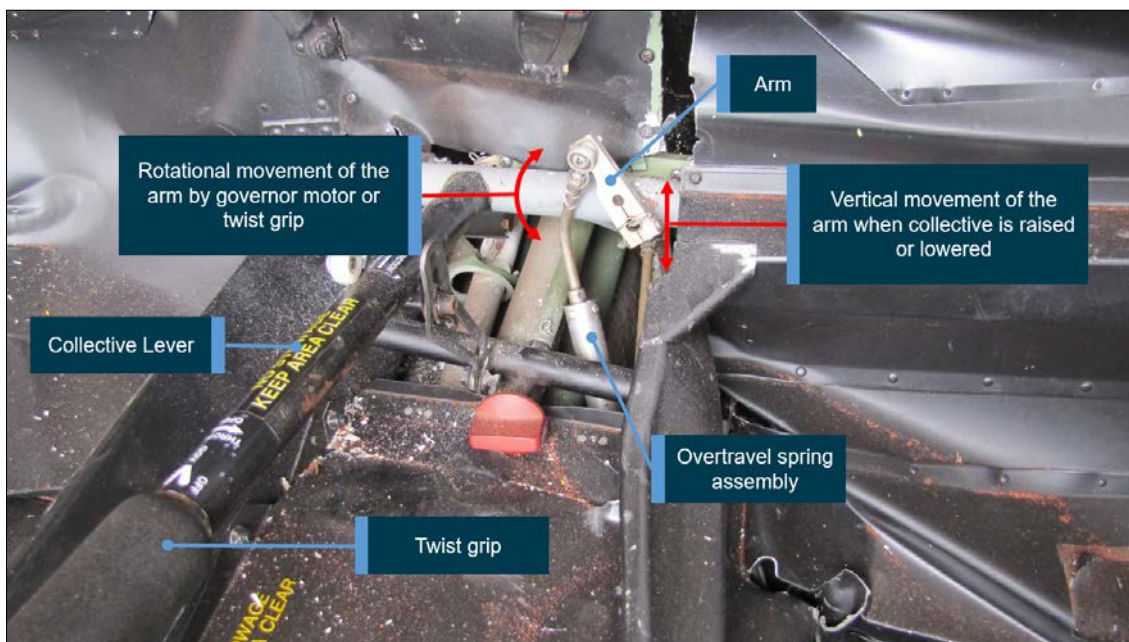
**Figure 6: VH-HGX collective lever assembly and overtravel spring assembly**

During the ATSB's examination of the wreckage (refer to section titled *Post-accident tests and inspections*), the overtravel spring assembly was found bent (Figure 6), most likely as a result of the ground impact. Robinson reported that, from the overtravel spring to the engine throttle valve, the system can be considered to be a purely mechanical link and extension or compression of the overtravel spring does not occur during normal flight regimes, only at the extremes of throttle travel.

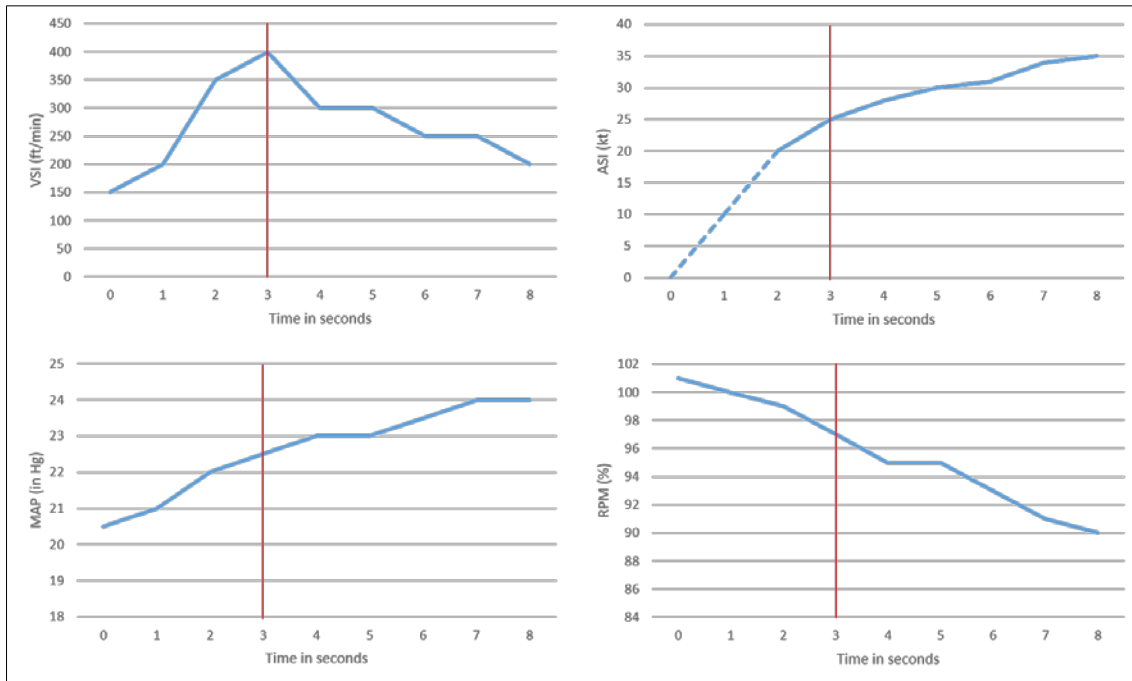
**Figure 7: Data plot of instrument indications**

The cockpit instrument indications for vertical speed (VSI – ft/min), airspeed (ASI - kt), MAP (in Hg) and engine RPM (%) were plotted (Figure 7). The measurements were based on passenger video footage of instrument readings using 1 second time intervals. Therefore, the accuracy of any individual data point should be treated with caution. As the engine and rotor RPM decayed together (within the tolerance of 1 per cent of each other), the rotor RPM trend can be inferred from the engine RPM trend.

this change, such as a loss of ground effect, increase in forward cyclic or reduced collective setting. The top right graph shows the airspeed steadily increased after it started to provide a reliable indication. The bottom left graph shows the MAP steadily increased and the bottom right graph shows the RPM steadily decreased.

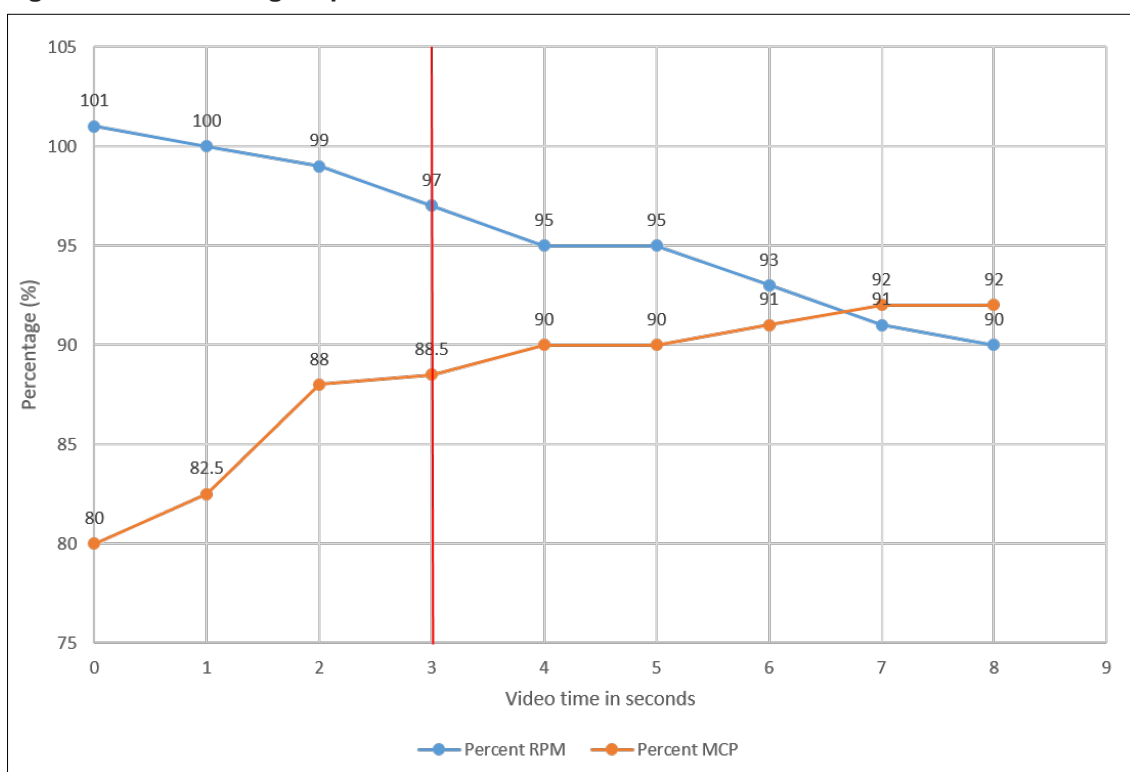
**Figure 8: Trend in engine power and RPM**

The Table 1 figures indicate that MAP and engine power were increasing during take-off, but at a decreasing rate. The engine manufacturer's fuel consumption charts indicate that the same throttle setting will produce a higher MAP at a lower RPM. Therefore, a MAP equivalent to the MCP throttle setting did not appear to have been achieved in this period. Figure 8 depicts the trend in engine power as a percentage of 205 hp (MCP) and the trend in RPM decay.

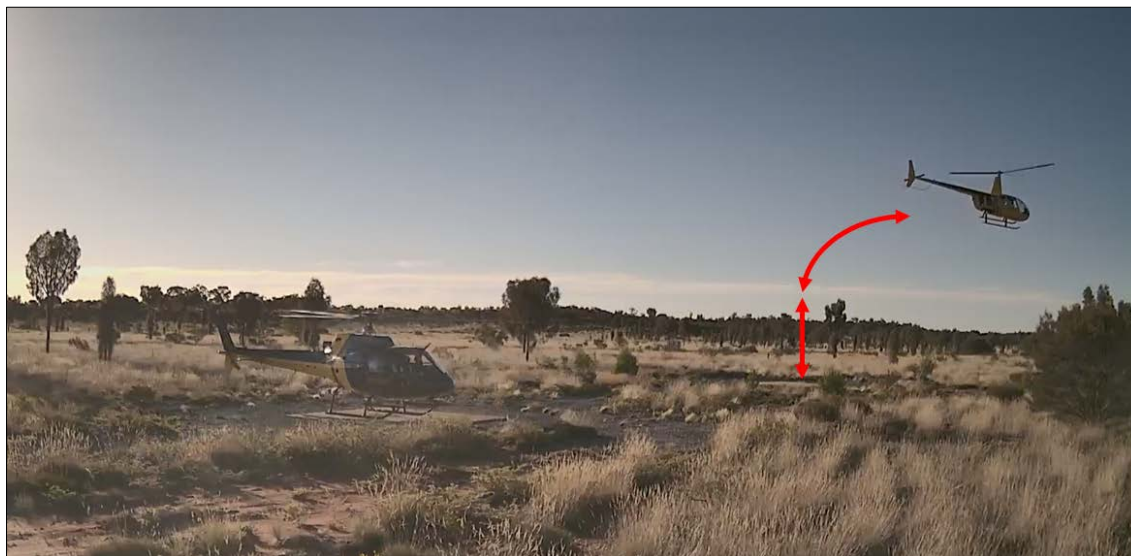
**Figure 10: Approximate position of the low rotor RPM warning**

At the start of the passenger video, the helicopter had started to transition forward. The altimeter then indicated a climb of about 20 ft in the 3 seconds from the start of the recording to the activation of the low rotor RPM warning. The airspeed increased from no positive indication to about 25 kt in this period, which was consistent with a take-off into wind. Consequently, it was likely the helicopter had reached a height of about 37 ft, and accelerated through translational lift, when the low rotor RPM activated (Figure 10). The proximity of the trees at the time of the low rotor RPM warning did not permit a safe abort.
