**REPORT OF CHAIRMAN
OF
BOARD OF ACCIDENT INQUIRY
ON
ACCIDENT TO VISCOUNT AIRCRAFT
VH-RMI NEAR WINTON, QUEENSLAND,
ON 22ND SEPTEMBER, 1966.**

ACCIDENT WHICH OCCURRED NEAR WINTON,
IN THE STATE OF QUEENSLAND, ON THE 22ND
OF SEPTEMBER, 1966, TO VISCOUNT AIRCRAFT
VH-RMI, OPERATED BY ANSETT TRANSPORT
INDUSTRIES (OPERATIONS) PTY. LTD., TRADING
AS ANSETT-A. N. A.

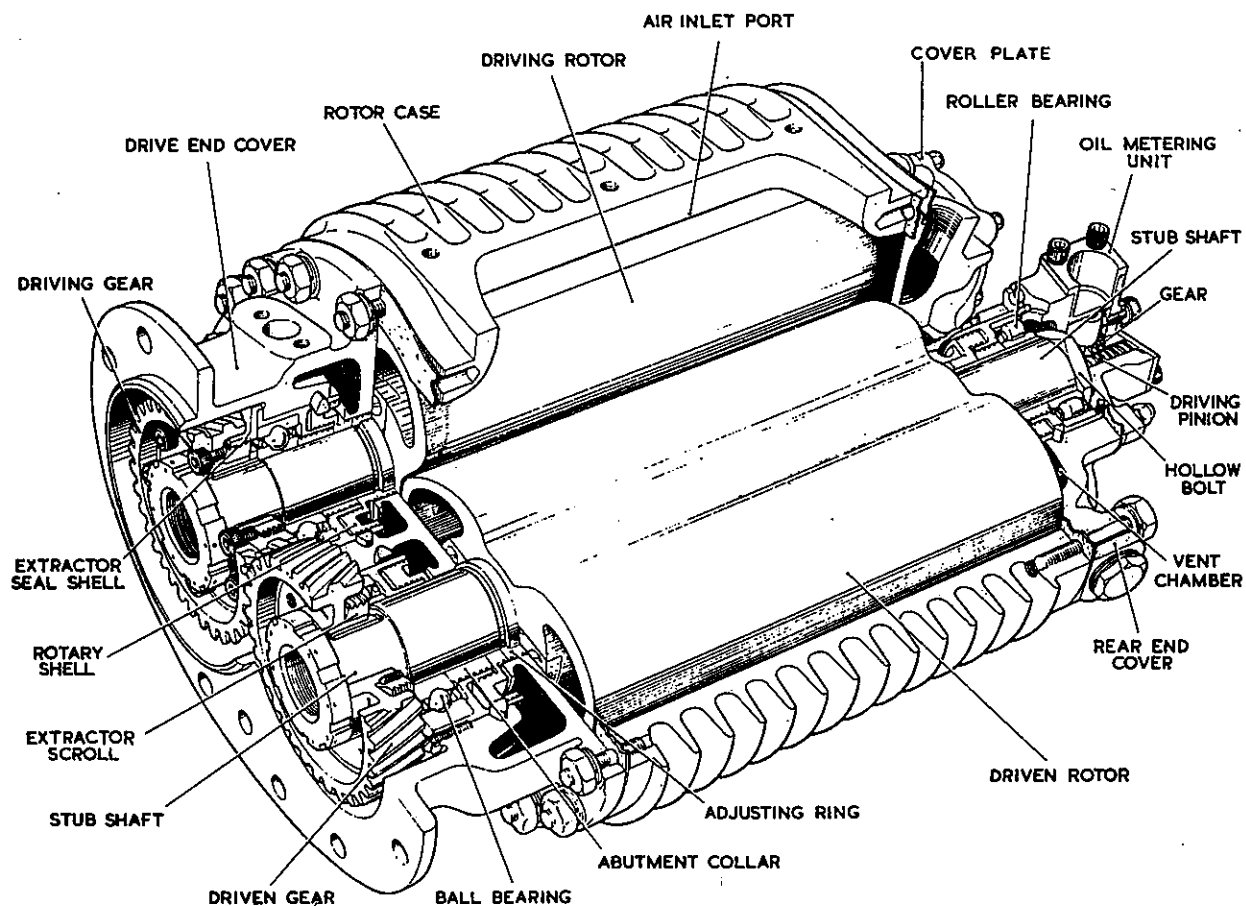
Sectioned view of cabin compressor

"18. The wreckage examination indicates that the nuts and studs securing the oil metering unit onto the rear end cover of the No. 2 cabin air blower loosened, probably as a result of an out-of-balance condition in the rotating elements of the blower, and the consequent separation of the oil metering unit induced both a mechanical failure of the blower and an internal fire. The fire entered the nacelle

Whatever may have been the cause, it seems clear that the oil metering unit moved rearward away from the blower rear end cover and this allowed the outer bearing track of the driven rotor roller bearing to separate from the remainder of the bearing. However, the metering unit continued to be driven after separation occurred and oil continued to be supplied to that area. The driven rotor lost its rear stub shaft location and this caused metal-to-metal contacts, generating high temperature. In addition, it caused the rotor to machine through the rear end cover between the rotor chamber and the vent chamber.

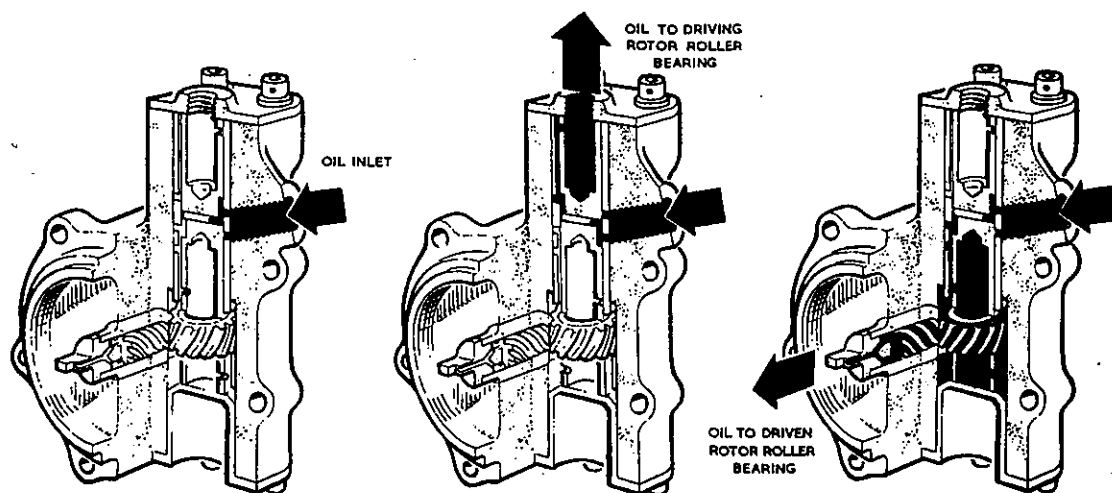
Sectioned view of oil metering unit

In the course of the Inquiry by the Board there has been no dispute as to the finding of the Investigation Branch that the nuts and studs which secured the oil metering unit to the rear end cover of No. 2 cabin blower worked loose. There has however been considerable controversy in relation to the question as to why they worked loose.
