Collision with terrain involving Cirrus SR22, VH-CKS

Boxwood, Victoria, on 27 June 2013

ATSB Transport Safety Report
Aviation Occurrence Investigation
AO-2013-104
Final – 30 June 2014

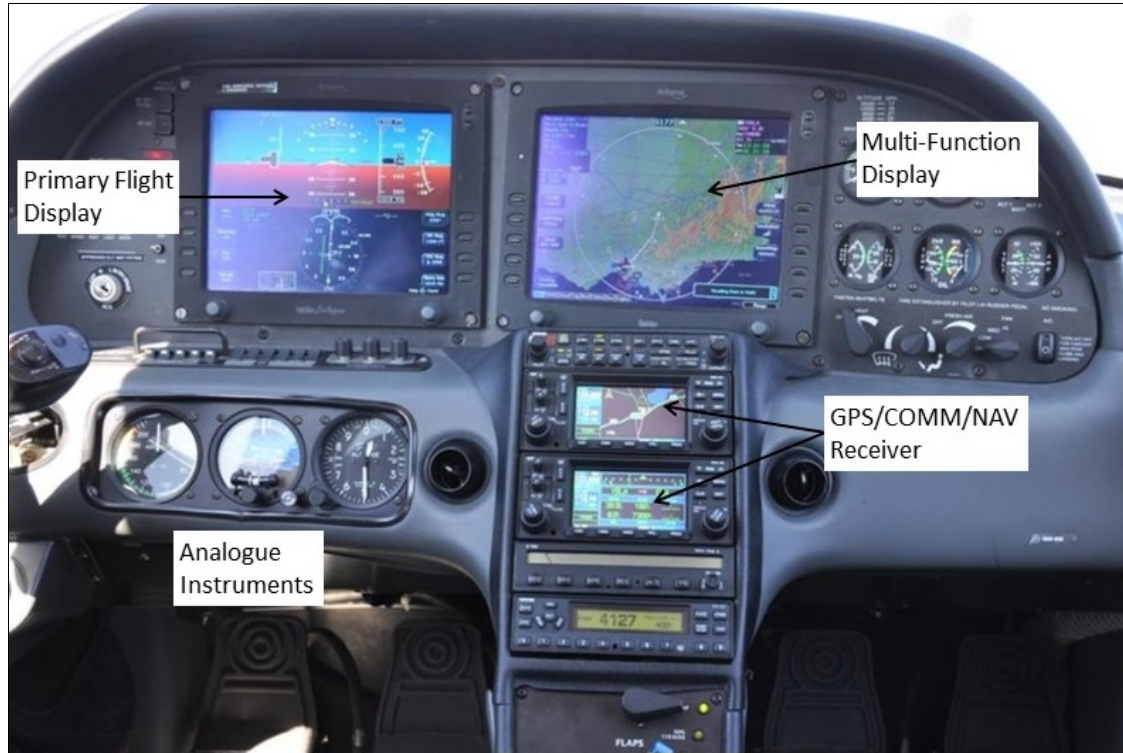
The aircraft was equipped with a factory-fitted advanced cockpit 'glass panel' instrument display that consisted of 2 Avidyne integrated flight displays (flat screens) mounted side-by-side (Figure 1). The left screen was referred to as the Primary Flight Display (PFD) and the more centrally mounted screen as the Multi-Function Display (MFD). The brightness of the screens is controlled manually for night operations.

Figure 1: Aircraft instrument panel showing the Primary Flight Display (left screen), the Multi-Function Display (right screen) and analogue instruments during a daylight flight

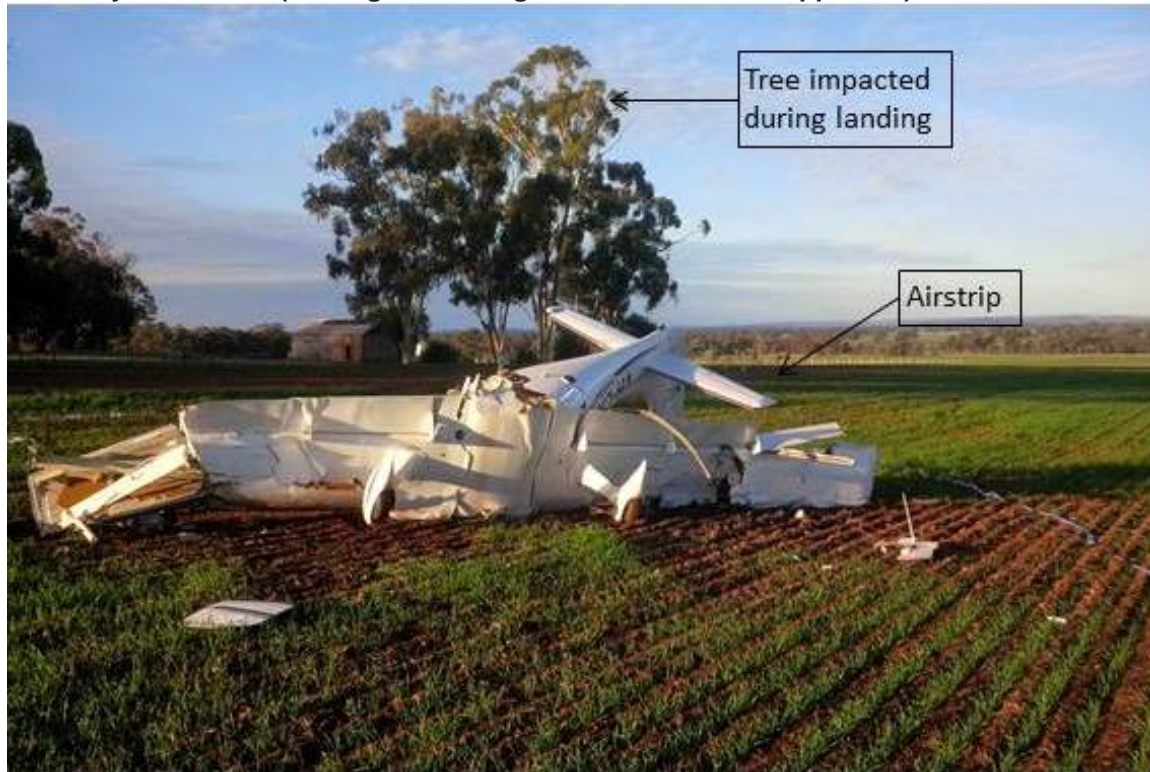
The aircraft impacted terrain in a nose-down attitude of approximately 70°-90° with significant forward speed. Both wings were breached from impact forces and all of the remaining fuel on board leaked from the damaged integral wing fuel tanks. There was no evidence of fire (Figure 2).

An examination of the wreckage identified no pre-existing mechanical defect that may have contributed to the accident. Consistent with there being no report from the pilot of a problem with the aircraft, there was evidence that the engine was producing power prior to the impact.

Figure 2: Aircraft wreckage showing the trees adjacent to the airstrip, one of which was struck by the aircraft (looking back along the direction of the approach)

The aircraft's primary structure and flight control surfaces were identified at the accident site. Flight control continuity was established with no pre-impact defects identified. Furrowing of the horizontal stabilisers and elevators and impact damage to the elevator leading edges was consistent with their striking tree branches during flight. In addition, portions of tree branches were embedded in the lower centre wing section, between the left and right main landing gear.

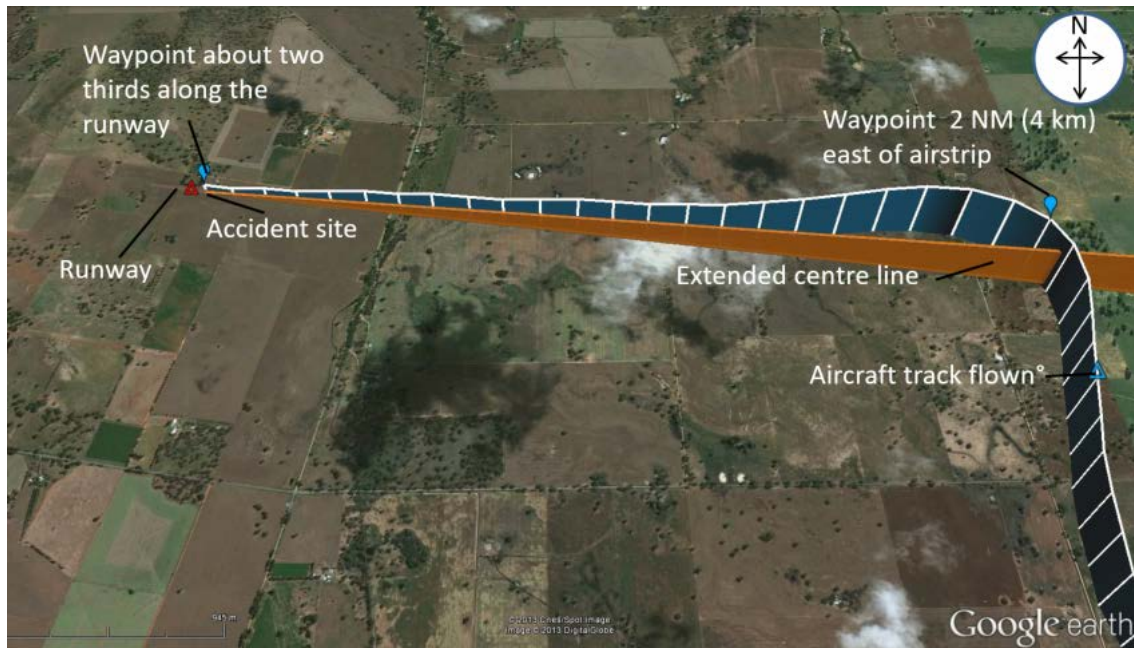
The recovered flight information included the aircraft's speed, track, altitude and a number of engine parameters. The flight data also included a number of waypoints, including one on the extended runway centre-line about 2 NM (4 km) east of the airstrip, and another about two thirds along the runway (Figure 3).

Figure 3: Approach flight path

The recorded data showed that at 1806:08 the aircraft was at 1,600 ft above mean sea level on a northerly heading on what appeared to be a base leg. The aircraft was then turned onto about 267° for the final leg of the approach. The aircraft was flown through the 2 NM (4 km) waypoint before the turn, which positioned it to the north of the extended centre-line. This required a number of heading corrections by the pilot to regain track to the final waypoint. The aircraft maintained a steady descent path and airspeed of 93 kt toward the last waypoint.

The approach was consistent with reliance by the pilot on the provision of lateral and vertical guidance from the course deviation and vertical speed indications on the aircraft's primary flight display. In this context, although the decent path was relatively constant, the turn onto final was commenced overhead the 2 NM (4 km) waypoint, resulting in the aircraft overshooting the extended centre-line. As a result, the aircraft was to the north of the intended track to the airstrip and required the pilot to track back to the centre-line during the remainder of the approach. This increased the risk that, given the inadequate lighting, the aircraft would strike the trees north-adjacent to the airstrip.
