# Loss of control involving a Cessna 152, VH-JIW

34 km east-south-east of Archerfield Airport, Queensland, on 28 May 2019

## **ATSB Transport Safety Report**

AO-2019-028

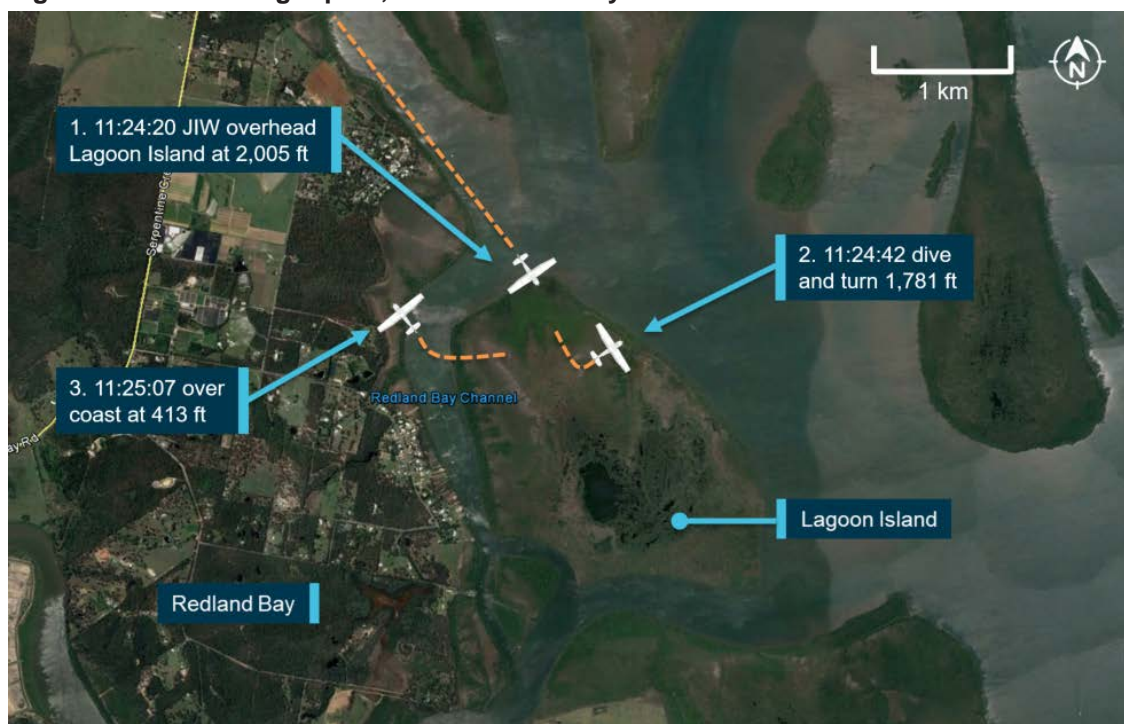
**Figure 1: VH-JIW's flight path, dive and recovery as derived from radar data**

The flight instructor took control of the aircraft and subsequently arrested the descent at about 400 ft, about 25 seconds after the descent commenced. The available radar data (Figure 1) showed that from when the dive commenced, to when the instructor regained control, the aircraft had an average rate of descent of over 3,000 ft/minute, with the rate being higher in the initial part of the descent.

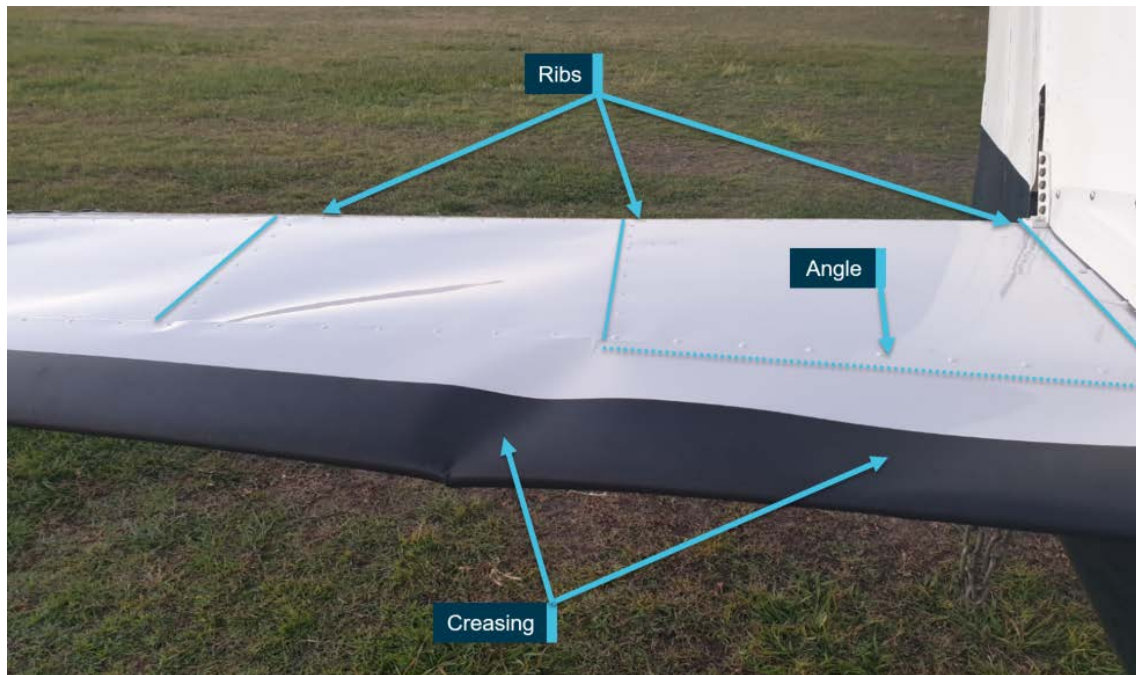
**Figure 2: Right stabiliser damage**

A post-flight inspection of the aircraft found that the right horizontal stabiliser was bent and twisted during the occurrence, resulting in creasing on the upper and lower skin sections (Figure 2). The left horizontal stabiliser had no significant damage.

The instructor attempted to regain control of the aircraft before placing the elevator trim into a neutral position, leading to the aerodynamic force being concentrated on the right horizontal stabiliser (where the trim tab was located) rather than spread across both stabilisers during the dive recovery.

These asymmetric flight loads, induced by the elevator trim imparting additional load on the right side, twisted the stabiliser at the forward outboard tip, about 30 mm downwards relative to its original position. This likely resulted in the right stabiliser being close to total failure. The large amount of nose-down trim at the time of the upset also increased the effort and effect required to recover from the dive.

- During the recovery from the dive, the horizontal stabiliser experienced excessive asymmetric flight loads, resulting in bending and buckling of the right horizontal stabiliser structure.

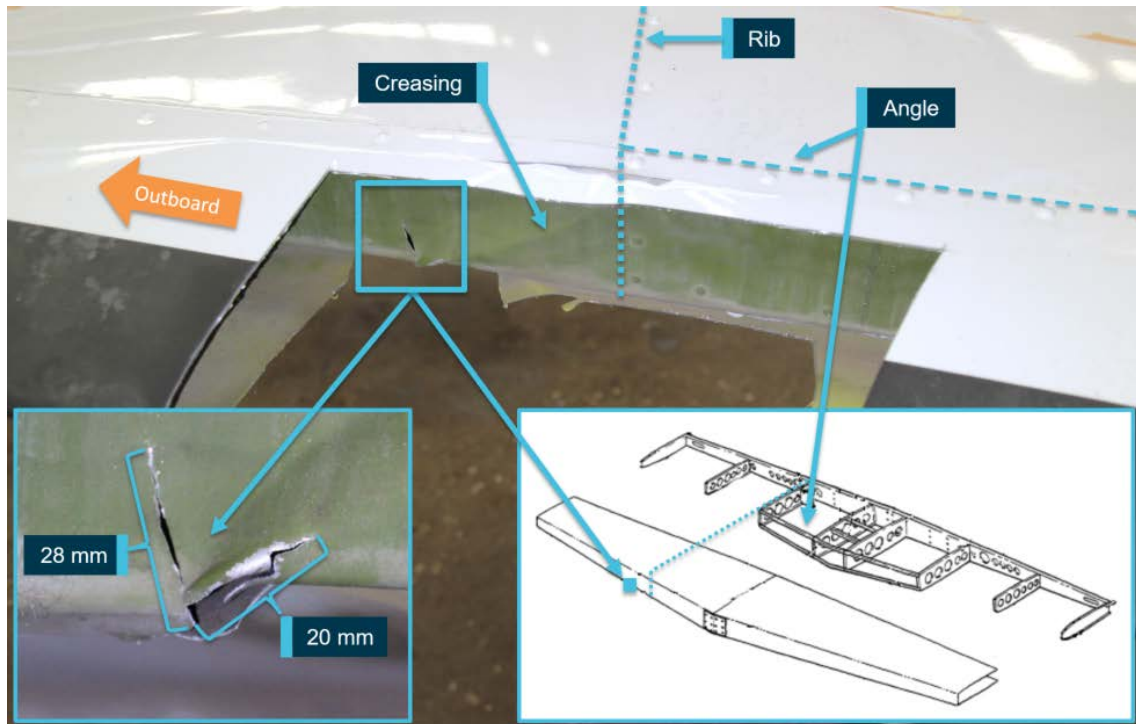
**Figure 3: Leading edge removed showing cracking to internal structure**

The deformation of the right stabiliser resulted in a number of rivets on the aft lower surface pulling through the skin. The internal structure was cracked and creased (Figure). There was no evidence of damage to attachment points of the stabiliser assembly.

An ATSB examination of the right horizontal stabiliser did not identify evidence of pre-existing damage to the structure.
