ATSB TRANSPORT SAFETY REPORT  
Aviation Short Investigations  
AB-2011-128  
Final

# Aviation Short Investigation Bulletin: Third Quarter 2011

Issue 7

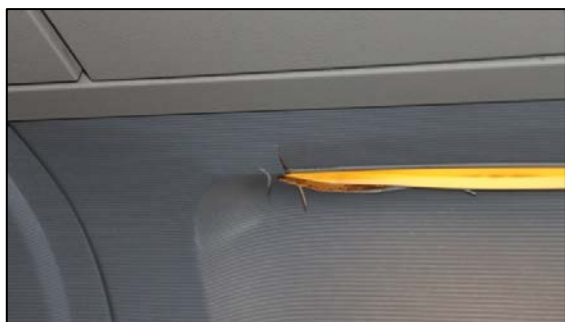
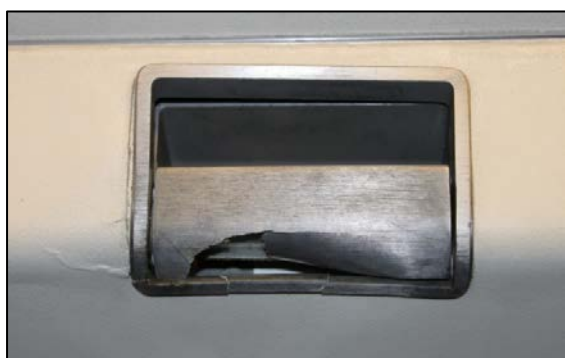
**Figure 1: Damage to window reveal and overhead locker**

Further turbulence was experienced and the flight crew elected to conduct a go-around. The aircraft was levelled off at 3,000 ft and the PIC made an announcement to reassure the passengers and cabin crew. The cabin crew then contacted the flight crew and advised that two passengers, who were reportedly not wearing their seat belts at the time, had sustained injuries from coming into contact with a window reveal and an overhead locker (Figure 1). The two passengers were seated separately.

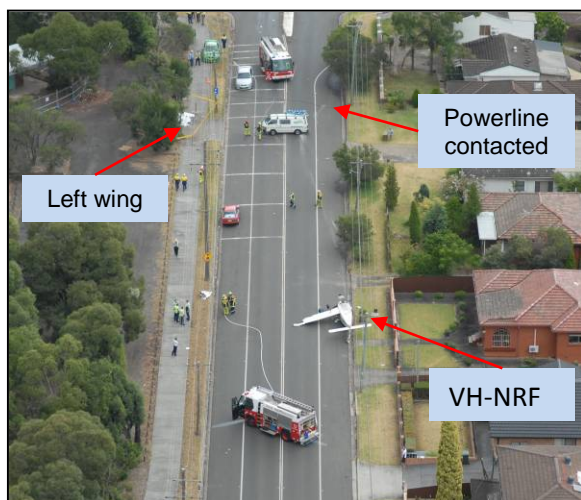
**Figure 1: Accident site**

About 1 minute later, in preparation for the landing, the pilot attempted to turn the fuel selector off and positioned the aircraft to fly between powerlines that ran across the street, but due to vehicles in the area he had to slow the aircraft. He determined he had insufficient height to fly over the powerlines so attempted to fly between two powerlines that were about 2.5 m apart. During the manoeuvre, the left wing contacted the lower powerline and became separated from the aircraft. The aircraft then rolled to the left and became inverted. It continued airborne along the street before the right wing collided with a power pole. The aircraft spun around and impacted the ground at about 1232 Eastern Standard Time<sup>6</sup> (Figure 1).

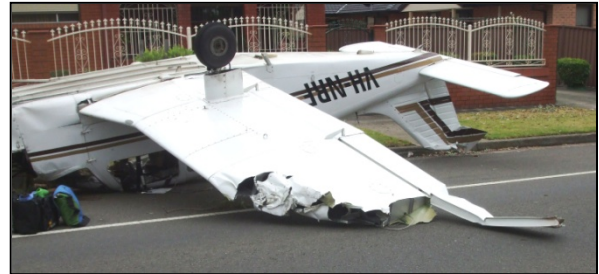
**Figure 2: Aircraft wreckage**

The pilot and passenger released their seatbelts. The door could not be opened, so the pilot kicked the door window out and both egressed. The pilot and passenger sustained minor injuries, the aircraft sustained serious damage (Figure 2).

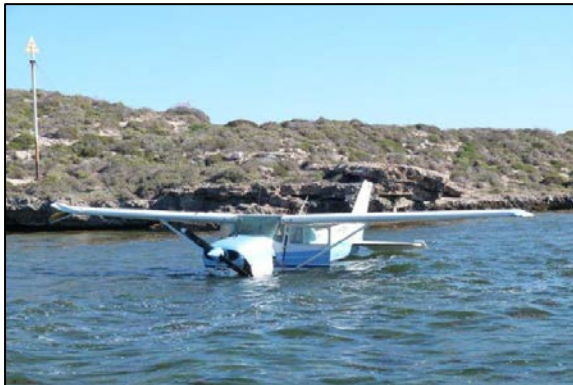
**Figure 2: VH-SMY**

The reason for the degraded engine performance was not determined.

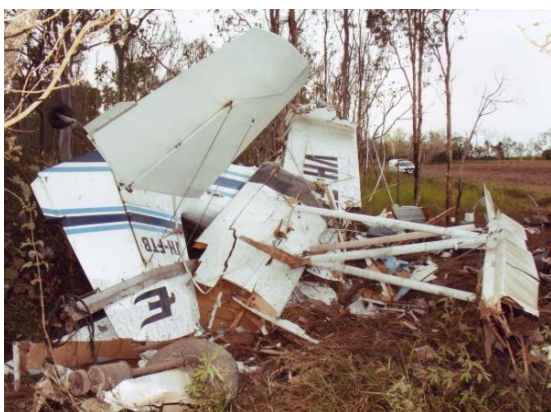
**Figure 2: Wreckage**

Although the pilot's injuries were serious, his being securely restrained and wearing a helmet significantly reduced the potential level of injury.

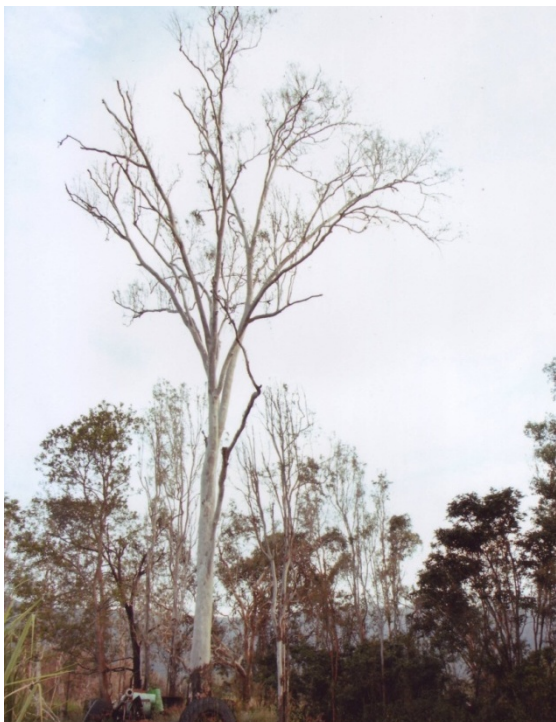
**Figure 3: Bare tree**

The pilot also commented that a cyclone had passed through the area recently which may have contributed to the condition of the impacted tree (Figure 3).

The tree's position and lack of foliage against the backdrop of green trees and mountain ranges, made it difficult to see from crop level. The pilot commented that while FTB still had a near full payload on board, a decision not to dump the load was made for fear that its release may have resulted in an uncontrolled inversion of the aircraft due to the sudden change of centre of gravity. The pilot believed that had the aircraft been inverted at ground impact the injuries sustained would have been fatal.

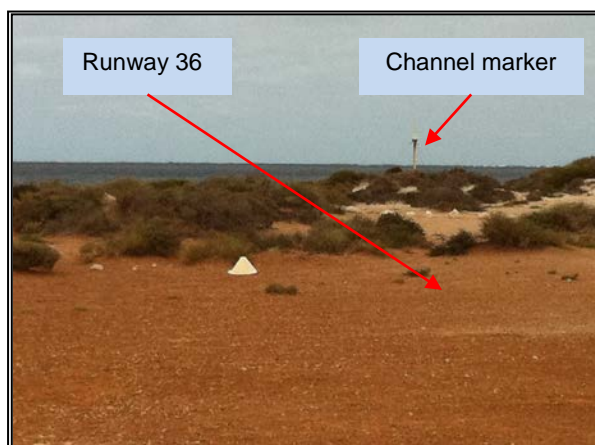
**Figure 2: Channel marker**

The channel marker provided navigational guidance for vessels operating into the anchorage and jetty area located on the eastern side of the Island. The marker, which was about 2.8 m in height, was located to the south-west of the runway<sup>3</sup> (Figure 2). The pilot stated that, while the marker was positioned to the left of the runway centreline, it was reasonably visible when on final approach.

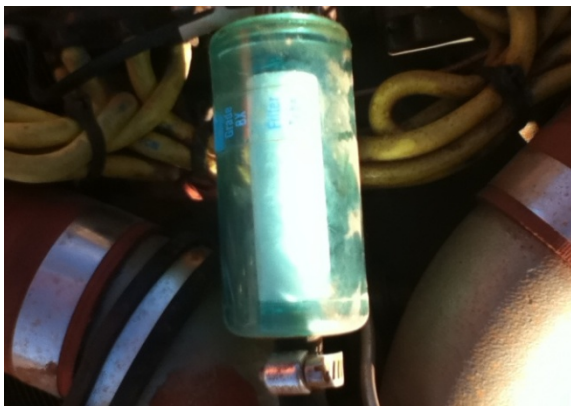
The fuel from both wings was found to be clean, bright and free of visible contaminants. The aircraft fuel filter, contained within the engine bay, was found intact but empty of any fuel (Figure 2).

**Figure 2: Empty fuel filter in engine bay.**

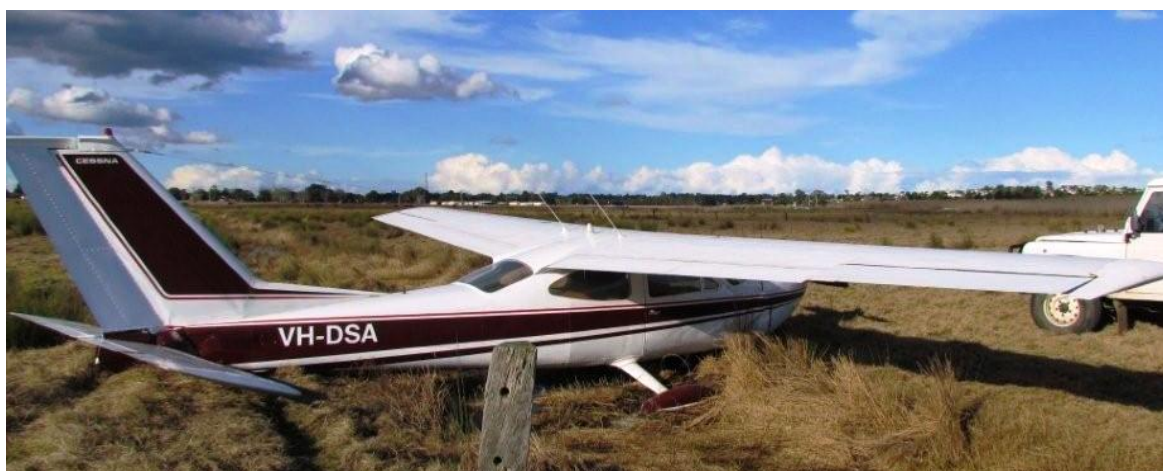
Figure 1: VH-DSA in the shallow earth drain.

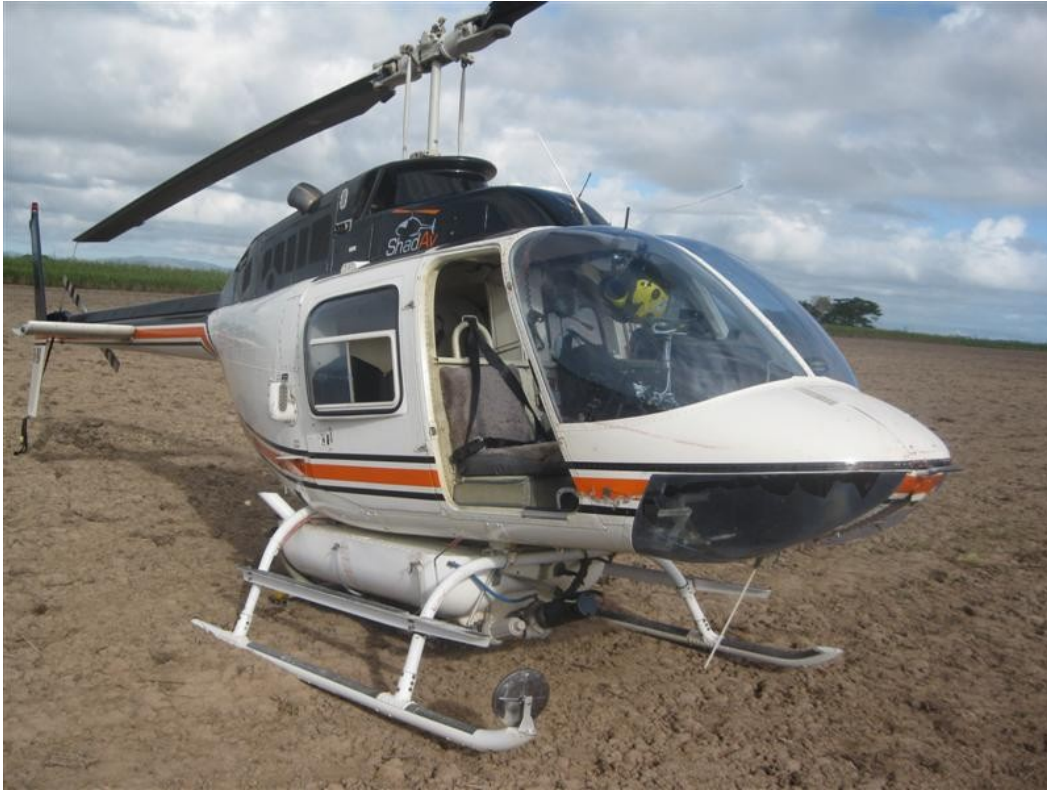
**Figure 1: VH-BNG after wirestrike.**

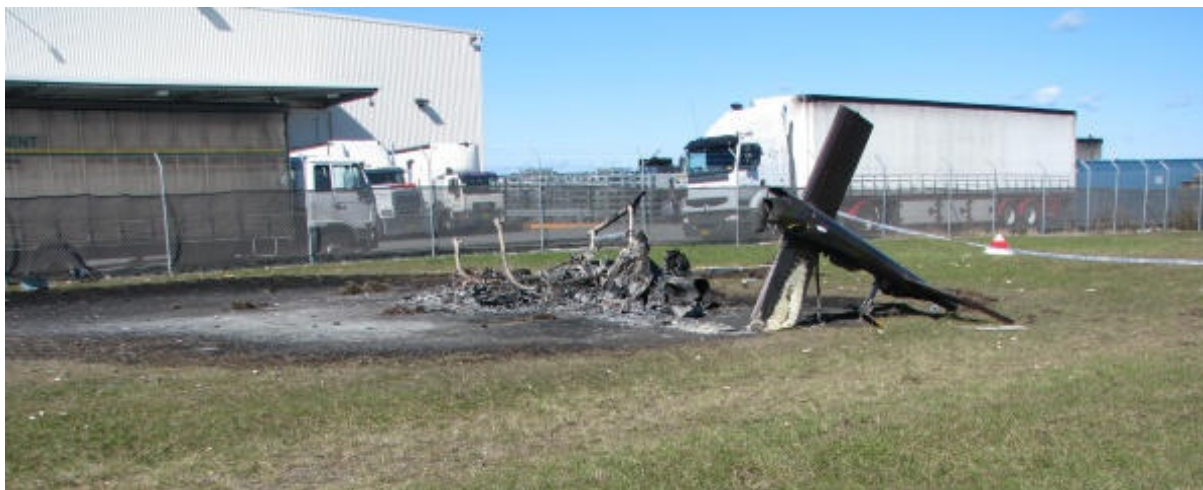
Figure 1: VH-XXW Wreckage

The ATSB did not attend the accident site, or examine the wreckage to assess the likelihood of a mechanical malfunction. The ATSB did, however, review maintenance documentation for the helicopter which confirmed there were no known problems with the flight controls or systems that may have affected yaw axis directional control. Based on the prevailing winds at the time and that the helicopter was in a stationary hover, the ATSB considered that XXW was in conditions conducive to loss of tail rotor effectiveness.

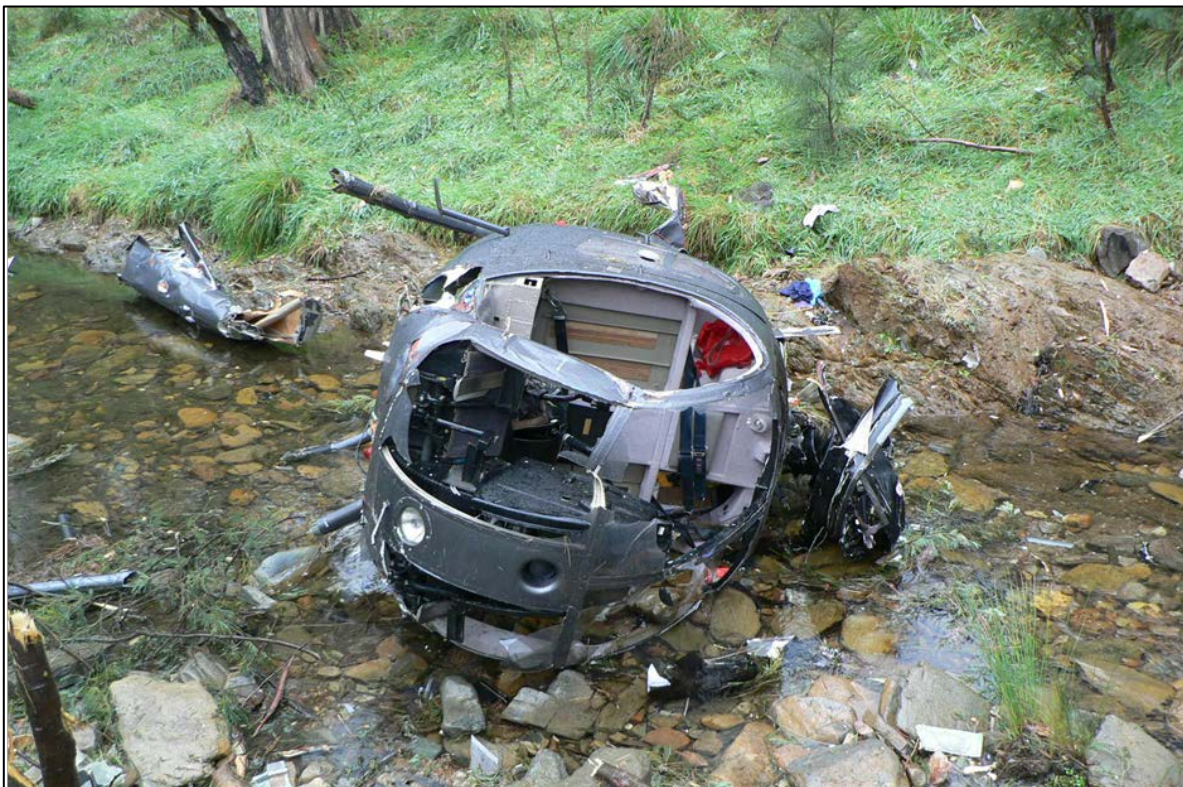
Figure 1: Wreckage of VH-XAA

The ATSB did determine that the increased power required for hovering OGE, coupled with a right pedal turn, increased the risk of LTE.

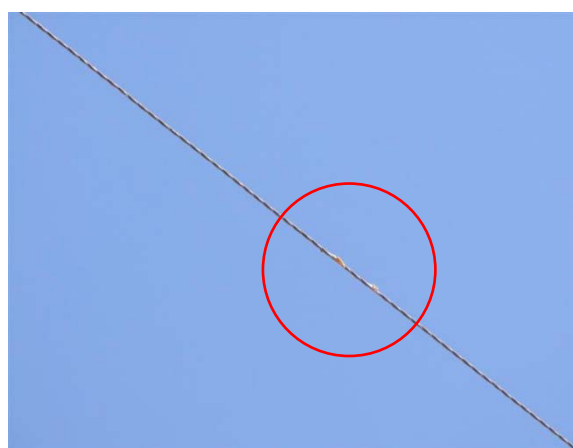
**Figure 4: Contact point with powerline**

The police also noted impact marks on the power line (Figure 4). An inspection of the helicopter revealed suspected wirestrike markings on the upper surface of the right side skid and the main rotor blades.
