# Near miss with maintenance worker on Skitube Alpine Railway

Bullocks Flat, New South Wales, on 3 July 2019

## **ATSB Transport Safety Report**

RO-2019-014

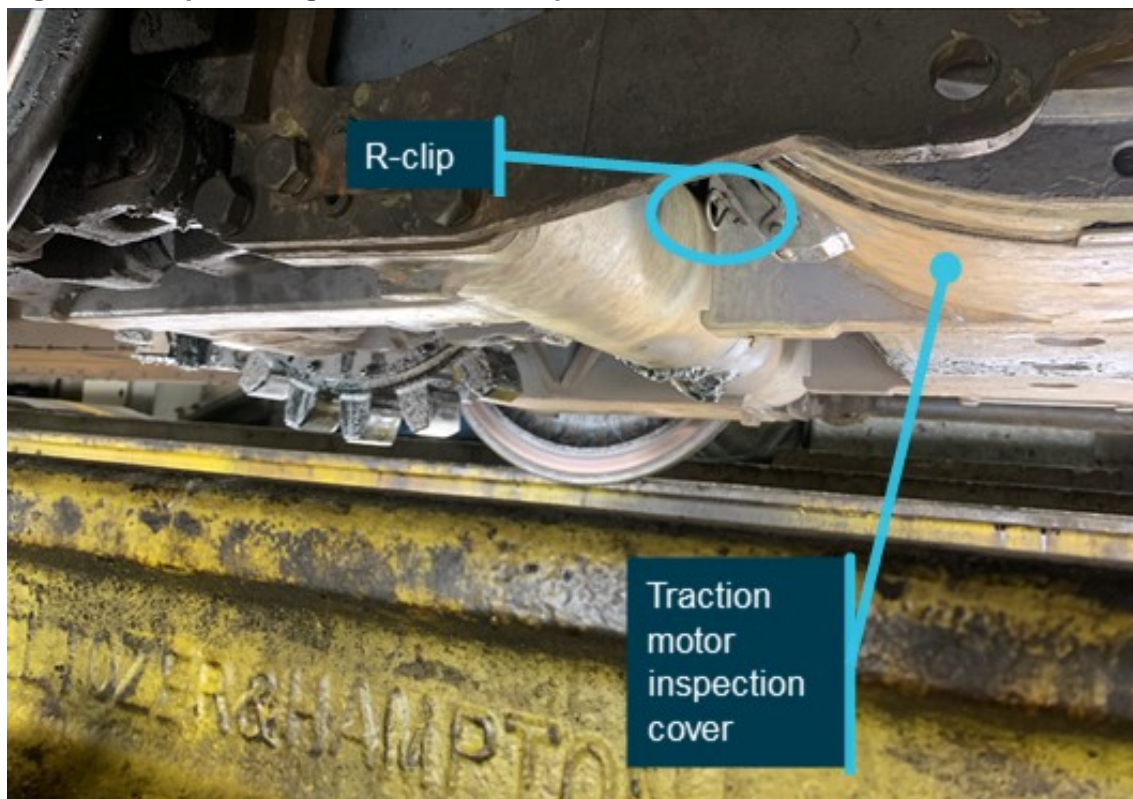
**Figure 1: R-clip securing traction motor inspection cover**

Based on the location it was found on the ground, electrician 2 understood where the R-clip may have come from and knew it to be a securing R-clip of a traction motor inspection cover.

*The image shows the traction motor inspection cover secured with the R-clip installed.*  
Source: Skitube, annotated by OTSI

*Electrician 2 expressed concern that the missing R-clip may lead to an equipment failure if the inspection cover dislodged and allowed the ingress of foreign material into the traction motor.*

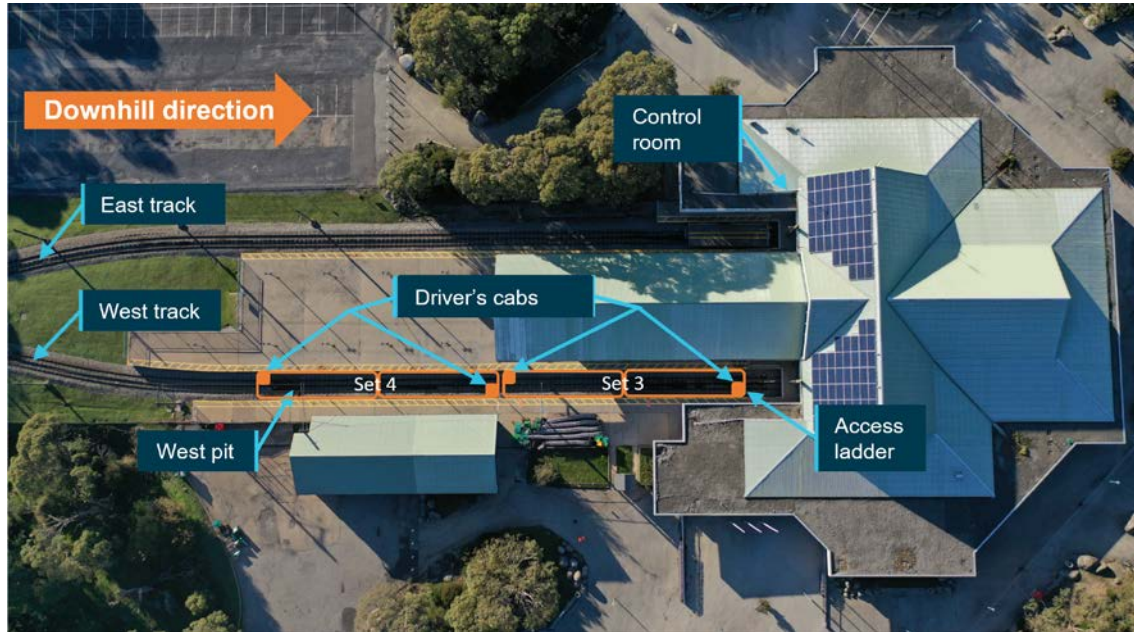
**Figure 2: Overhead view of Bullocks Flat Terminal**

*Approximate location of Alpha 24 (set 3 and 4) when it arrived at Bullocks Flat Terminal.  
Source: OTSI*

The duty controller provided the electrician clearance to enter the west track inspection pit (west pit). The duty controller's view of the west platform was partially obstructed by train Charlie 25, stationary at the BFT east platform.

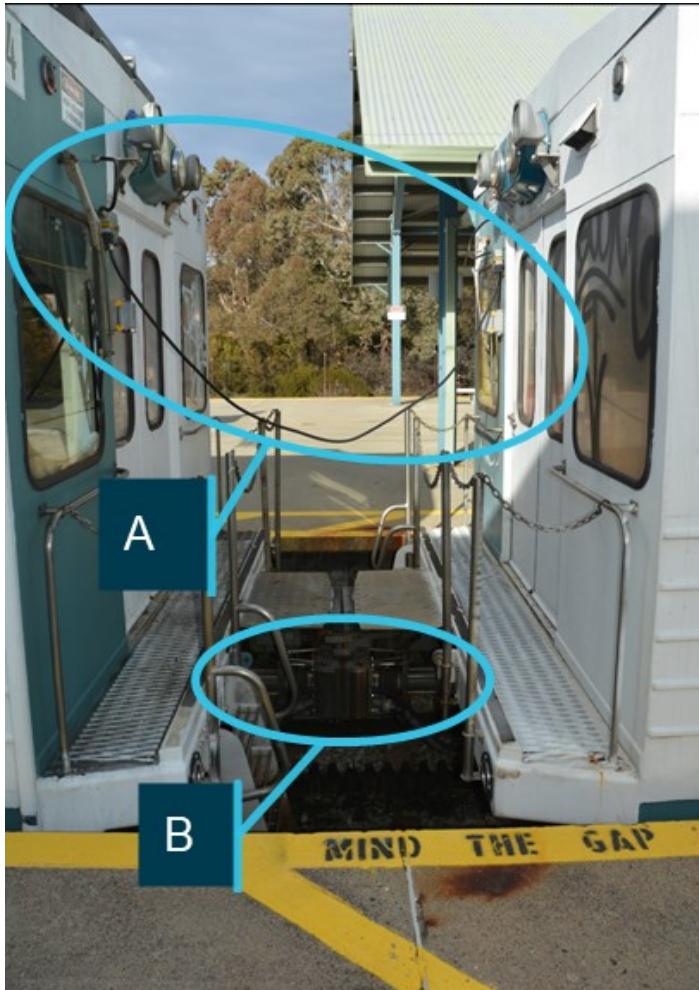
**Figure 3: Coupling between set 3 and set 4**

At 1659, driver 1 and driver 2 commenced uncoupling Alpha 24, by firstly removing the hi-fog fire suppression system inter-car connector between set 3 and set 4. Driver 2 then entered the driving cab on the uphill end of set 3 and propelled set 3 (first movement) downhill towards the platform dead-end by approximately 50 cm to ensure disengagement of the Scharfenberg type couplers.

*Hi-fog fire suppression system inter-car connector (A) and Scharfenberg type coupling mechanism (B)*  
Source: OTSI

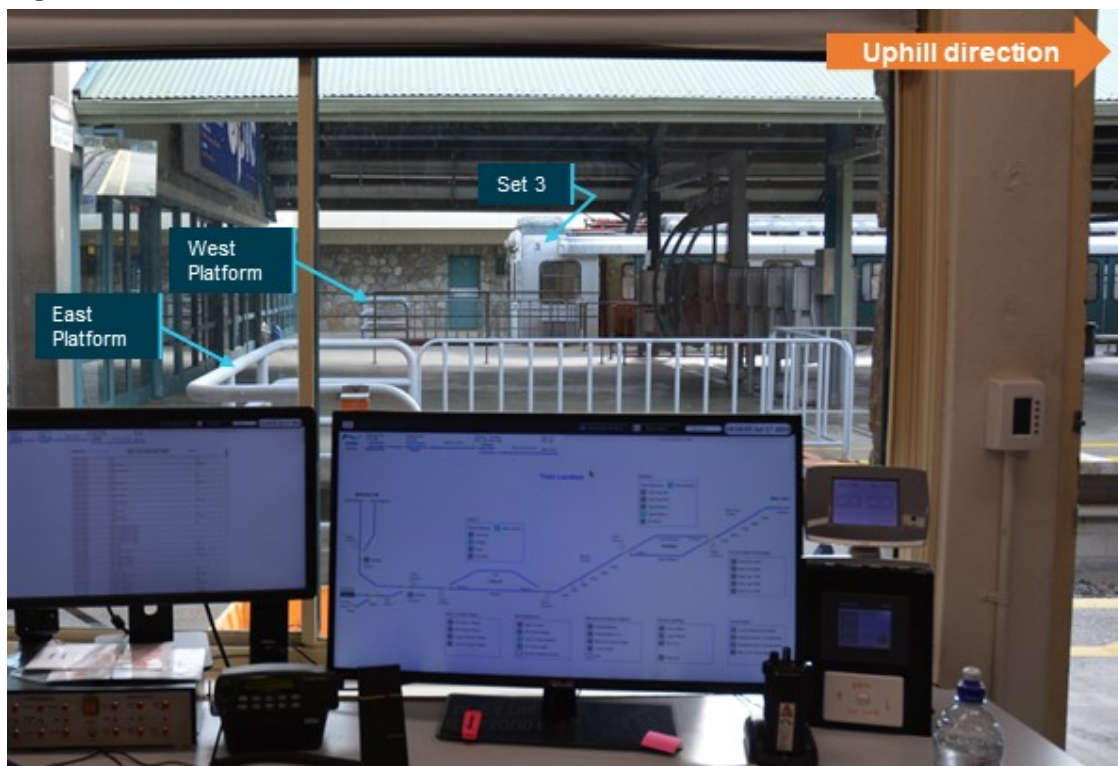
**Figure 4: View from Control room window**

*Set 3 on west track, east track clear at Bullocks Flat Terminal.  
Source: OTSI*

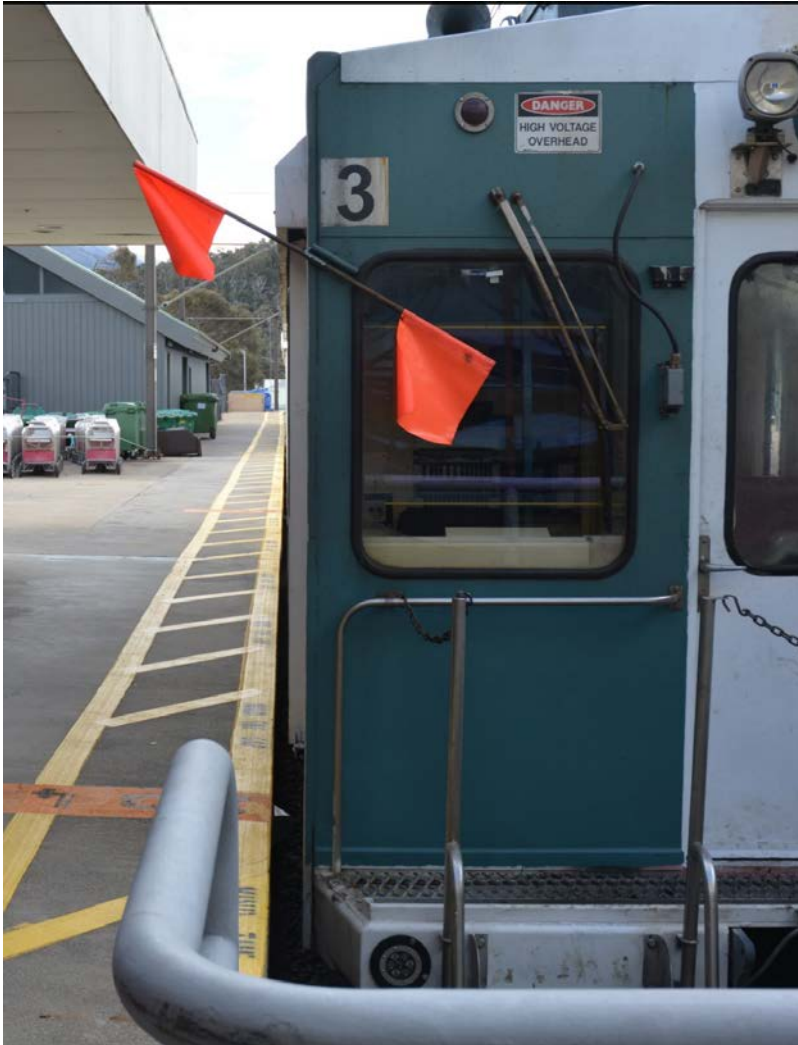
**Figure 5: Example of protection flag on set 3**

The Skitube duty controller's manual outlines the function of the protection flag. The protection flag (red rectangular flag) is to be fitted on the end of trains to indicate the train is defective or someone is working on the train. When the flag is in place it states the action is "do not move the train".

Electrician 2 did not place protection flags on the train prior to entering the track area below the train. The duty controller had not checked that the electrician had taken the protection flags from the control room.

As protection flags had not been placed on the train set, there was nothing to alert the driver of the electrician being under the train. However, protection flags on the far ends of the train may not have been visible from the inwards cabs between set 3 and set 4. Therefore, there was a possibility of the driver missing the visual cue of the red protection flag and moving a train set when uncoupling.
