Collision with terrain involving Liberty Aerospace XL-2, VH-XLK

9 km north-east of Braidwood, New South Wales, on 6 August 2019

ATSB Transport Safety Report

AO-2019-040

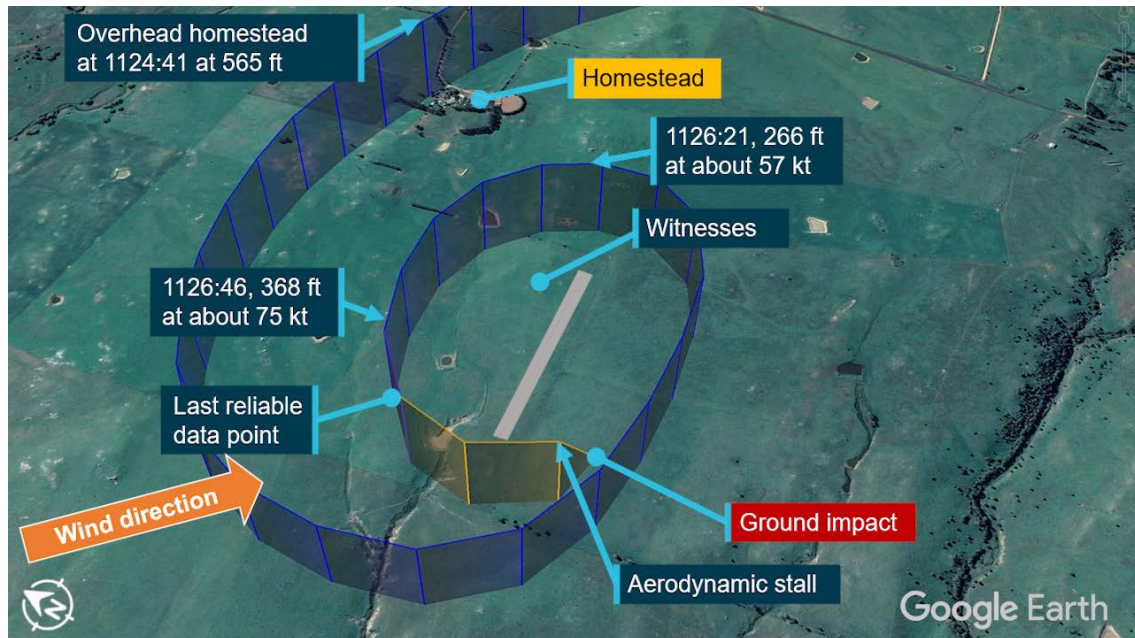
Figure 2 : VH-XLK flight path approaching the Braidwood landing area

Recorded data showed that VH-XLK approached the landing area (Figure 2) from the south-east and overflowed the property homestead at about 1123, before turning left to circle around the landing area. A witness reported that the aircraft appeared to be slowing and descending and that the engine noise was a lot less noticeable overhead the landing area than when it first approached the property. The witness also stated that the aircraft appeared to be 'hanging off the prop', describing VH-XLK having a slowing speed and nose-high attitude. The recorded data indicated an inconsistent airspeed and height during the first orbit overhead the Braidwood landing area (Figure 5).

As VH-XLK approached the western end of the landing area, it began a left turn to track close to the western threshold of the runway on a slow descent, at about 400 ft above ground level. At about 1127, after passing over the western threshold and travelling in a southerly direction, a further left turn was initiated.

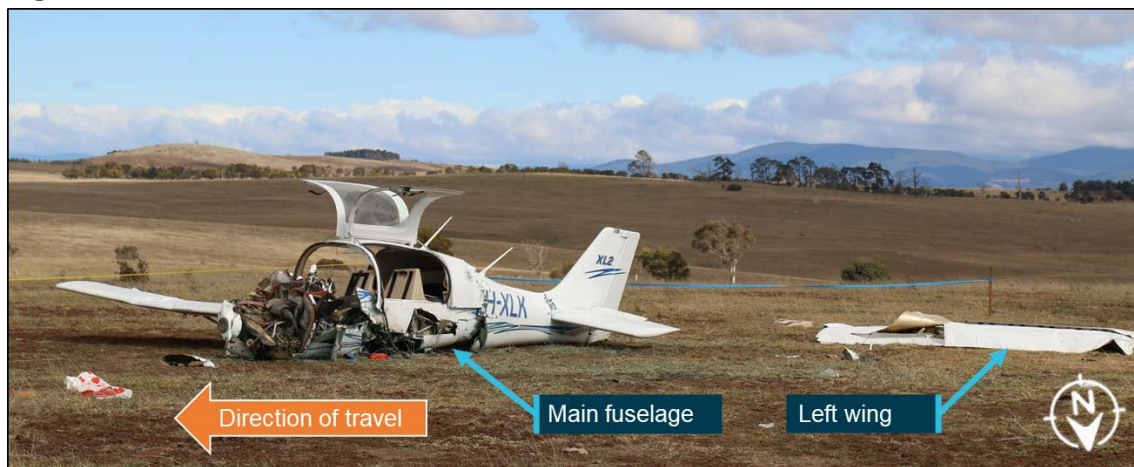
Figure 3: Accident site

Impact signatures were consistent with witness reports, indicating that the left wing struck the ground first, followed by the propeller, engine and then the fuselage. The wing ground strike resulted in compression damage to the left lower fuselage below the gull door at the wing root location, and subsequent separation of the left wing from the fuselage.

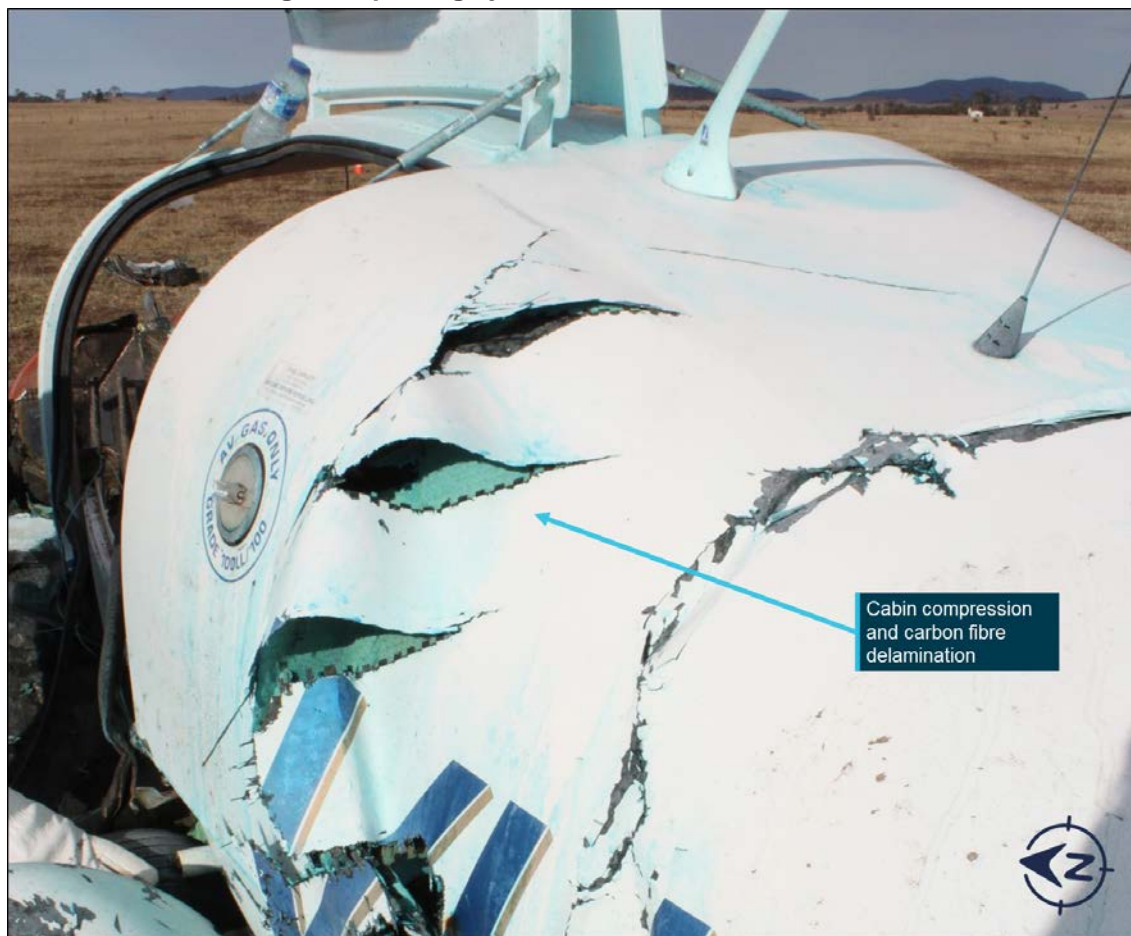
Figure 4: VH-XLK rear fuselage section showing compression damage to composite structure and creasing at empennage junction

No pre-impact defects were identified with the engine or aircraft structure. The internal cabin fuel tank had ruptured and a quantity of fuel had leaked into the ground. Fuel was observed in the fuel filter bowl, free of contamination. There was no post impact fire.

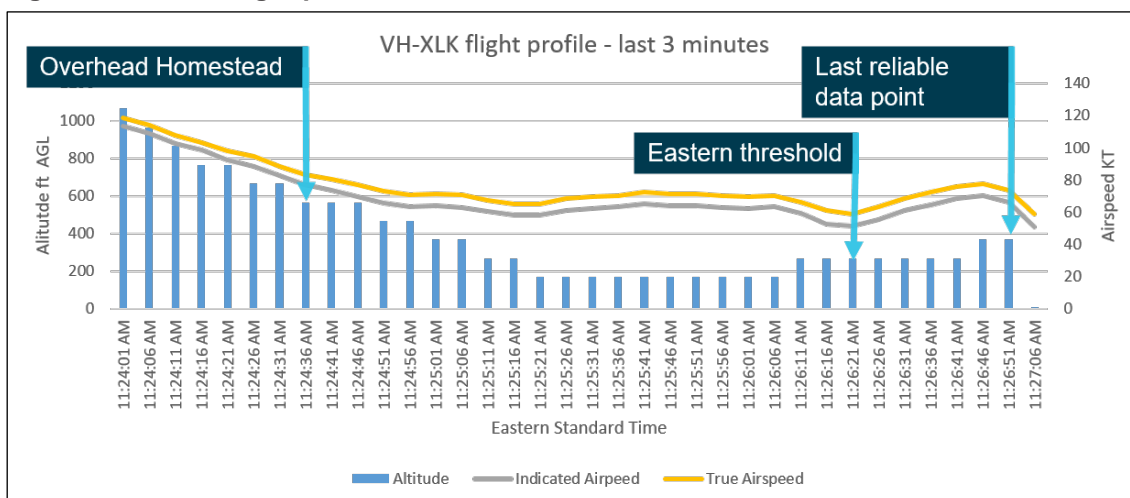
Figure 5: VH-XLK flight profile

Figure 5 shows the derived airspeed and height above ground level for the last 3 minutes of the flight. However, constraints on the buffering of the in-flight data meant that the last 15 seconds of flight Figure 5 (data after 1126:51) were considered less reliable.

VH-XLK descended to fly overhead the landing area, and at 1125:21 the altitude stabilised at about 2,300 ft, which was about 170 ft above ground level. From 1125:21 to 1126:41 the altitude increased to about 2,400 ft, which was about 270 ft above ground level.
