# Engine failure and forced landing involving Cessna 208B, VH-LNH

8 km north-west of Solomon Airport, Western Australia, on 16 November 2016

**ATSB Transport Safety Report**  
Aviation Occurrence Investigation  
AO-2016-155  
Final – 18 December 2020

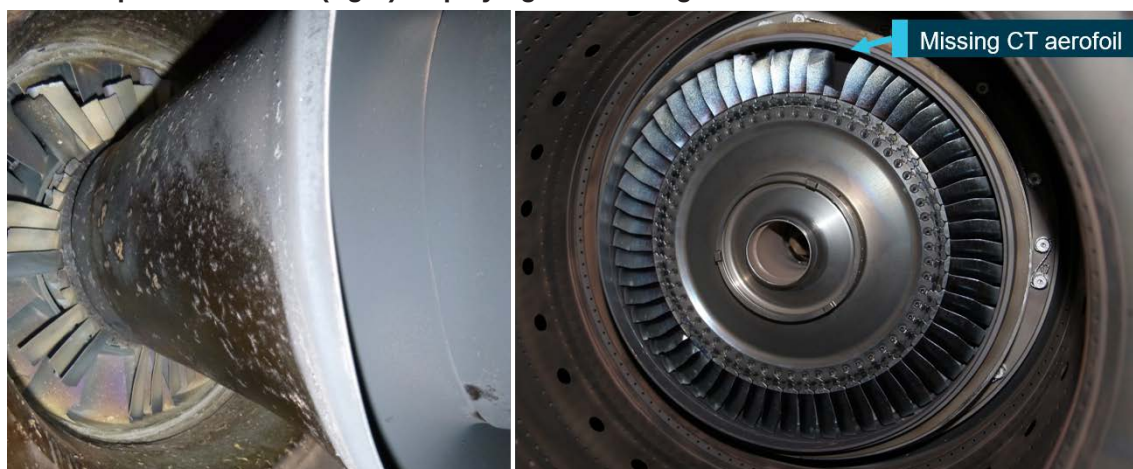
Following the forced landing, the aircraft was relocated from the mine road to Solomon Airport. An initial on-wing inspection through the exhaust duct of the engine revealed considerable damage to the power turbine (Figure 6). Several power turbine blades were missing, having fractured at places varying from the blade root to the tip. Aviair personnel subsequently removed the engine and transported it to an approved facility for controlled disassembly and examination.

**Figure 6: Composite image displaying the observed damage to the power turbine (left) and compressor turbine (right) displaying the missing aerofoil section.**

The power turbine had sustained the most severe damage, with several blades having fractured due to overstress at varying heights between the blade root and the tip due to contact with upstream<sup>10</sup> debris (Figure 6). The upstream face of the power turbine inlet guide vane had sustained significant hard-body impact damage, most likely from metallic debris released from the compressor turbine. The power turbine was seized and not able to rotate freely. The propeller shaft was also unable to be rotated.

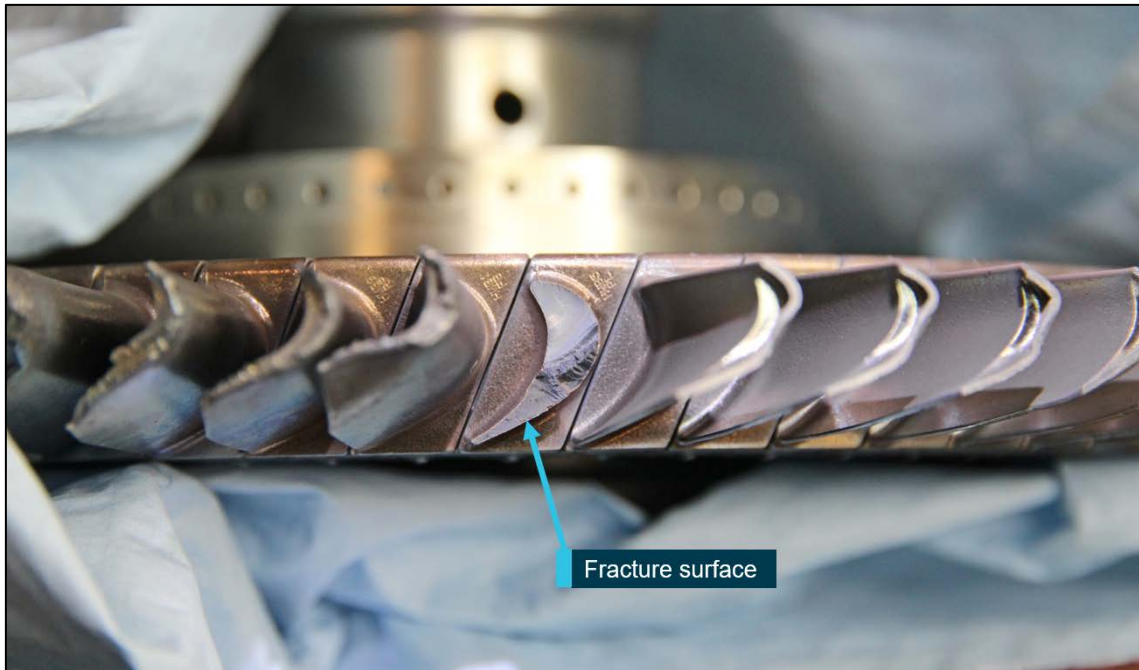
Examination of the compressor turbine (CT) identified that a single CT blade had fractured close to the blade root (Figure 7 and 8). Multiple blades had sustained bending from impact damage with the liberated aerofoil section. One of the adjacent blades displayed a clear imprint from contact with the liberated aerofoil section (Figure 9). The fracture surface of the failed blade was largely flat and located at the root, close to the platform. Characteristic 'beach mark' features were present that extended to approximately 50 per cent of the overall fracture surface, indicating that a fatigue crack had progressed through that portion of the blade. The remainder of the fracture was jagged and angular and representative of a sudden overstress fracture.

**Figure 7: The fractured CT blade**

Fractured blade manufacturing identifiers; part number 3079351-01, serial number HWB5PL, vendor supplier 702055  
Image source: ATSB

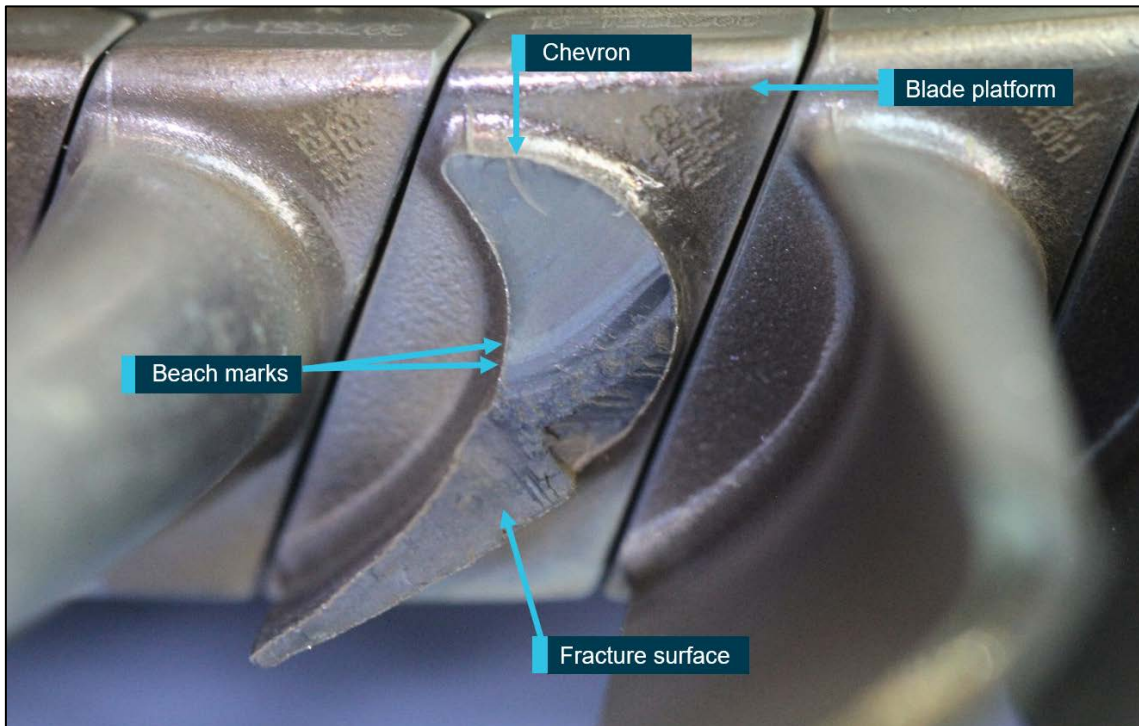
**Figure 8: Close view of the the CT blade fracture surface**

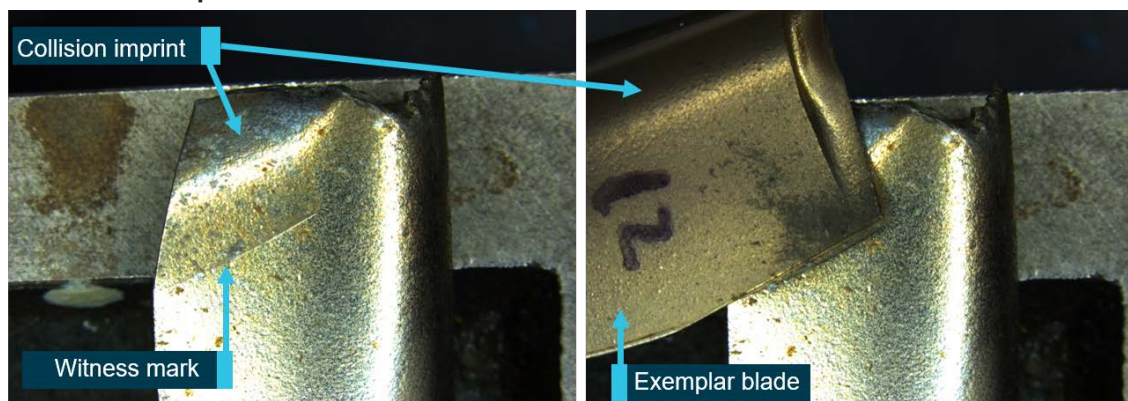
**Figure 9: Composite view of a CT blade adjacent to the one that had fractured showing the collision imprint from the liberated aerofoil section**

An exemplar blade (right image) from the disc has been used to illustrate the collision of the liberated aerofoil section from the fractured blade. Image source: ATSB

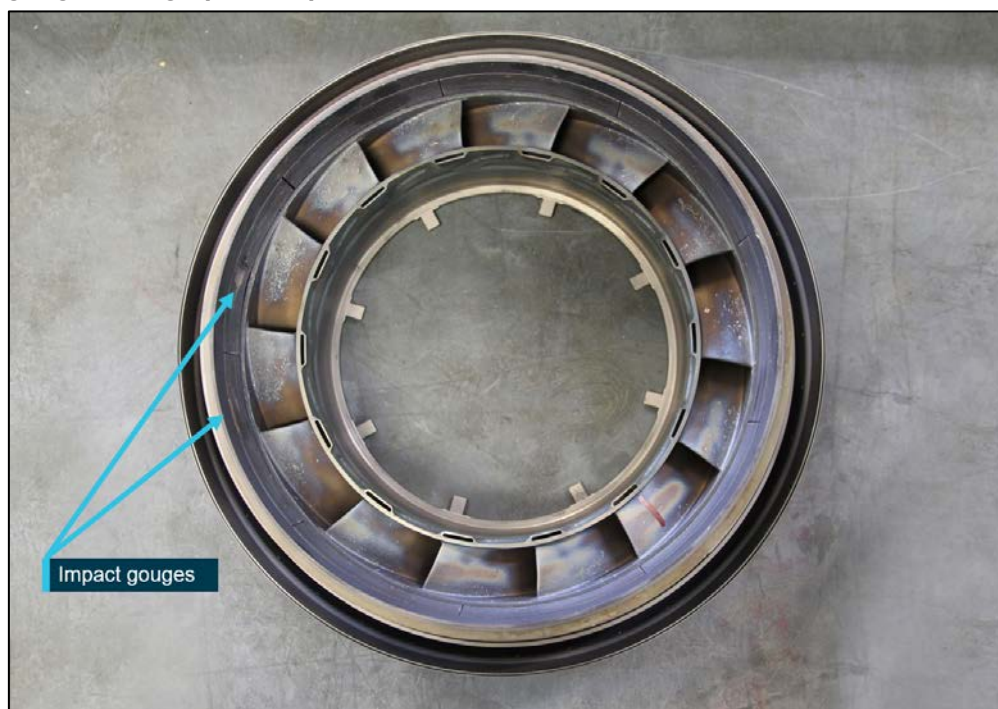
The CT vane ring fitted to the engine was also examined (Figure 10). The vanes had sustained abrasion and minor impact damage. The shroud segments had sustained two major gouges from the engine failure. The following manufacturing part numbers were identified:

**Figure 10: Compressor turbine vane ring assembly, view of the downstream face with gouge damage (labelled)**

CT vane ring manufacturing identifiers: (part number) 3029051, (serial number) 931E, (work order) WO 0452R16, (flow class) CL 6.25, (major repair specification) STI 72-50-254, (repair authority) STI 02-0356  
Image source: ATSB

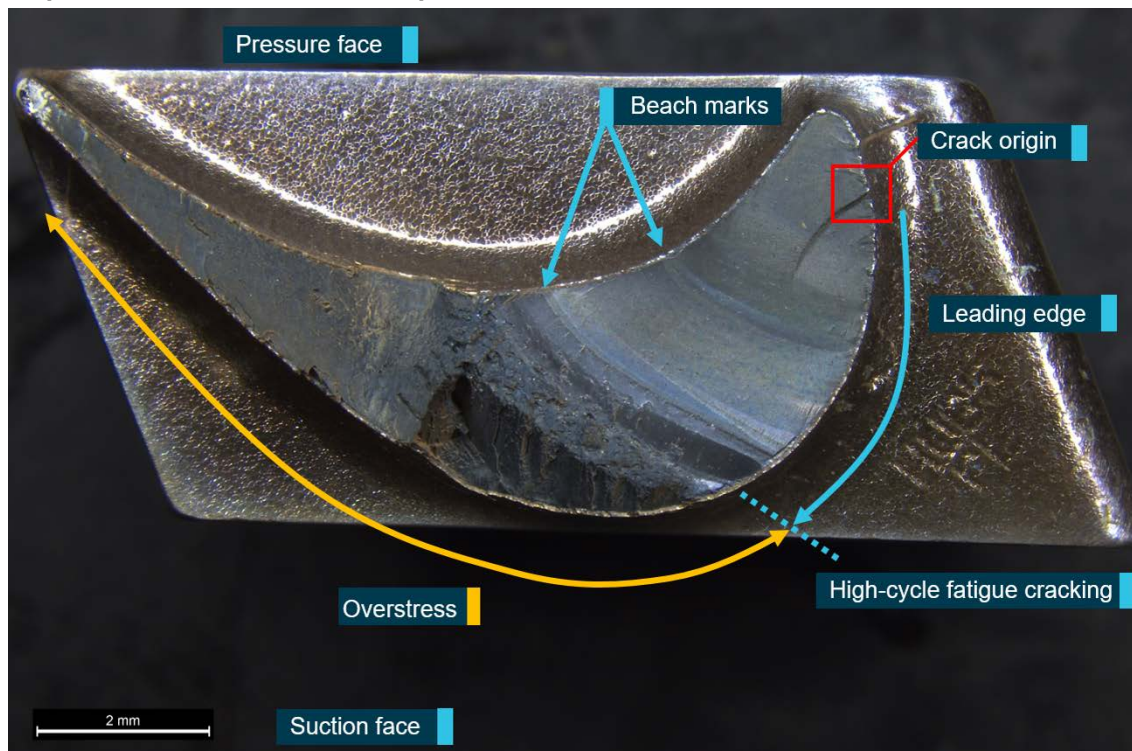
**Figure 11: High-magnification optical image of the fractured blade showing that cracking initiated at the leading edge on the suction face, progressing through approximately 50 per cent of the cross-section prior to overstress fracture and release of the aerofoil**

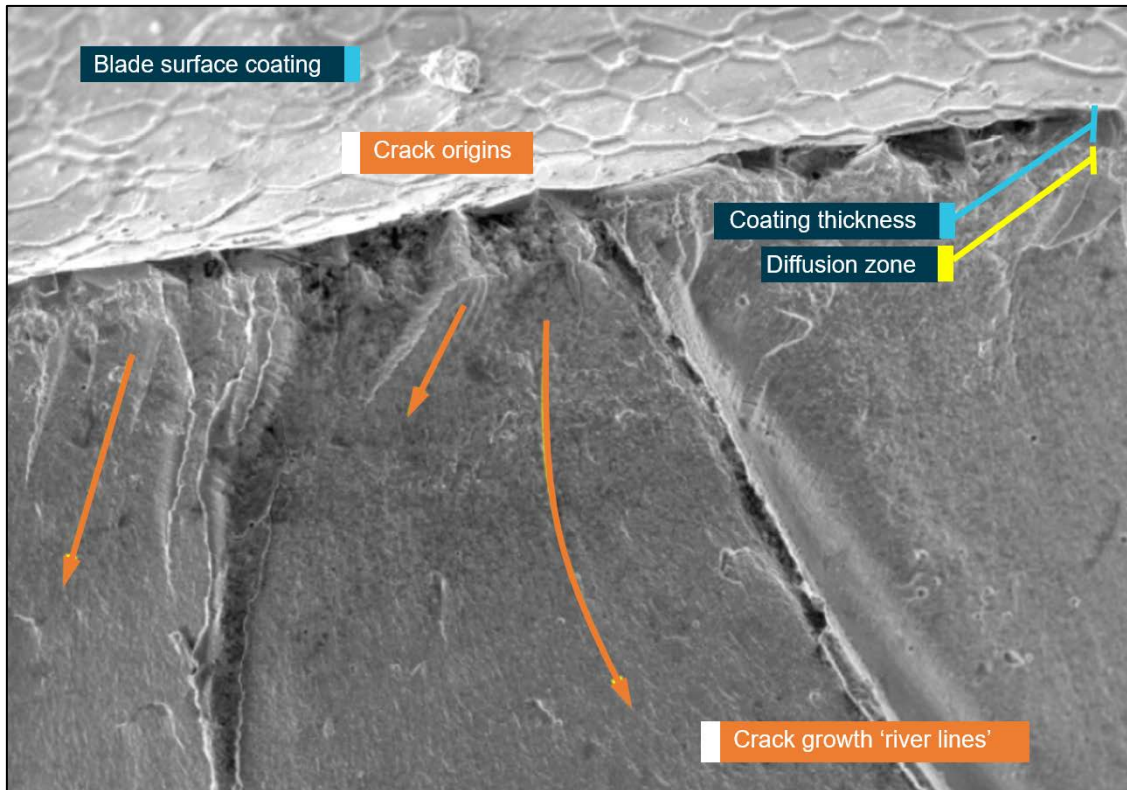
The SEM examination did not identify any defective features within the nickel-base alloy or coating material that might otherwise have led to the cracking.

**Figure 12: High-magnification SEM image of the crack origin at the leading edge showing the direction of propagation ‘river lines’ and other features associated with the blade coating**

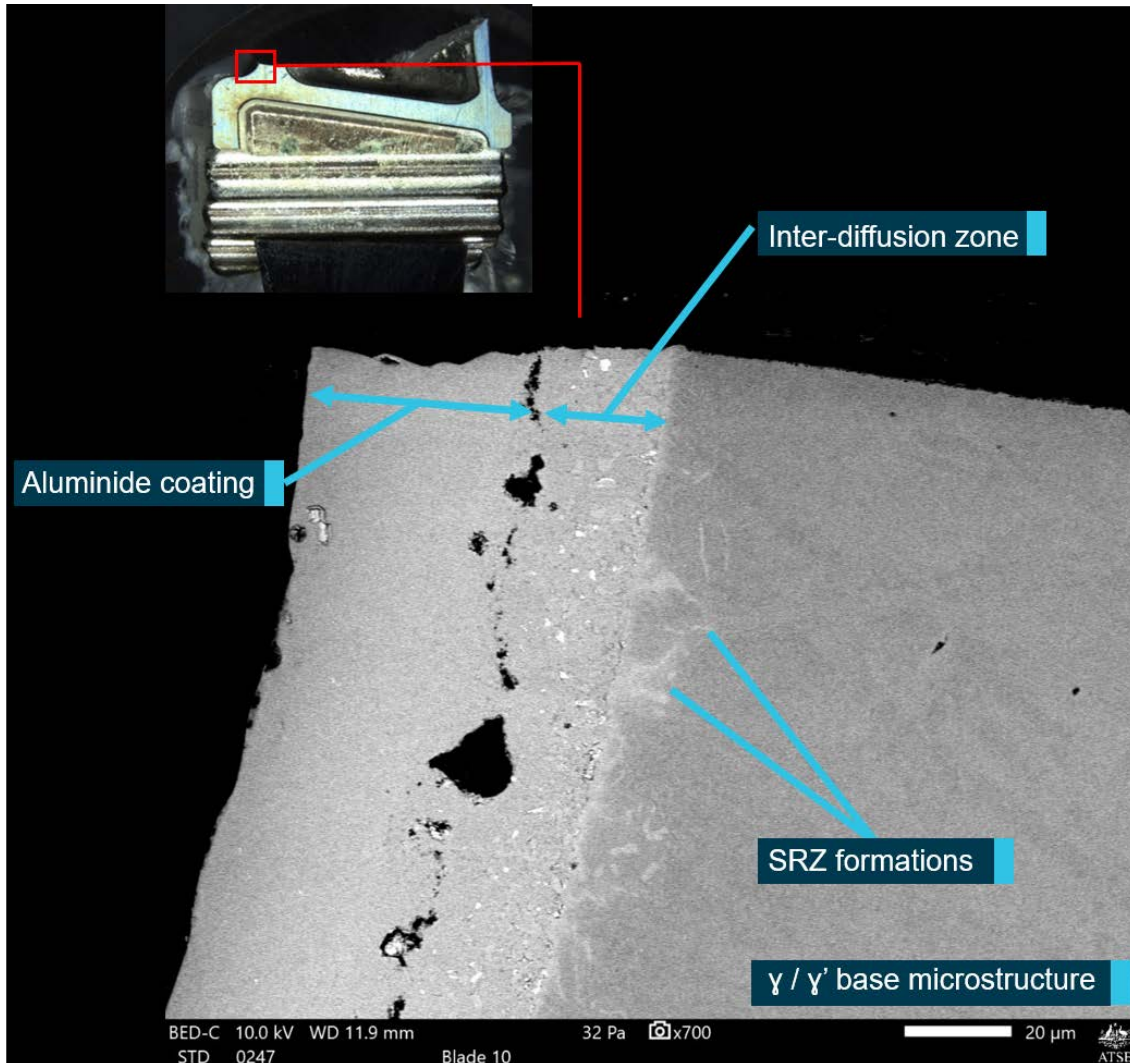
**Figure 13: Composite optical and SEM micrograph of the remnant fractured CT blade**

The main SEM image is a cross-section through the crack origin. The primary microstructural features are described. Some alteration of the microstructure was observed with the formation of secondary reaction zone (SRZ) between the gamma / gamma -prime ( $\gamma / \gamma'$ ) base microstructure and the blade coating.  
Image source: ATSB

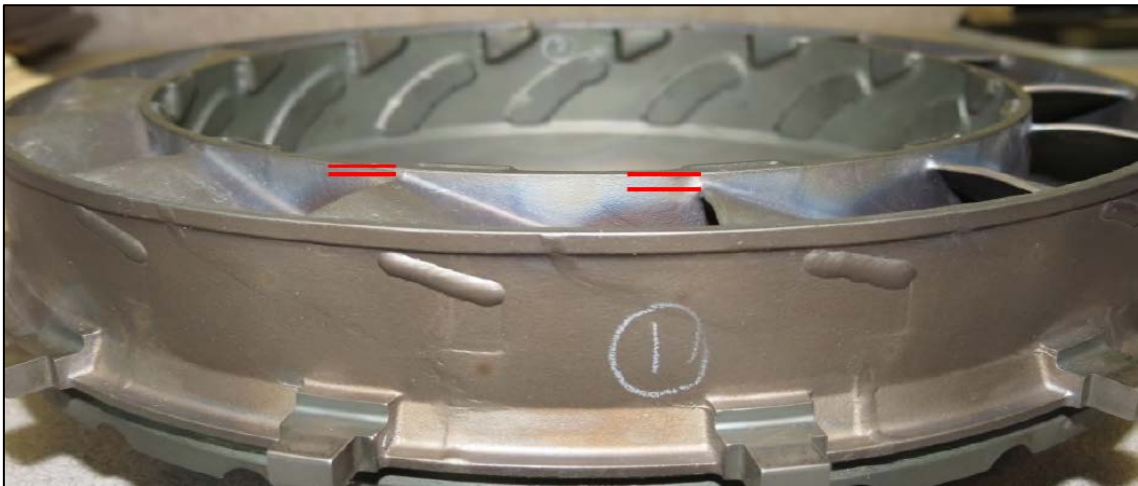
**Figure 14: Trailing edge positioning variations against the inner shroud from the STI-repaired CT vane ring, highlighting a non-conformance**

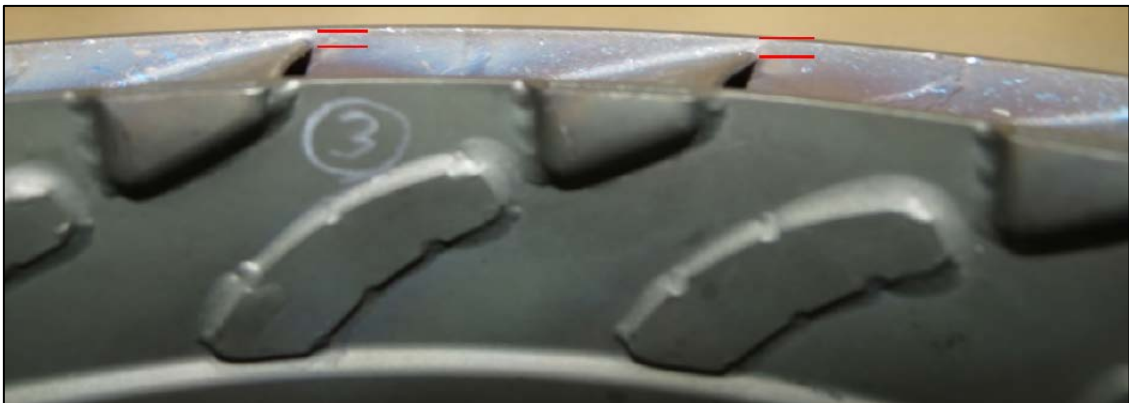
**Figure 15: Trailing edge positioning variations against the outer shroud from the STI-repaired CT vane ring, highlighting a non-conformance**

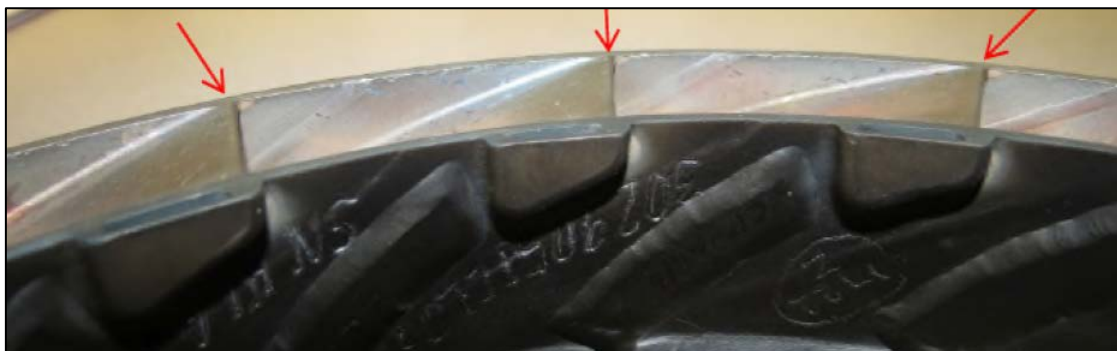
**Figure 16: Example of trailing edge positioning against the outer shroud from a PWC-manufactured CT vane ring**

Notable differences in vane positioning exist when compared with the STI-repaired item from the occurrence engine.  
Image source: Pratt & Whitney Canada

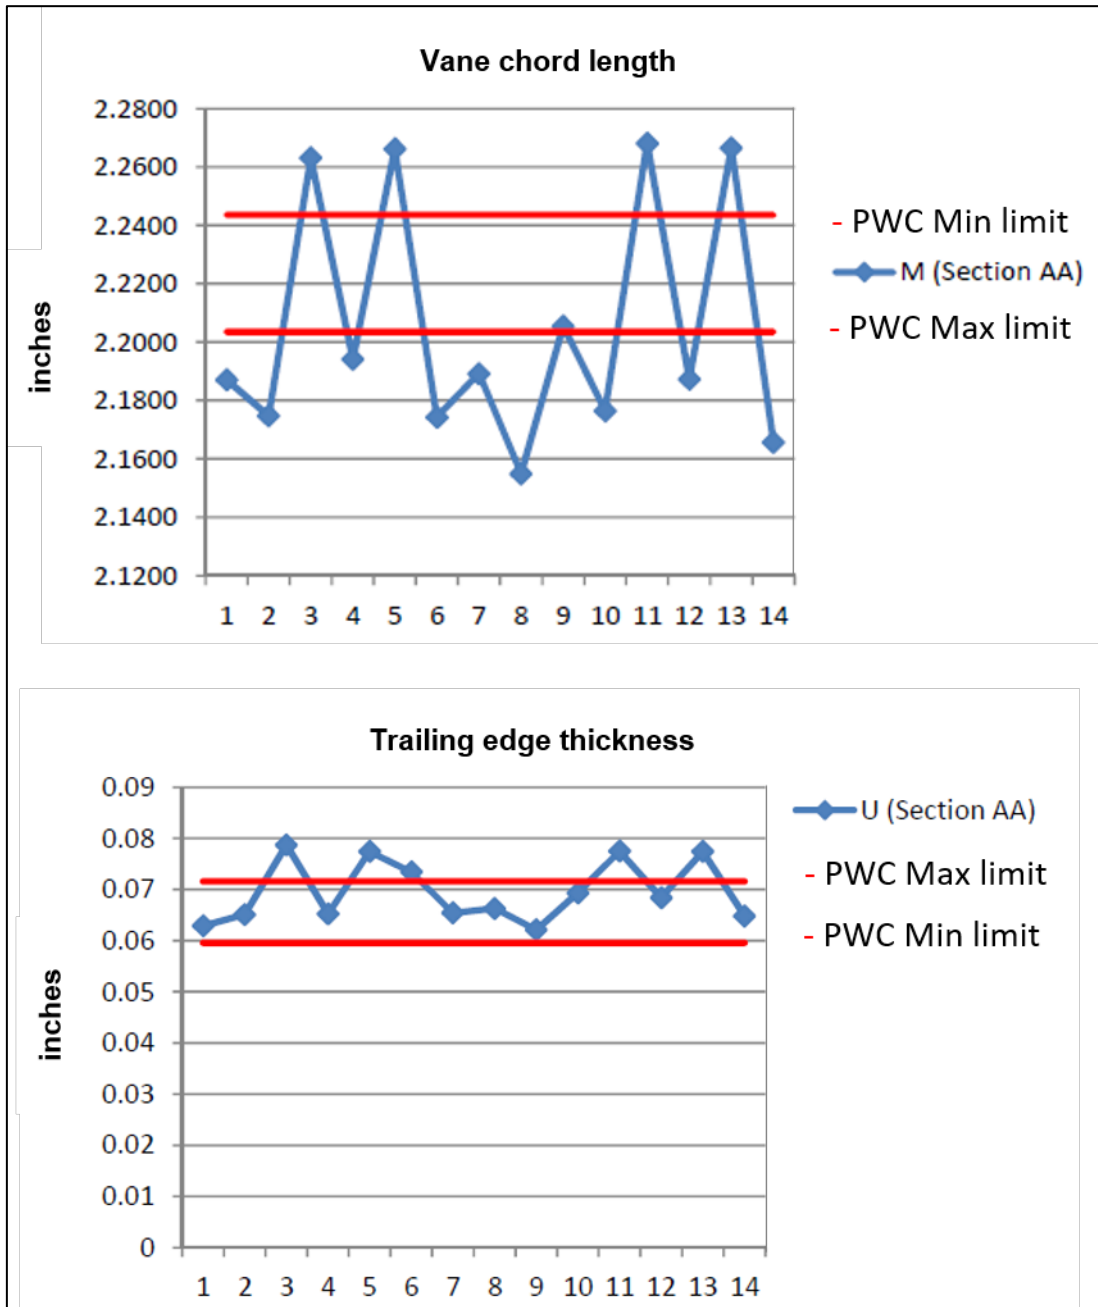
Figure A1: The measured vane chord length and trailing edge thickness measurements of the STI-repaired CT vane ring from the occurrence engine (Aviair Cessna 208, VH-LNH) compared to the Pratt & Whitney Canada design tolerance.

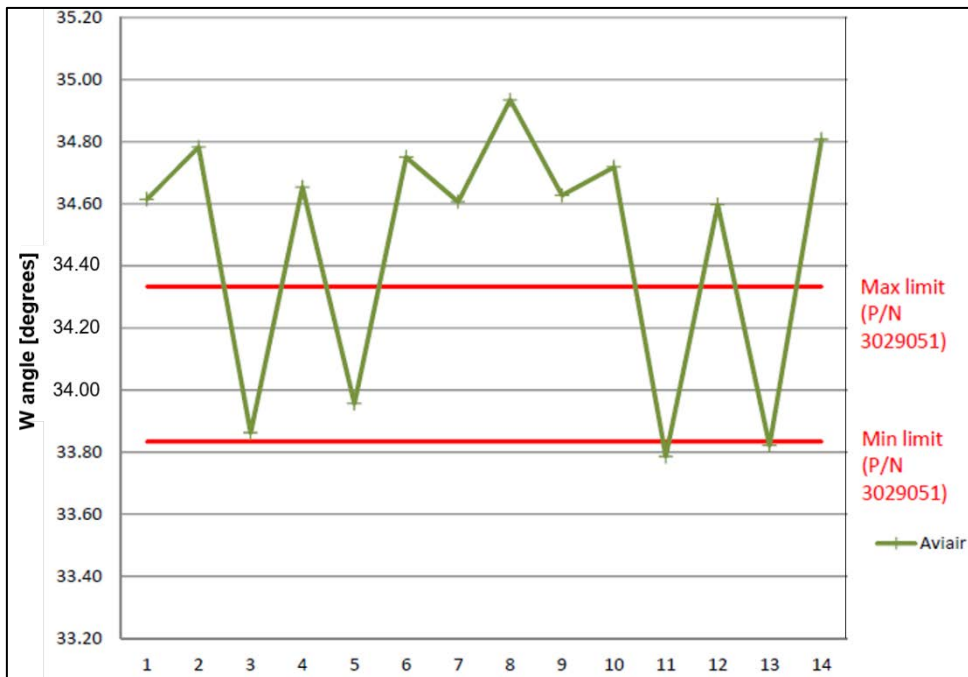
**Figure A2: The respective vane stagger angles of the STI-repaired compressor turbine vane ring from the occurrence engine (Aviair Cessna 208, VH-LNH) compared to the Pratt & Whitney Canada design tolerance.**

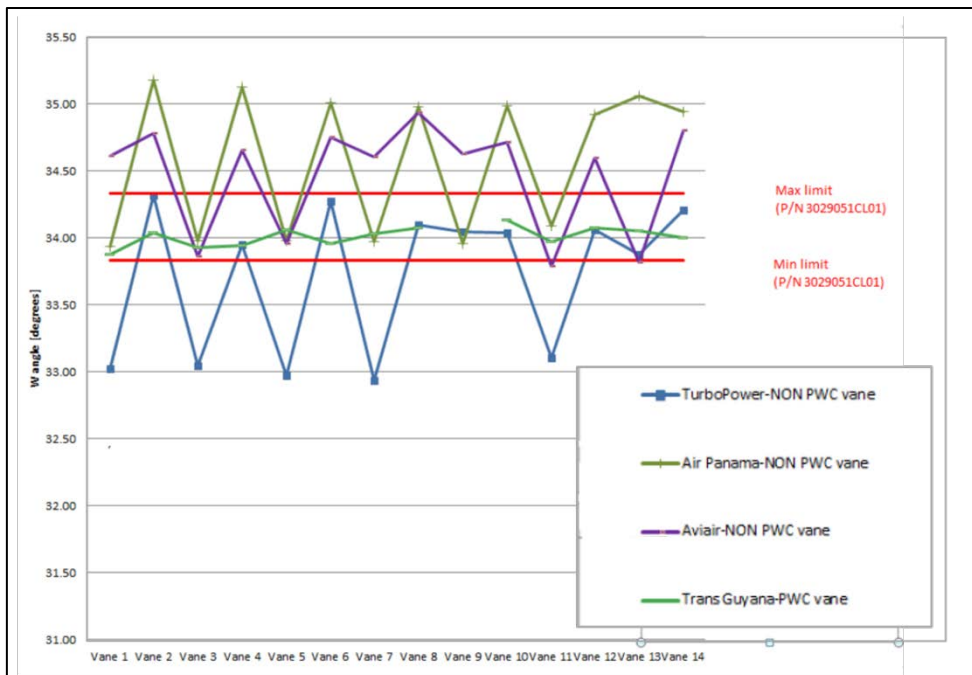
**Figure A3: The vane stagger angles of three STI-repaired compressor turbine vane rings fitted to three PT6A-114A engines that had sustained compressor turbine blade fracture, compared a CT vane ring with a Pratt & Whitney Canada CT vane ring that had also sustained a CT blade failure.**
