Controlled flight into terrain involving Mooney M20J, VH- DJU

26 km west of Coffs Harbour Airport, New South Wales, on 20 September 2019

ATSB Transport Safety Report

AO-2019-052

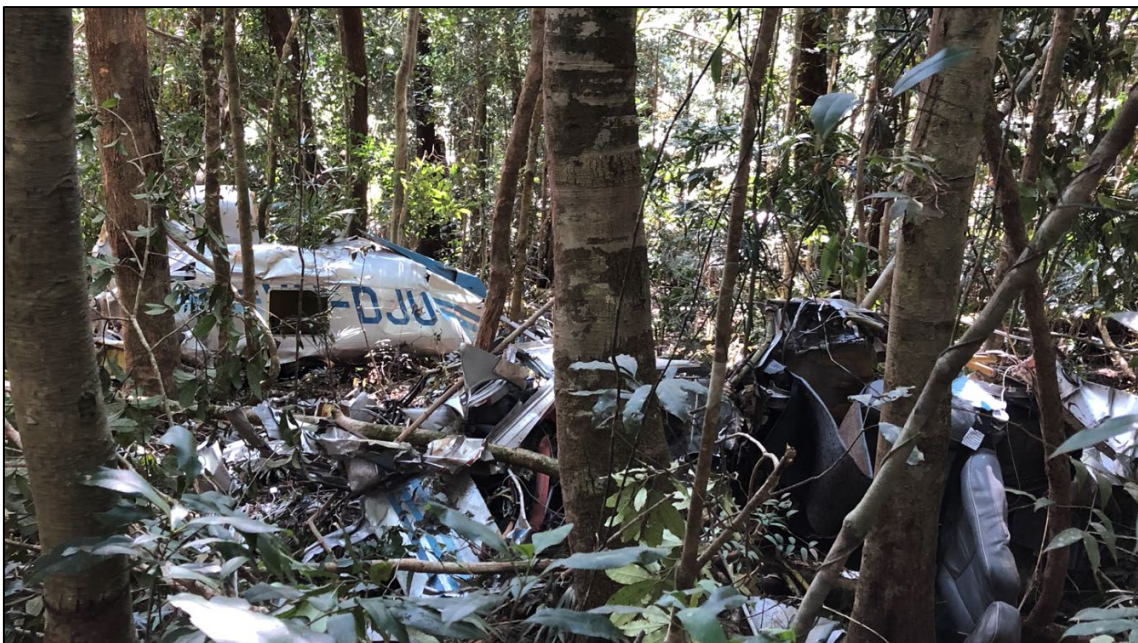
Figure 2: Accident site

In response to the aircraft not arriving at Taree as expected, a search was initiated. Although the search was initially hampered by rain and low cloud in the vicinity of the aircraft's last known position, the aircraft was located, having impacted terrain at an elevation of 2,920 ft. The wreckage was positioned in line with the last recorded track and about 2.8 km south of the last recorded position. The two persons on board were fatally injured and the aircraft was destroyed (Figure 2).

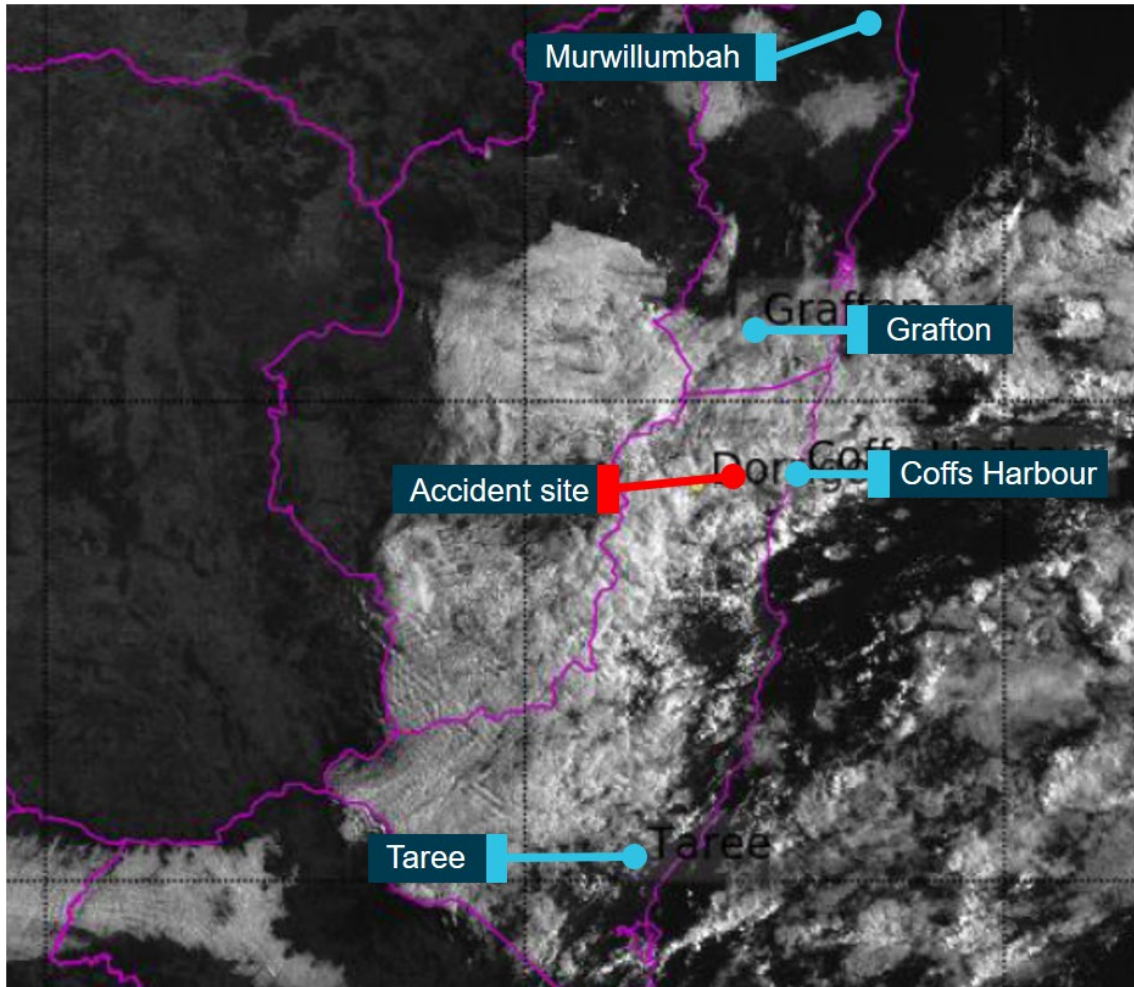
Figure 6: Meteorological satellite image extract for 0730 on 20 September 2019

Satellite images (Figure 6) for the area just prior to the accident time showed generally clear conditions between Murwillumbah and Grafton. South of Grafton and throughout the area encompassing the high terrain west of Coffs Harbour, the images showed extensive cloud coverage. Further along the intended route towards Taree, the cloud coverage reduced near the coast, but persisted inland.

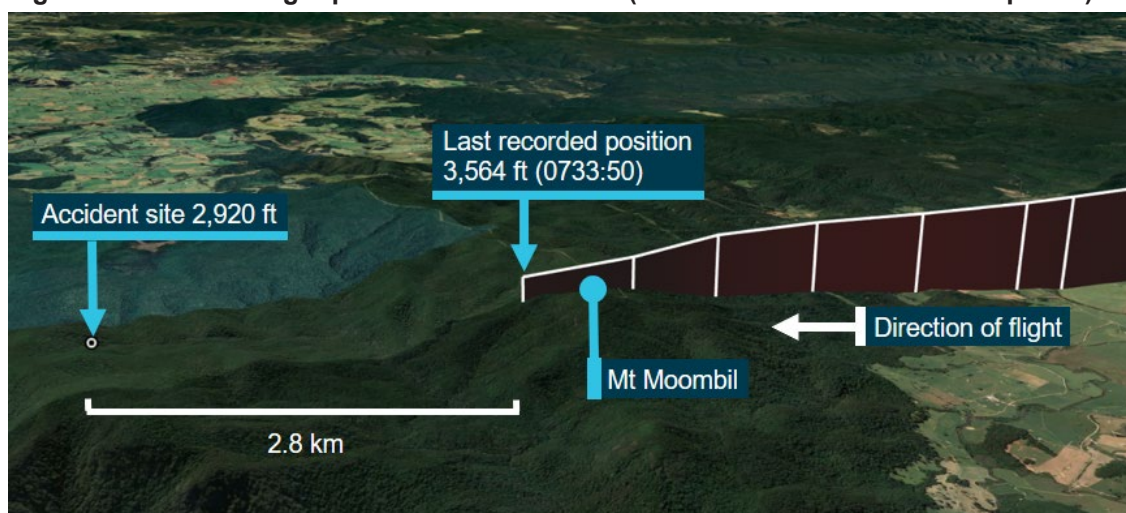
Figure 8: Recorded flight path near accident site (towers on Mt Moombil not depicted)

From 0722 until 0724, the aircraft descended from its cruising altitude of 6,500 ft to 4,100 ft. At this time, the pilot reported operating in clear conditions. About 2 minutes later, the aircraft climbed to 4,500 ft.

The aircraft remained at 4,500 ft until 0732 when a descent commenced and continued until the last recorded position at 0733:50. The descent rate averaged about 850 ft per minute with a groundspeed between 165 kt and 175 kt. The observed wind was almost directly across the descent track at 10-20 kt. According to the aircraft's previous owner, this descent profile was consistent with maintaining a cruise engine power setting.

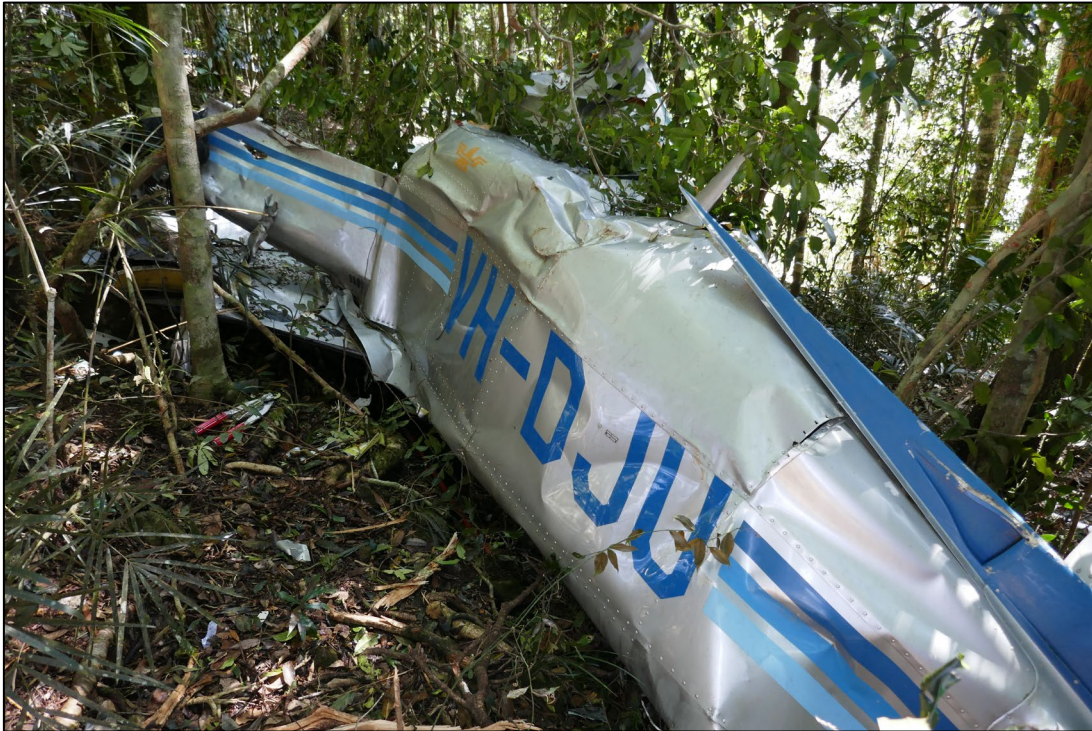
Figure 9: Aircraft wreckage

The accident site was located at an elevation of 2,920 ft in heavily wooded, steep terrain within Dorrigo National Park (Figure 9).

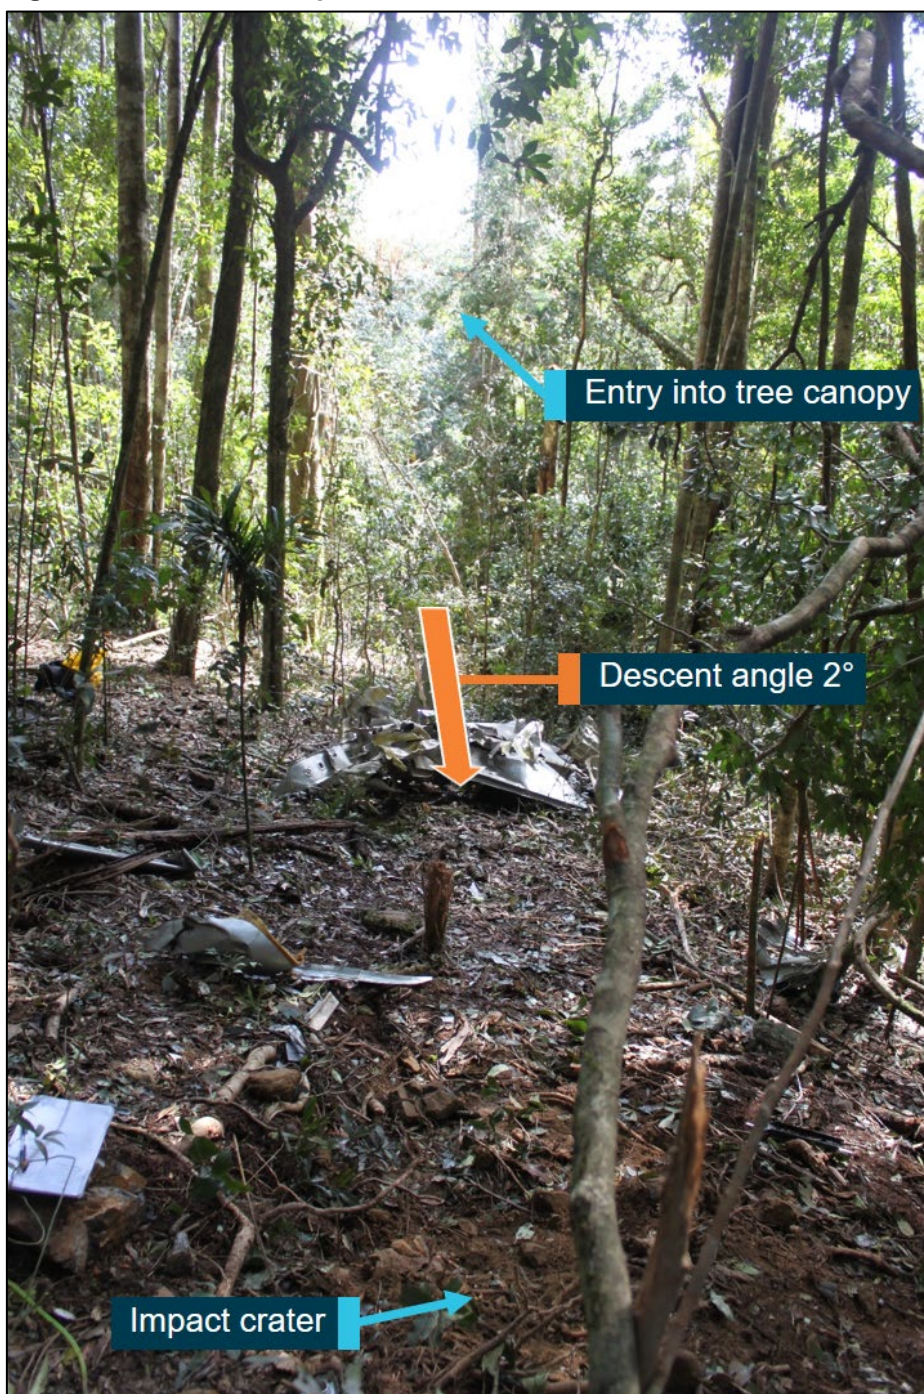
Figure 10: Final descent path of the aircraft

The path made by the aircraft through the vegetation continued for about 65 m from the first identified aircraft component to the ground impact point (Figure 10). Tree-impact marks and the impact crater showed that the aircraft entered the vegetation in a wings-level attitude on a continuation of the previously recorded descent angle of about 2°.

Examination of the wreckage found that the aircraft entered the vegetation at relatively high speed with the flaps and landing gear retracted. No pre-impact faults were identified, but the examination was limited by the extensive damage. The serviceability of the flight instruments and associated systems could also not be verified. Both fuel tanks ruptured and an odour of fuel was present. The engine separated from the fuselage and the engine controls were severely disrupted during the accident sequence, which prevented determination of their positions. Damage to the propeller indicated that it was being driven by the engine at the time of the accident. The accident was not survivable.
