Depressurisation and emergency descent involving a Fokker 100, registered VH-NHC

167 km south-south-east of Geraldton Airport, Western Australia, on
10 August 2020

ATSB Transport Safety Report

AO-2020-041

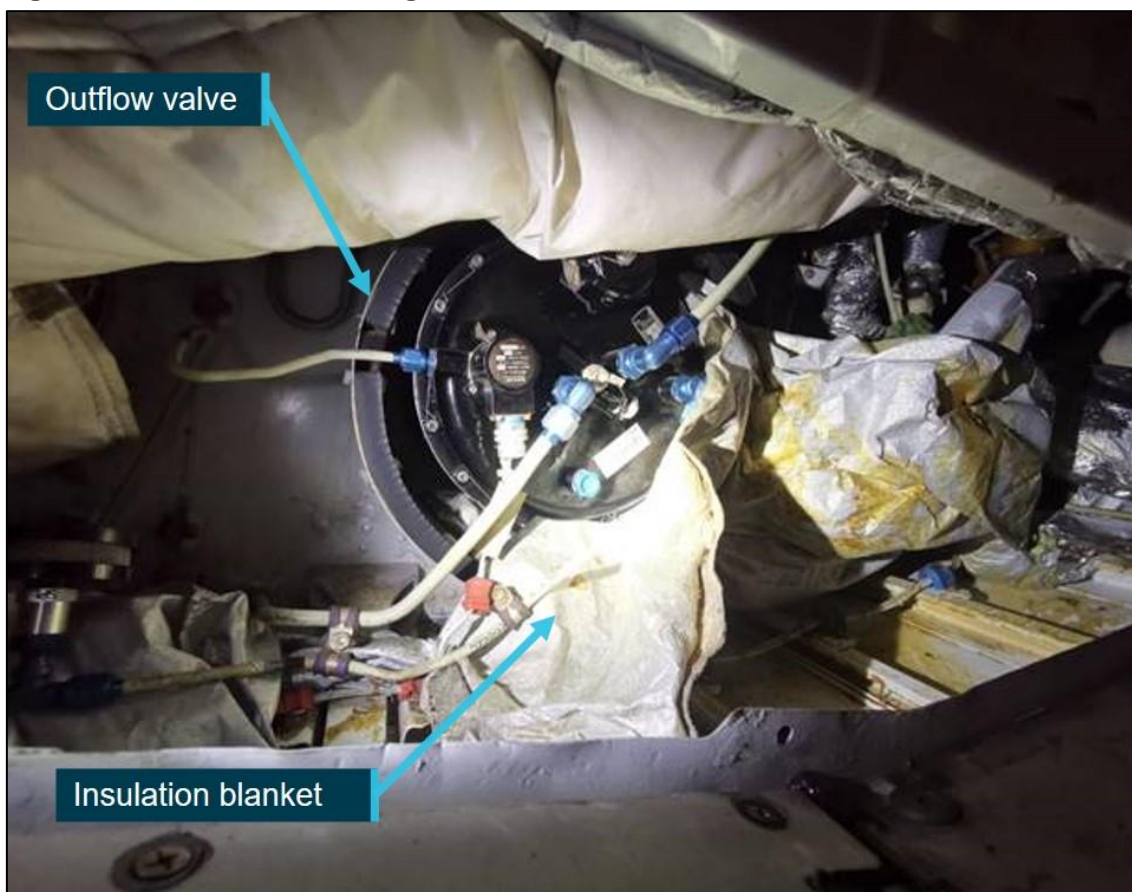
Figure 1: Insulation blanket caught in the outflow valve

An insulation blanket had become wedged in one of the two air outflow valves, preventing modulation of the aircraft's cabin pressure. In addition, it was established that the insulation blanket had not been correctly secured to the structure, which allowed it to migrate into the outflow valve.

A post-flight maintenance inspection identified that an insulation blanket had become wedged in the secondary (air) outflow valve, affecting pressurisation (Figure 1).

The ingested insulation blanket prevented the modulation of one of the outflow valves, affecting cabin pressure control. This resulted in a gradual cabin altitude increase, until the flight crew were alerted, once the cabin altitude had exceeded 10,000 ft.

A fleet-wide inspection by Network Aviation identified that only one of their 17 aircraft had the insulation blankets correctly installed. As a result, they have commenced a fleet-wide program to systematically replace insulation blankets with new items, ensuring correct installation as per the manufacturer's instructions.

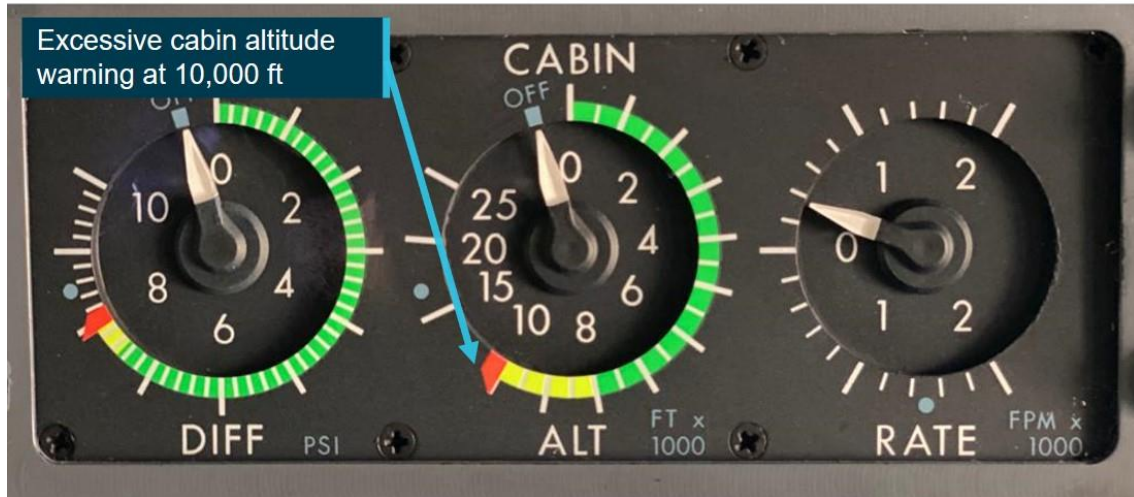
Figure 2: Cabin altitude indicator

The cabin altitude (pressure) indications are located in the flight deck, in an overhead panel (Figure 2). Cabin altitude is regulated by the primary and secondary outflow valves, which are located at the pressure bulkhead at the rear of the forward cargo compartment. The secondary

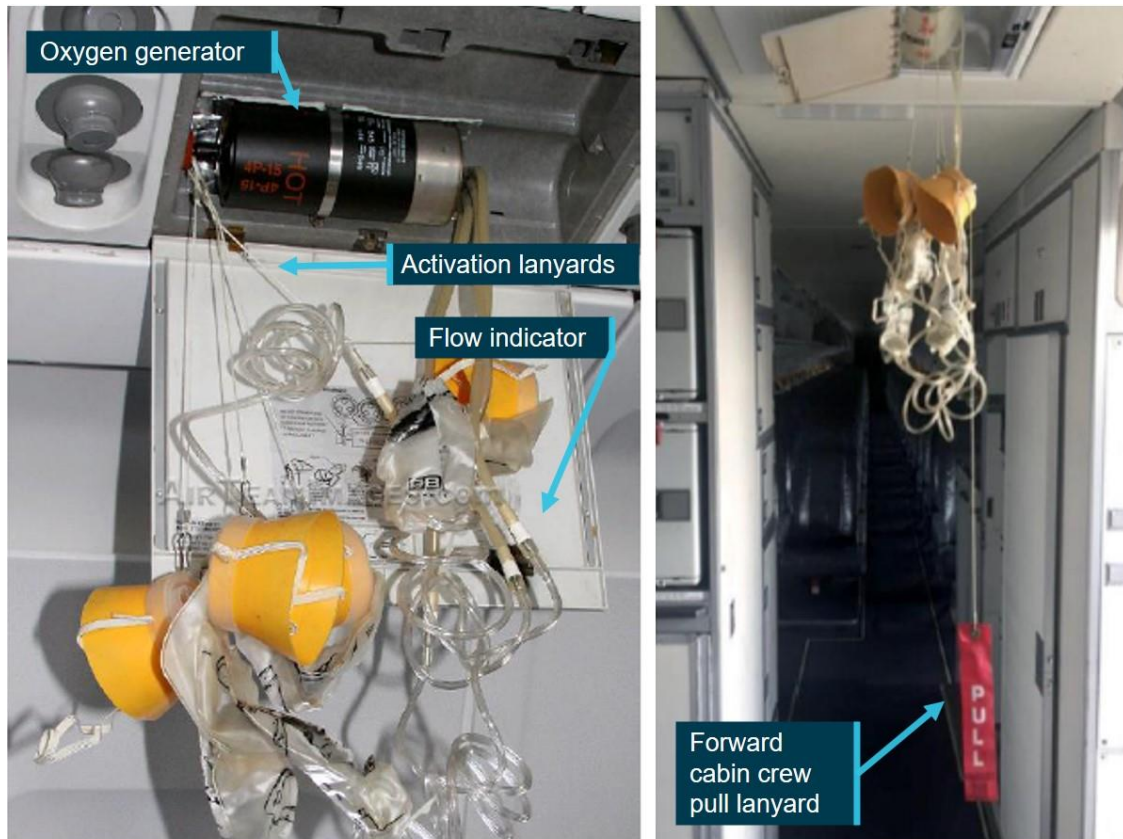
Figure 3: Cabin oxygen system

There were drop-down systems located above every seat group, in the toilets and above the cabin crew seats. Each location consisted of a chemical oxygen generator, supplying the drop-down masks. A spare mask was available at each location. That is, three masks were available above each dual-seat group, each cabin crew station and in the toilets. Four masks were available for each 3-bay seat group. The forward cabin crew system also had a 'pull' lanyard extension, to enable the seated cabin crew to reach the masks, as the unit was not directly overhead (Figure 3).

With regard to the detached oxygen mask, Network advised it was not able to determine if the mask had separated due to it being pulled, or if it had not been connected at last maintenance. Irrespective of the detached mask, Network also advised that oxygen should have flowed to the remaining masks in that unit. Further, the cabin crew had the option to use any spare passenger masks.

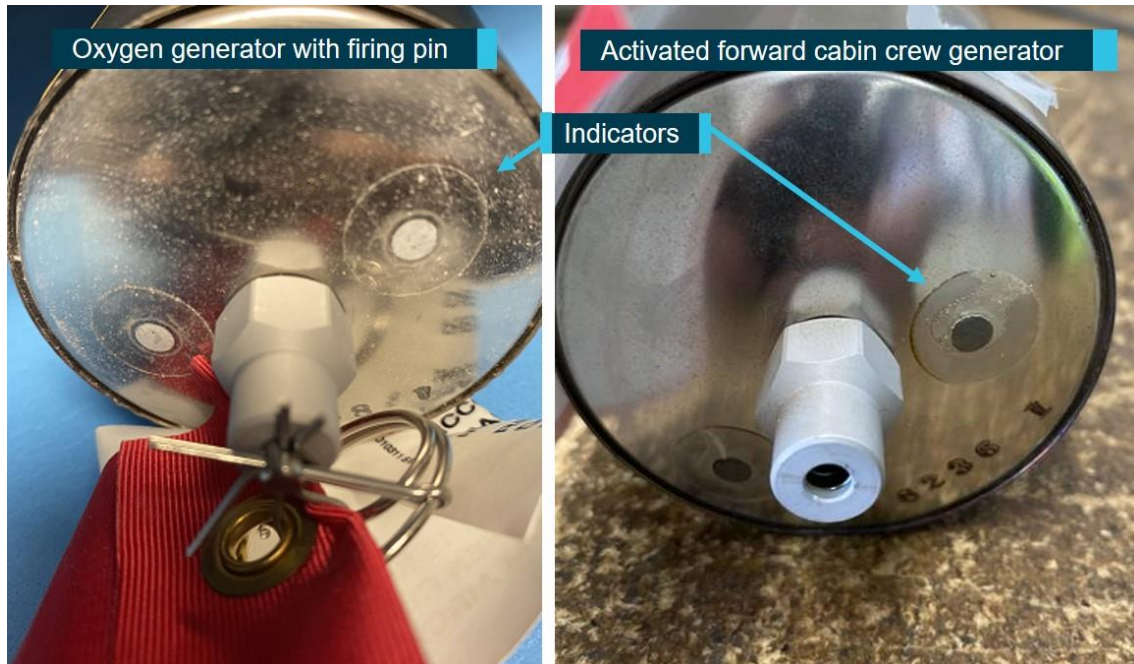
Figure 4: Oxygen generator firing pin and activated forward cabin crew generator

Post-occurrence maintenance included replacement of oxygen generators where passengers had been located and refitting of the system on unoccupied seats, where the generator had not been activated. Network's maintenance department advised that the forward crew oxygen generator

had been activated, evidenced by the configuration of the firing mechanism and colour-change of the chemical indicator dots (Figure 4).⁶

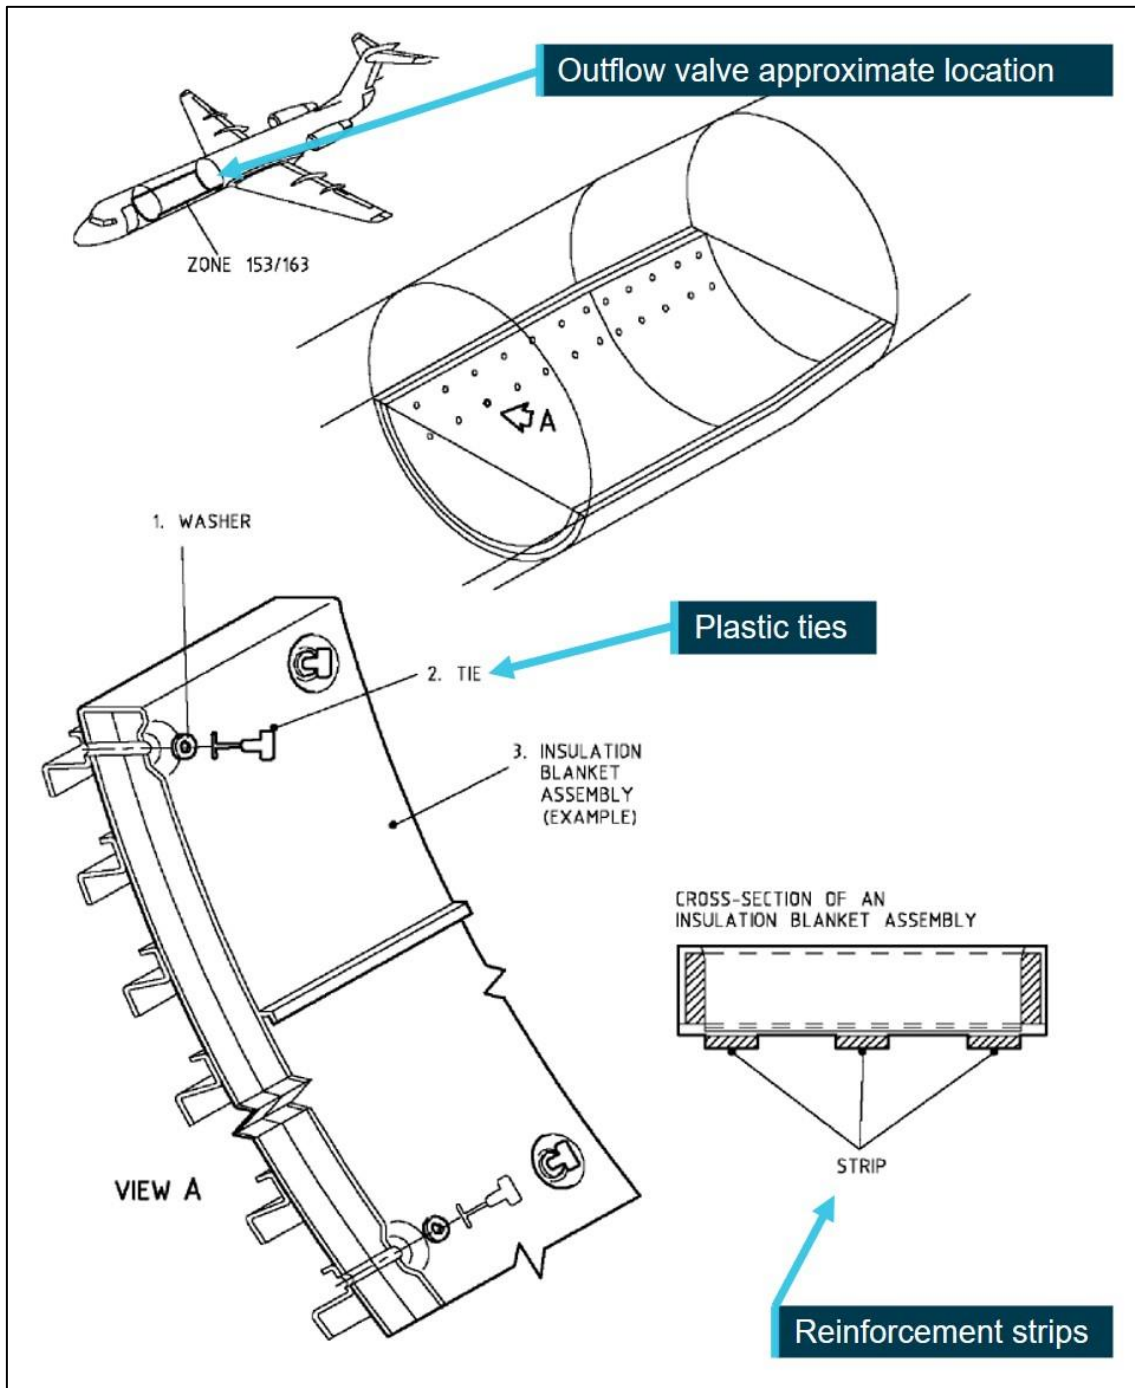
Figure 5: Insulation blanket location and installation

The insulation blankets installed on the Fokker F100 are made from glass fibre with a foil outer covering. They are located throughout the fuselage and provide thermal insulation⁷ and acoustic damping. Reinforcement strips are fitted on the underside, to prevent sagging of the insulation blanket against the aircraft skin, where moisture may become trapped. The insulation blankets are fixed to the airframe structure via plastic ties (Figure 5 and Figure 6). The aircraft maintenance manual (AMM) tasks 25-53-00-000-814A *Remove the insulation blanket assemblies* and

Insulation blankets were available from the manufacturer, with each being assigned a part number, to suit each location. Alternatively, Service Letter 293 (SL 293) permitted local manufacture, detailing manufacture process and installation procedures. SL 293 advised that the insulation blankets were to be installed in accordance with 'AMM Task 25-28-00-400-814A and/or with double-sided tape' (of a defined specification). SL 293 did not reference the requirement for the reinforcement strips.

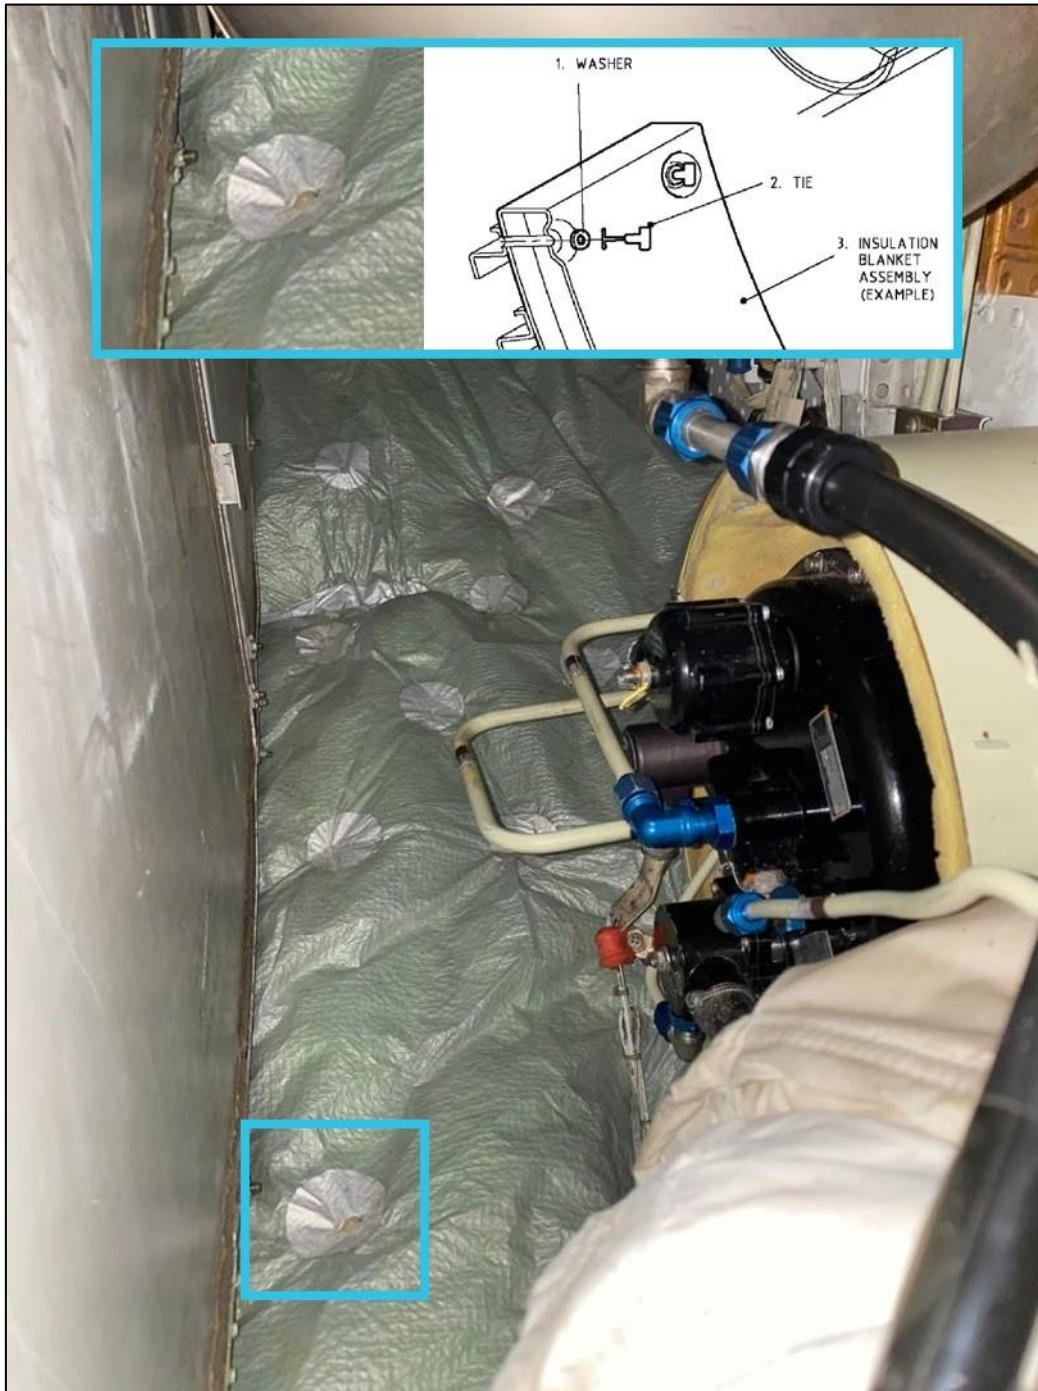
Figure 6: Typical insulation blanket installation using the plastic ties

Following notification of the issue from Network, FSA conducted an investigation into how the insulation blankets came to be installed without the required plastic ties. They identified that the JICs for the zonal inspections did not reference the associated AMM tasks for removal, inspection and installation of the insulation blankets.

Due to unavailability of the plastic ties and replacement insulation blankets, Network received approval from Fokker Services to temporarily install the blankets under the outflow valves with a defined double-sided tape. These blankets were to be inspected fortnightly, until the replacement blankets and plastic ties were available.
