Runway undershoot involving Beechcraft 200, VH-FDO

Cairns Airport, Queensland, on 9 July 2020

ATSB Transport Safety Report

AO-2020-034

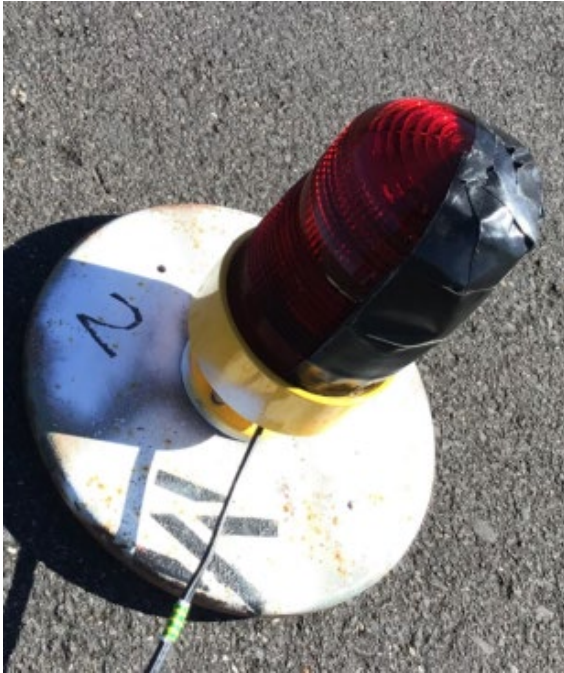
Figure 1: Example of temporary runway end light – taped to be unidirectional

Later that morning, at about 0500, an ASO reported that one of the temporary runway end lights was broken. The metal base had been pushed about 30 cm across the runway and the red light was shattered. No aircraft other than VH-FDO had landed the previous night.

The aircraft operator's senior base pilot was advised of the broken light by Cairns Airport personnel. The senior base pilot phoned the flight crew and asked whether the aircraft had struck anything the previous night, but neither was aware that it had. The supervisory pilot subsequently found a corresponding scuff mark on the right main landing gear tyre of VH-FDO. After some investigation, it was established that the flight crew had misidentified the works limit line as the displaced runway threshold and landed short of the displaced threshold. The aircraft tyre had struck the temporary runway end light, which was taped to be unidirectional to aircraft using runway 33 and was therefore not visible to flight crew when they landed on runway 15 (Figure 1).

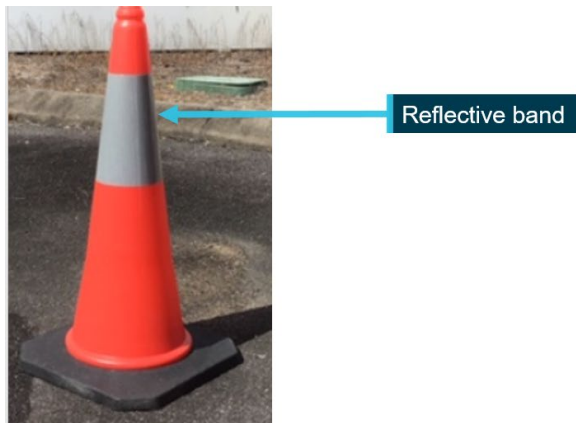
Figure 2: Witches' hats used to mark the works limit line

At the time, the duty ASO observed that the reflective band on the witches' hats were lit up 'incredibly brightly' with 'a bright white light extending across the runway'.

When the WSO collected the witches' hats from their storeroom, there were no MOS-compliant orange witches' hats available, only traffic cones with reflective bands (Figure 2). These were branded with 'ELL', which indicated to the WSO that they were appropriate for use. The WSO reported that an orange flare torch was placed between each pair of witches' hats on the works limit line.

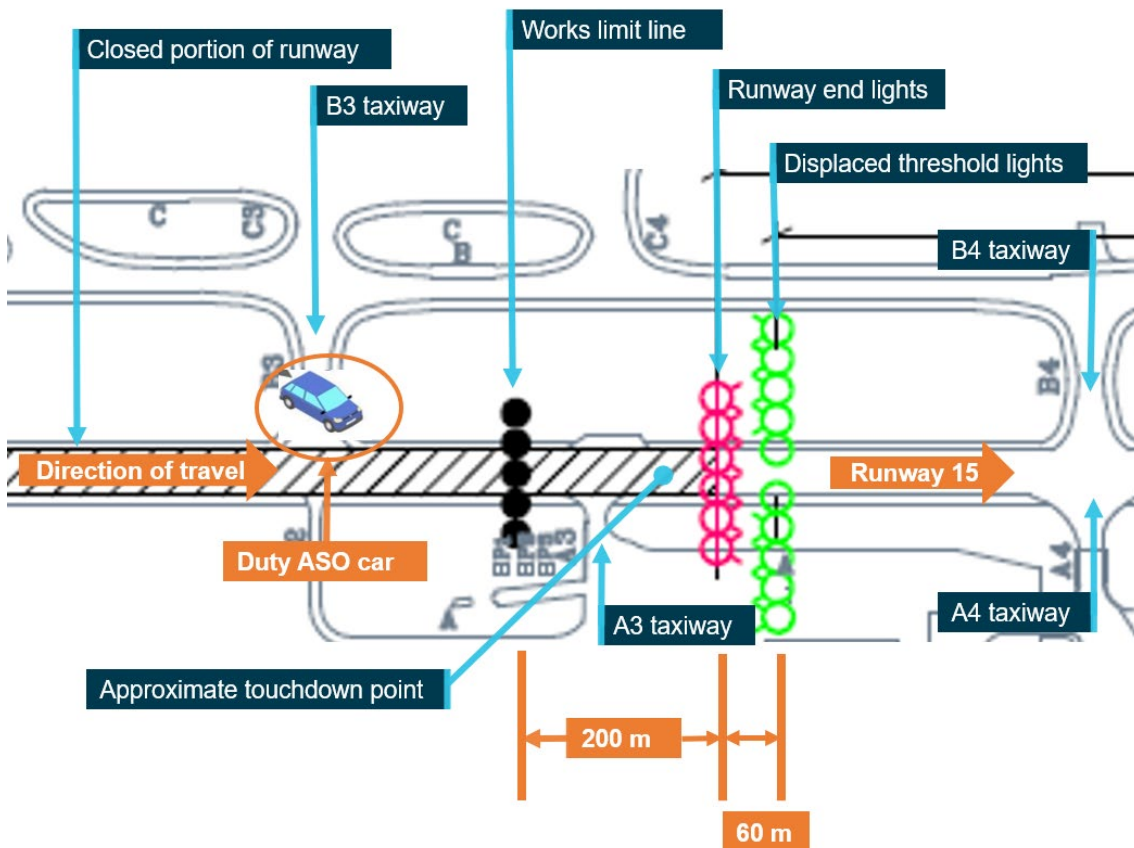
Figure 4: Extract of drawing depicting the displaced threshold and associated lighting

The drawing of the overlay for the runway 15 displaced threshold operations, an extract of which is depicted in Figure 4, was an annex to the MOWP. The drawing indicated that the displaced threshold was 1,856 m beyond the permanent runway 15 threshold, and the temporary runway end was 60 m prior to the displaced threshold. The works limit line was 200 m prior to the runway end and there was 260 m between the works limit line and the displaced threshold. The legend for the drawing described the following:

- equipment (works) limit line was orange witches' hats during daylight hours and flashing amber lights at night
- runway end lighting was at least six lights spaced evenly between the rows of runway edge lights
- displaced threshold lighting was five green lights either side of the runway, 2.5 m apart, with the innermost lights on each side omnidirectional and in line with the runway edge lights.

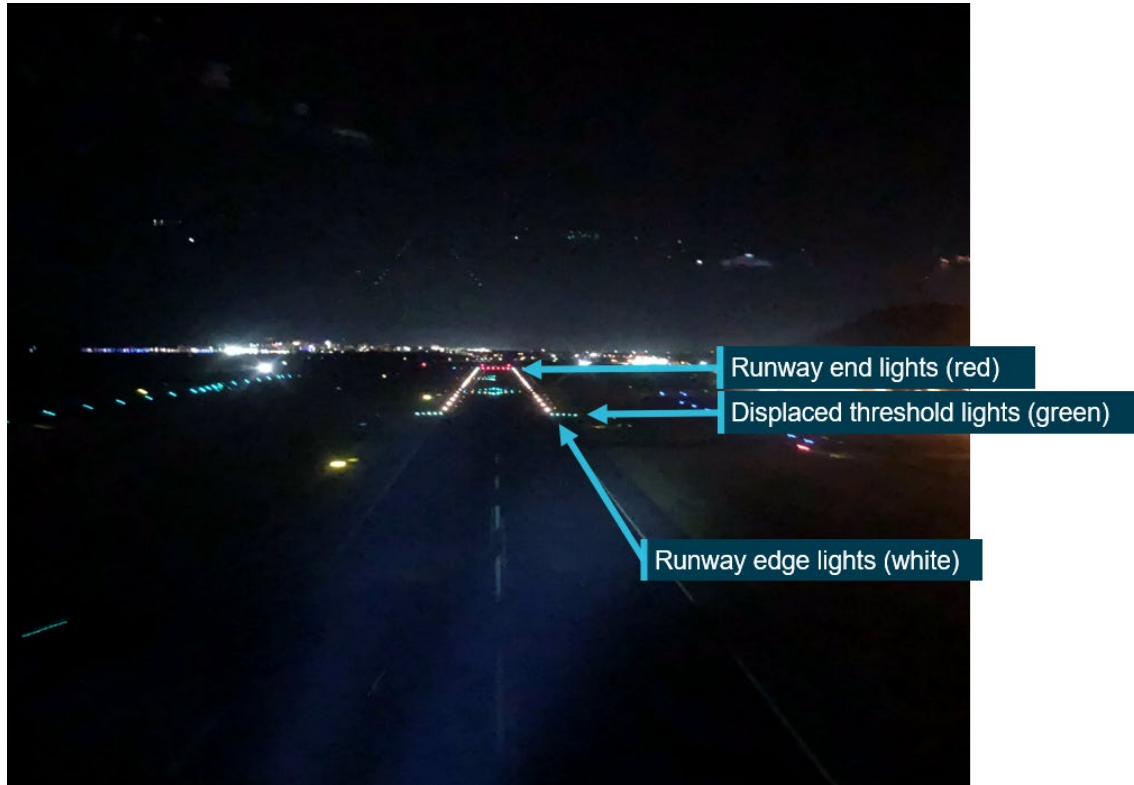
Figure 5: Runway lighting for the runway 15 displaced threshold several nights after the incident

Several nights after the incident, the flight crew again flew into Cairns, using the runway 15 displaced threshold. The flight crew reported that, compared to the incident night, the displaced threshold was distinct and that, due to the absence of extraneous lighting, there was no confusion. Differences to the runway lighting arrangement included:

- the reflective witches' hats were absent and a single amber light to the side of the runway marked the works limit line
- no safety car headlights were directed at the runway
- taxiway lights were deselected until the aircraft landed such that the only green lights leading to/from and perpendicular to the runway were the displaced threshold lights
- there was no runway lighting prior to the displaced threshold (Figure 5).

- No vehicle headlights were to be directed at the active runway during any aircraft operations on, or on approach to, the runway.
- The works limit line was marked by an amber solar-powered light only.
- Witches' hats with reflective tape were not to be used.
- Air traffic control was requested to only activate taxiway lights once an arriving aircraft had landed and to deactivate the taxiway lighting after an aircraft had departed.
- Green temporary displaced threshold lights were replaced with solar lighting that did not require electricians to wire.
- The notice to airmen was amended to advise that taxiways were not available, and of temporary blue taxiway edge lighting on taxiway A between A3 and A4.
