# Engine failure involving Fokker 100, VH-FWI

41 km south-east of Geraldton Airport, Western Australia on 9 July 2019

## **ATSB Transport Safety Report**

AO-2019-033

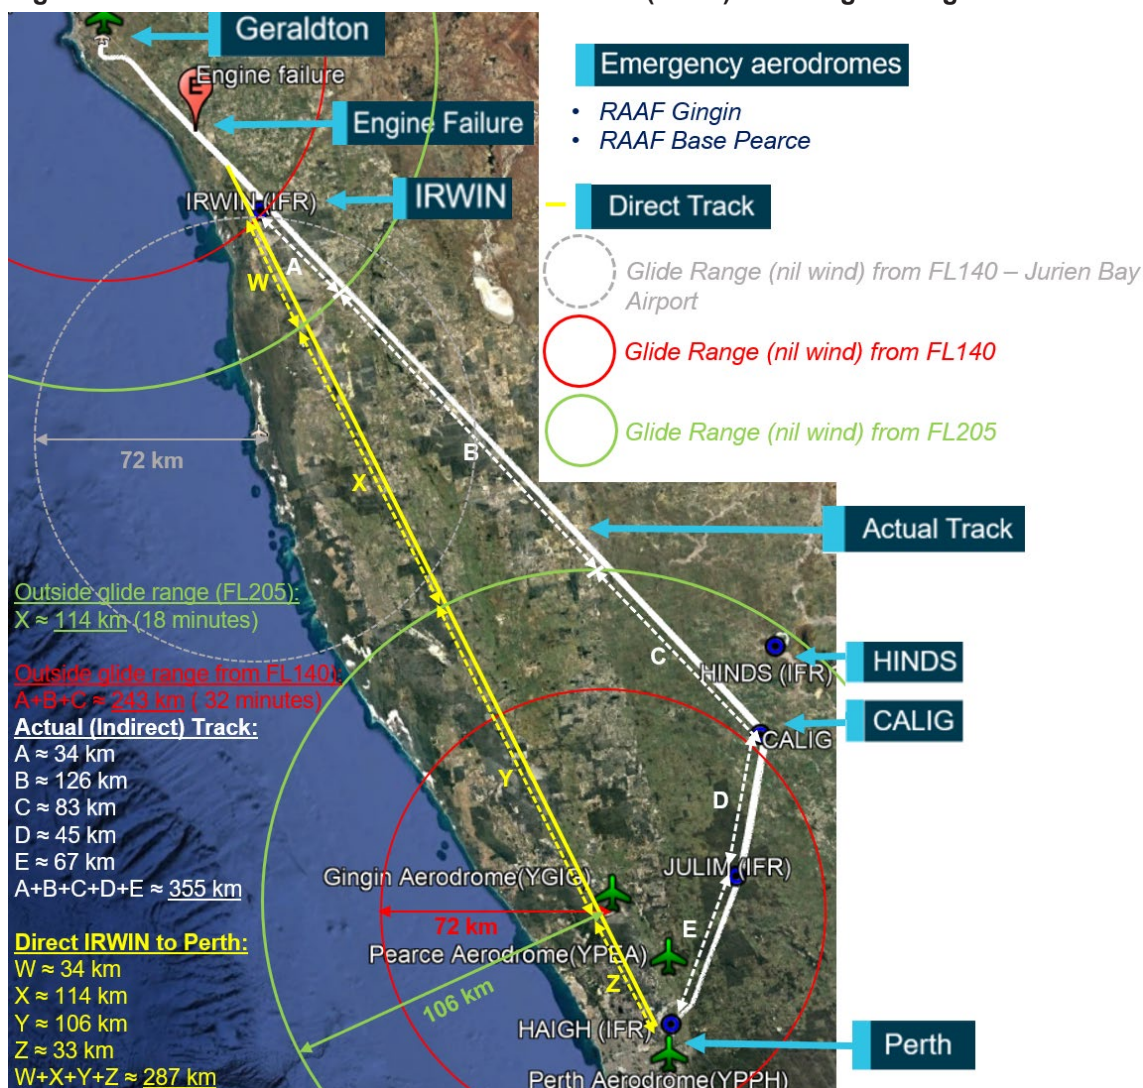
Figure 1: Actual versus direct route to destination (Perth) following the engine failure

Figure 1 illustrates the glide ranges from FL 140 and FL 205 respectively. At the time of the engine failure, the forecast wind at FL 140 was south-westerly at 15–20 knots. This would have reduced the glide range if/when the aircraft was turned west towards any of the available alternate airports.

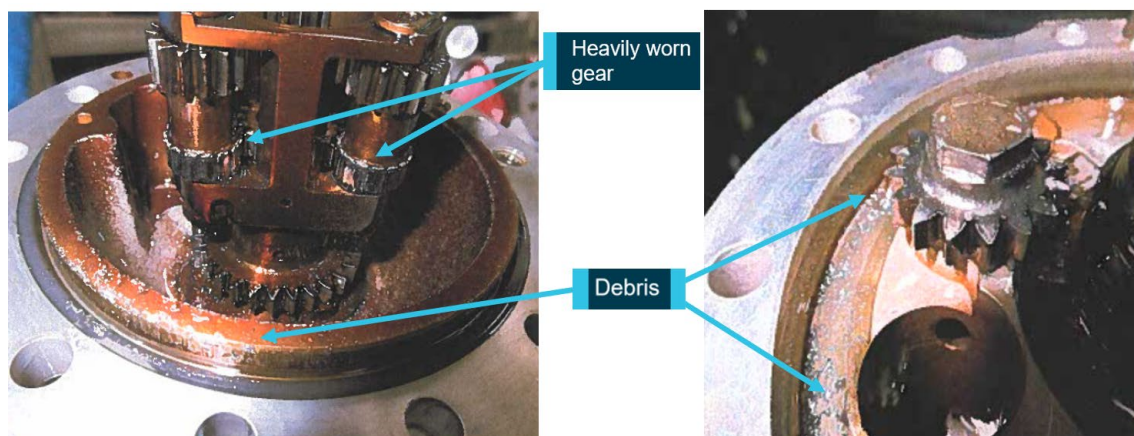
**Figure 5: Internal damage to drive, planetary and transfer gear within the FFR**

The unit was subsequently examined by Rolls-Royce, who found that the internal gear within the drive end assembly was significantly worn (see the section titled *Fuel flow regulator* and Figure 5). The FFR was replaced, however this unit was also found to be faulty. Another FFR was then fitted and the aircraft was successfully returned to service.

Following the engine failure, the FFR (S/N L1660) was removed and sent to an approved overhaul facility (Rolls-Royce) for detailed examination. Their report found that the internal planetary and sun gears within the FFR had worn, which would have contributed to the loss of drive, leading to the in-flight shutdown event (Figure 5).

Following this incident and a review of the global failure rate specific to the FFR unit utilised by the VARA F100 fleet, the engine manufacturer, Rolls-Royce, amended the applicable component management plan to revise the recommended FFR maximum overhaul interval (full-life) down from 16,000 to 10,000 hours.
