Tail rotor strike and collision with terrain involving a Bell B206L1, VH-NBR

14 km north-east of Kubin Airport, Queensland on 22 April 2020

ATSB Transport Safety Report

AO-2020-023

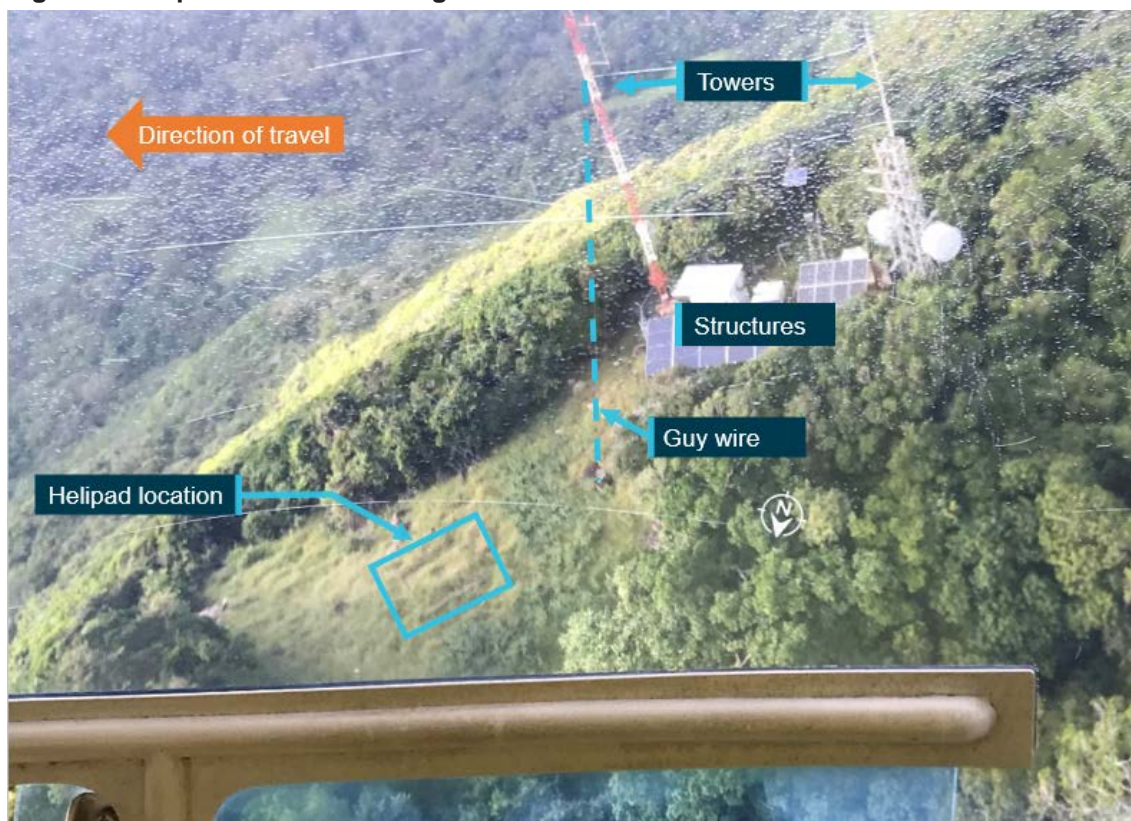
Figure 1: Helipad as viewed during aerial reconnaissance circuit

Overhead Banks Peak, the pilot conducted an aerial reconnaissance circuit of the helicopter landing site (HLS). The pilot then approached the site from the north, for landing. Closer to the ground, the pilot had difficulty locating the helipad. Grass had grown across the helipad and its edges (Figure 1).

On the day of the accident, long grass obscured the helipad. Although the outline was apparent to the pilot during the aerial reconnaissance circuit of the site, when the helicopter was closer to the ground the pilot reported that the helipad became difficult to see. In the months following the December maintenance, there had been about 1,000 mm of rain recorded at nearby Horn Island.

The compacted gravel centre of the helipad provided a surface for grass to grow over the helipad. The extended time and significant rainfall since the last maintenance, 4 months earlier, allowed that grass to grow to a length that obscured the whole helipad from view of the pilot during the approach. The obscured pad increased the complexity of the operation and increased the workload on the pilot during a critical phase of flight.

The high rainfall and tropical environment of Moa Island generated a high rate of vegetation growth. The rate of scheduled maintenance conducted at the helicopter landing site was too low to prevent the helipad becoming overgrown, effectively camouflaging the helipad during the approach.

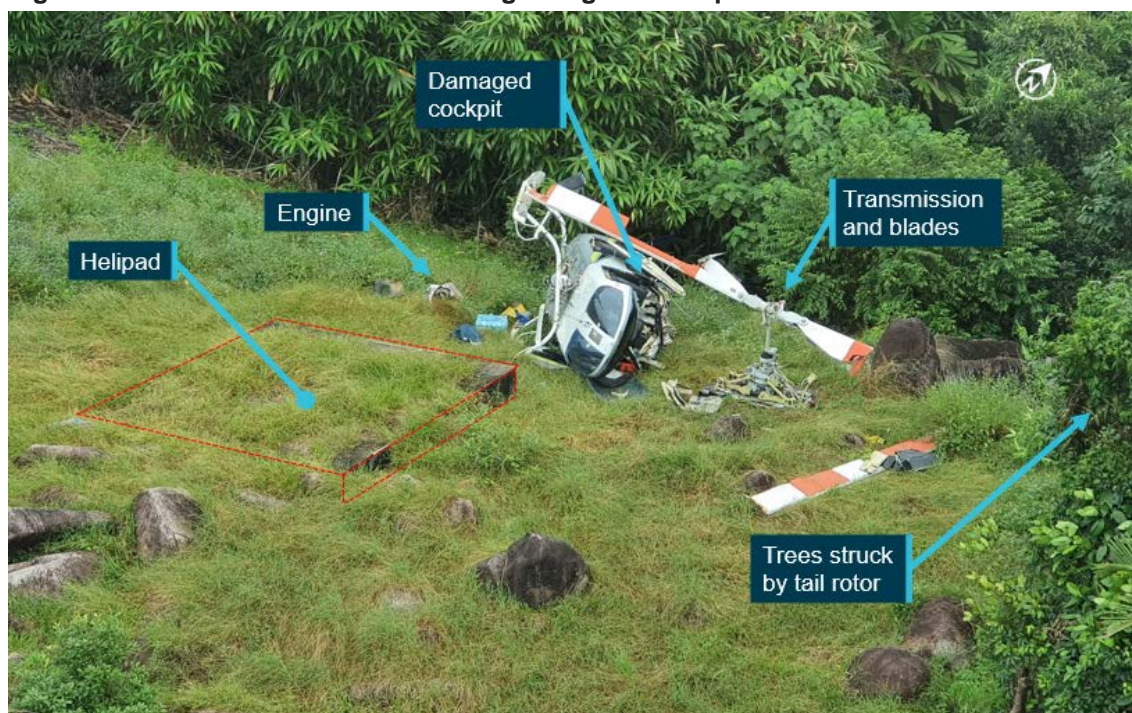
Figure 2: VH-NBR accident site showing overgrown helipad

after this sound, the helicopter spun rapidly to the right before rolling left. The helicopter collided with terrain and was destroyed (Figure 2).

- The helipad maintenance schedule was not sufficient to prevent the gravel helipad from being overgrown. This enabled vegetation to grow out from the centre of the helipad, obscuring its edges and making its borders difficult to identify during landing.
- While the pilot was manoeuvring in the confined area, the tail rotor contacted a tree. This led to a tail rotor failure, resulting in rapid rotation and collision with terrain.

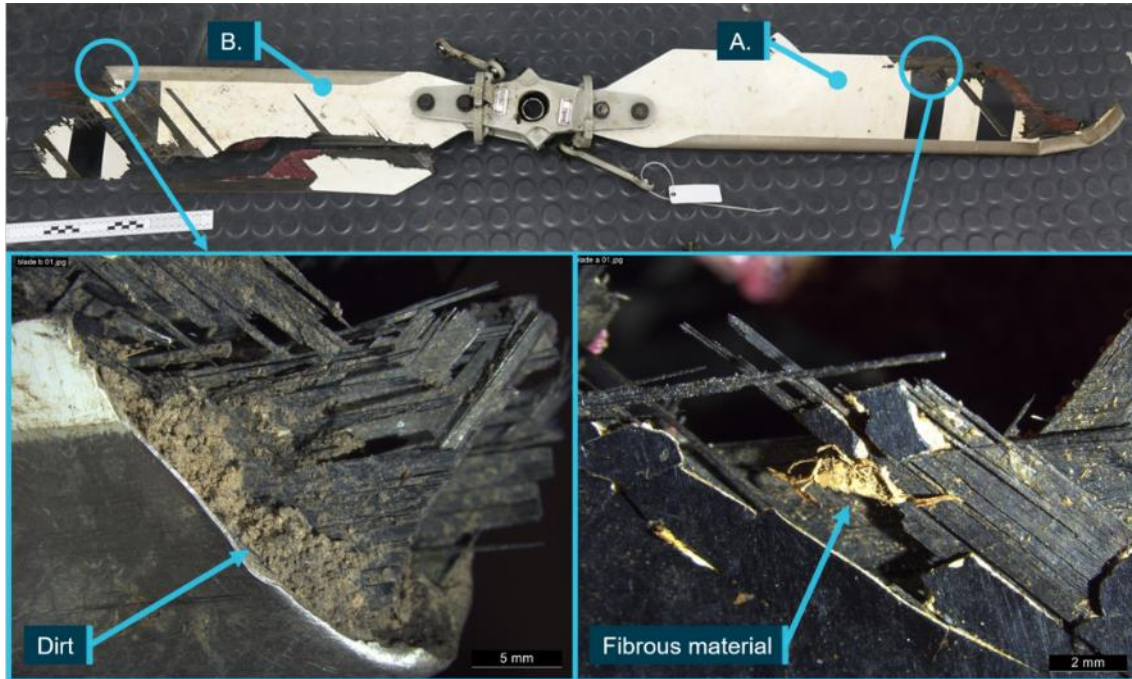
Figure 3: Tail rotor damage showing fibrous material and dirt within the blade structure

Several branches of up to 45 mm thick were struck by the tail rotor, leading to fracturing of both blades about two-thirds of the way along their respective span. This led to bending of the leading edge protection and splintering of the carbon fibre skins.

A detailed examination of the tail rotor blades was conducted by the ATSB. This examination found that blade A (Figure 3) had sustained bending about the leading edge strip, opposite to the direction of its rotation. That damage was consistent with an impact under power. It also had numerous deposits of woody fibrous material throughout the inner structure. The leading edge of blade B showed the surfaces were contaminated with a quantity of dirt throughout the fractured sections and internal structure. This was most likely due to ground contact during the accident sequence.

The passenger video recording had distinct audio of a buzzing sound and then a crack, immediately prior to the loss of control. ATSB examination of the tail rotor showed no evidence of pre-existing damage. The damage on both blades was consistent with impact under power.

A detailed examination identified numerous deposits of woody fibrous material throughout the inner structure. The video evidence and the presence of the fibrous material indicated that it was likely the blade had impacted a tree or branch, immediately prior to the loss of control.

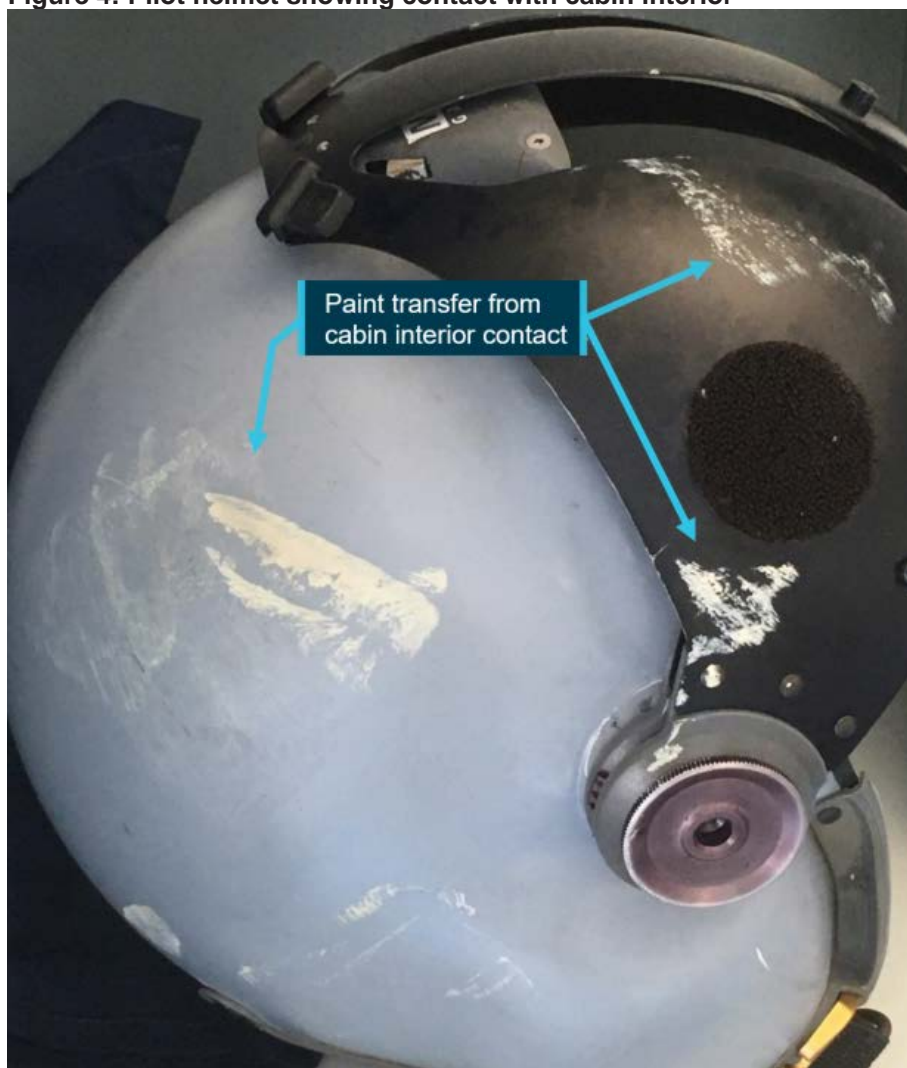
Figure 4: Pilot helmet showing contact with cabin interior

The pilot was wearing a helmet at the time of the accident, which was approved for helicopter operations. The helmet was damaged from impact with the aircraft structure, and a 25 mm split was noted in the helmet outer shell. Paint transfer on the pilot's helmet was of a colour matching the interior paint of the cabin (Figure 4).

The pilot was wearing an approved flight helmet. During the accident sequence, the helmet was struck by the internal structure after the structure was impacted by the main rotor system. This resulted in minor damage to the helmet, and the pilot was unconscious for a short period of time. It is very likely that had the pilot not worn the helmet, the severity of their injuries would have significantly increased.

- The helmet worn by the pilot very likely prevented a more serious head injury.
