# Collision with water involving de Havilland Canada DHC-2, VH-NOO

Jerusalem Bay (Hawkesbury River), New South Wales, on 31 December 2017

## **ATSB Transport Safety Report**

AO-2017-118

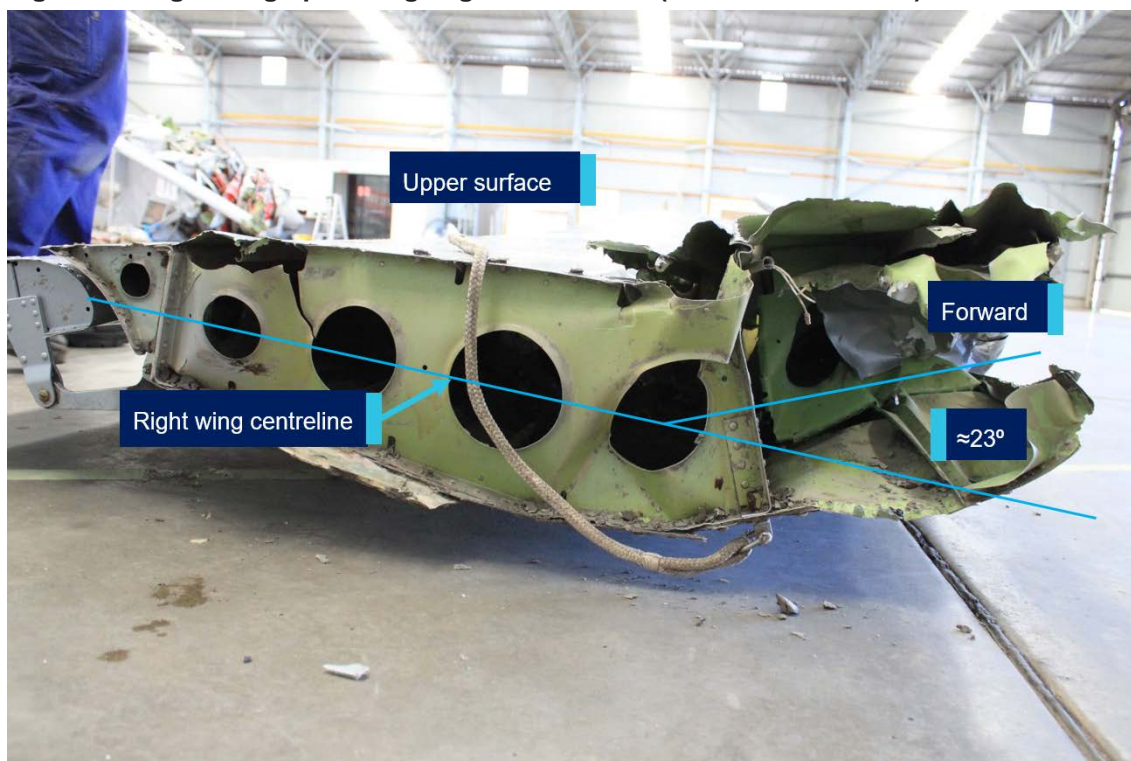
**Figure 22: Right wing tip leading edge deformation (view from outboard)**

- The right wing tip leading edge impact damage indicated a considerable upward pressure relative to the wing chord on impact. The wing tip indicated deformation of approximately 23° upwards (Figure 22).<sup>32</sup>

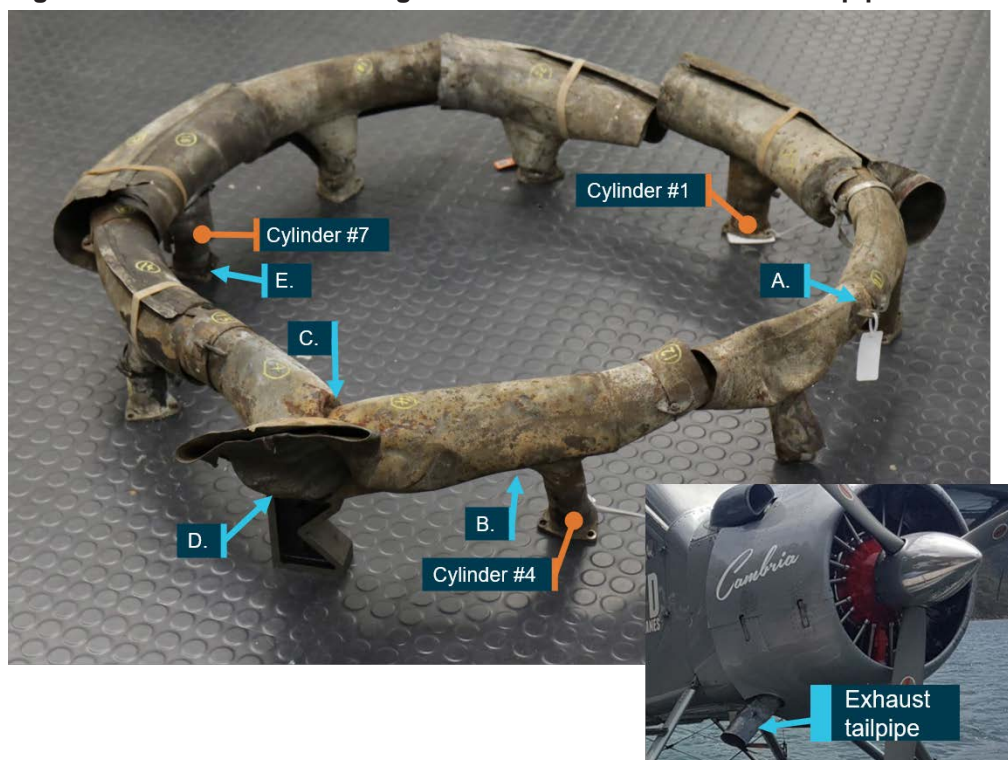
**Figure 25: VH-NOO exhaust segments and location of exhaust tailpipe on aircraft (inset)**

*Note: Image includes carburettor heat muff. Cylinders numbered clockwise. Labels A through E shows location of fractures examined.*  
 Source: ATSB and passenger, annotated by the ATSB

The Y-segment (D) had been repaired or re-manufactured, but the extent to which the repairs may have influenced the observed cracking could not be determined. Further, it was worth noting that the extent of the exhaust deformation meant that all of the cracks identified were wider (more 'open') than they would have been pre-accident.

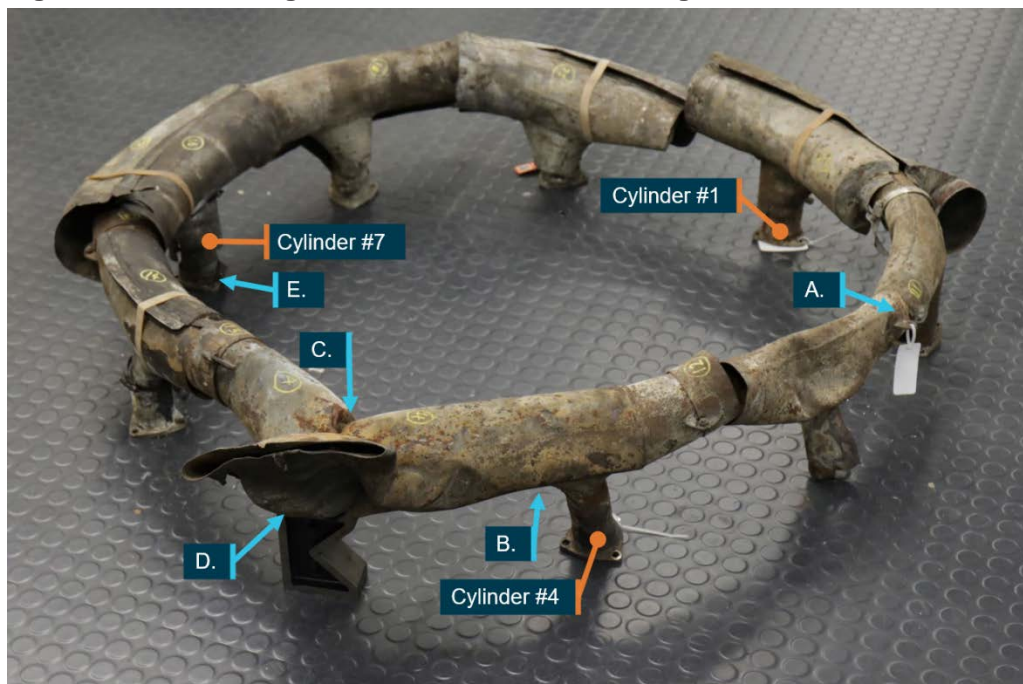
**Figure 47: Exhaust segments from VH-NOO, including carburettor heat muff**

Note: Cylinders numbered clockwise. Labels A through E shows location of fractures examined.  
Source: ATSB

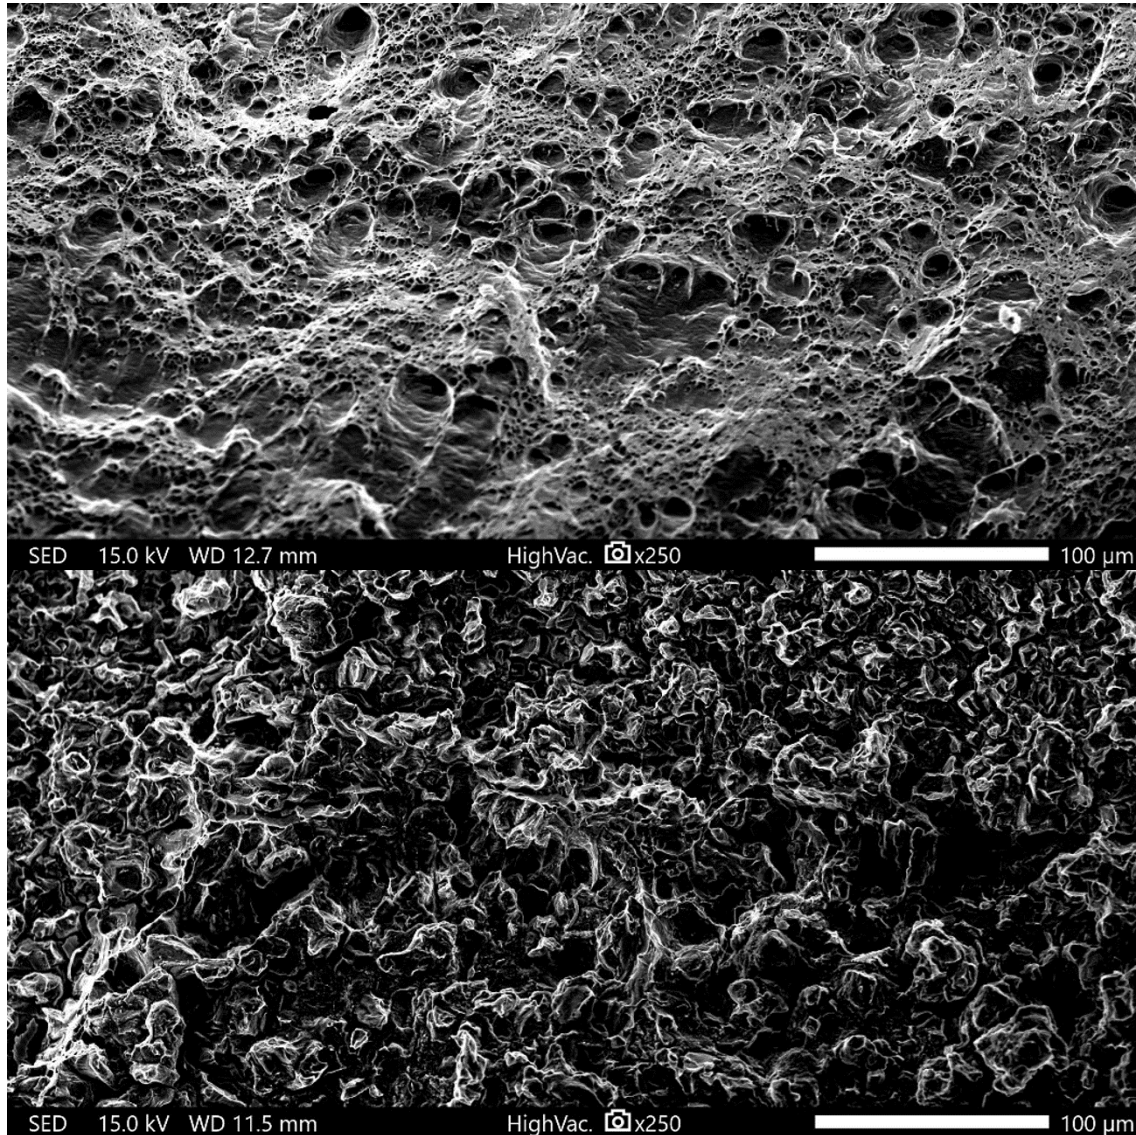
**Figure 50: Scanning electron microscope images of cylinder number 7 exhaust flange crack fracture surfaces**

*Note: Accident fracture (ductile rupture, top) and existing crack (intergranular, bottom).*  
Source: ATSB
