# VFR into IMC and loss of control involving Wittman Tailwind, VH-TWQ

Tooloom National Park, New South Wales on 12 January 2020

## ATSB Transport Safety Report

AO-2020-004

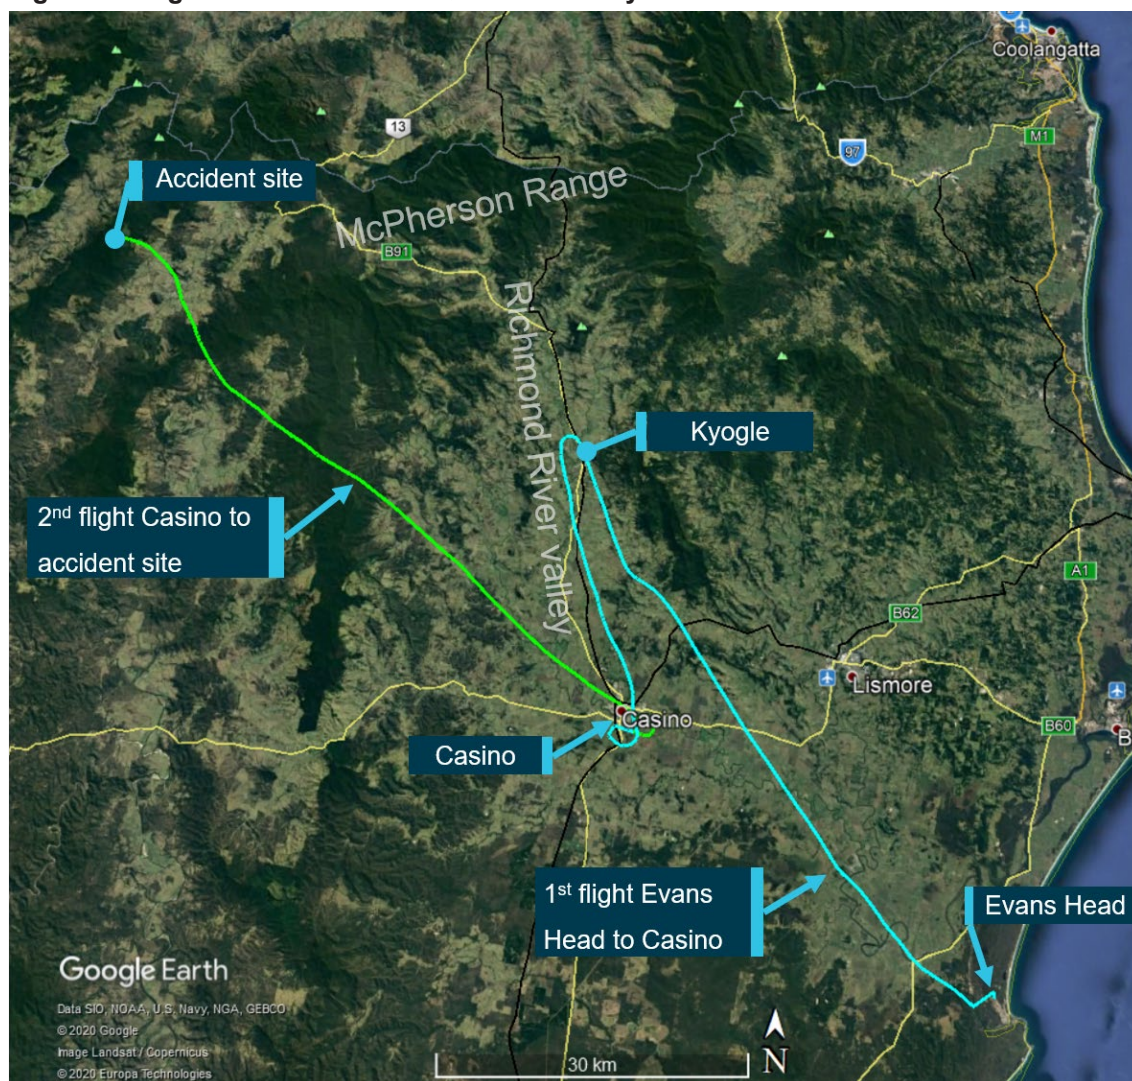
**Figure 2 - Flight tracks for VH-TWQ on 12 January 2020**

The pilot flew in a north-north-westerly direction towards Boonah via the Richmond River valley (Figure 2). The aircraft reached a maximum altitude of 1,950 ft above mean sea level<sup>3</sup> just prior to

reaching Kyogle. At 1353, the pilot commenced a 180° turn overhead the township of Kyogle and diverted, likely due to low cloud on their intended flight path. At 1357 a family member contacted the passenger as they had seen the turnaround overhead Kyogle on OzRunways.<sup>4</sup> The passenger replied to say they were 'going home due low cloud'. The pilot flew south back down the valley to Casino Aerodrome, landing at 1406.

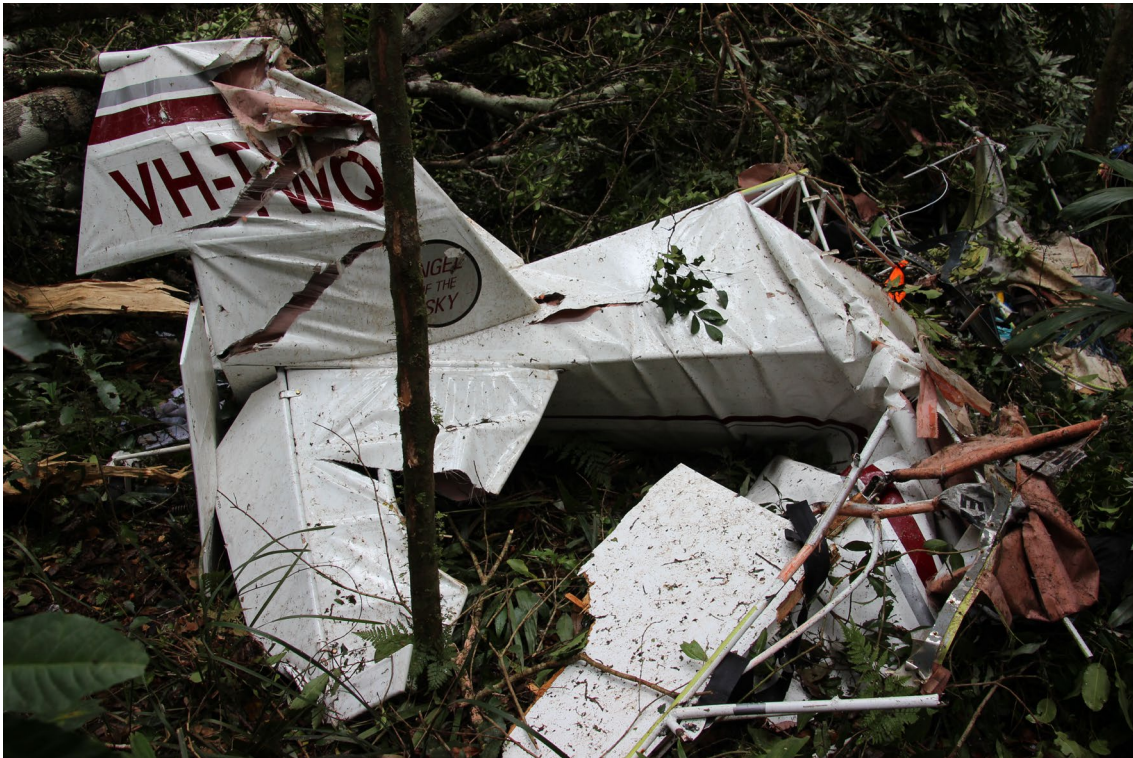
**Figure 3 - VH-TWQ's empennage at the accident site**

The aircraft's structure was substantially disrupted (Figure 3). The wreckage trail was about 120 m long on a bearing of approximately 270°. All major aircraft components were located at the accident site. ATSB investigators did not identify any signs of pre-existing airframe damage. Due to the disruption of the airframe, the aircraft's attitude when it entered the tree canopy could not be determined. There was no evidence of fire. Site and wreckage examination did not identify any defects or anomalies that might have contributed to the accident.

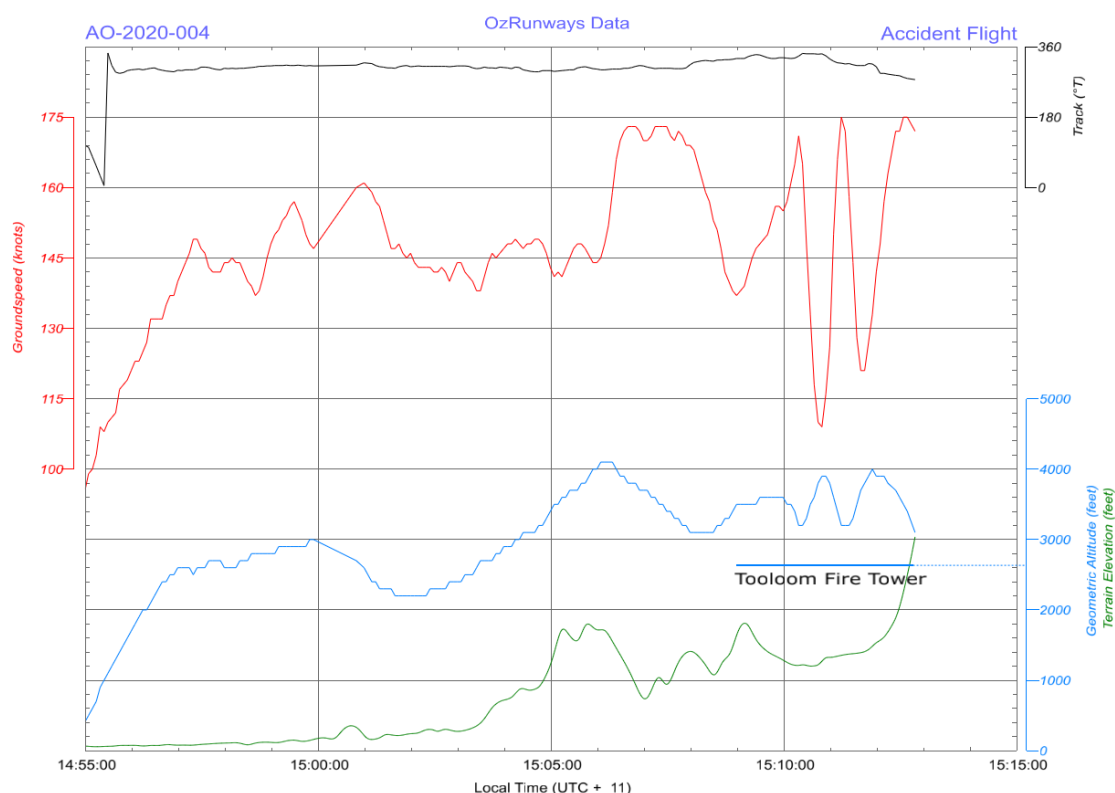
**Figure 6 - OzRunways data and terrain elevations for the final flight of TWQ**

Figure 5 shows the aircraft's flight data from OzRunways. Groundspeed is annotated in red, altitude in light blue and track in black. The altitude of Tooloom fire tower is also marked in blue. This line starts from the time where TWQ was abeam the fire tower. Terrain directly underneath the flight path is marked in green.

this area is approximately 1,800 ft high. At about 1506, the aircraft reached a maximum altitude of 4,100 ft then entered a 600 ft/min descent where the groundspeed rapidly increased from 145 kt to 173 kt. It is likely that the pilot initiated the climb to clear terrain and then descended when the cloud conditions became unsuitable. This climb took TWQ above the forecast and observed cloud heights in the area, which indicated a cloud base of around 2,600 - 2,800 ft. The descent levelled out at 3,100 ft, and the terrain underneath was about 1,430 ft, allowing the pilot to continue the descent a further 1,670 ft and remain clear of the terrain, if the pilot was visual with terrain. It is possible that the pilot entered an area of deteriorating visibility at this time leading to the rapid descent and level off well above terrain.
