# Engine power loss and collision with terrain, Bell 206B3 helicopter, VH-FHW

107 km south-west of Jabiru, Northern Territory, on 21 May 2019

**ATSB Transport Safety Report**  
Aviation Occurrence Investigation (Defined)  
AO-2019-025  
Final – 26 February 2021

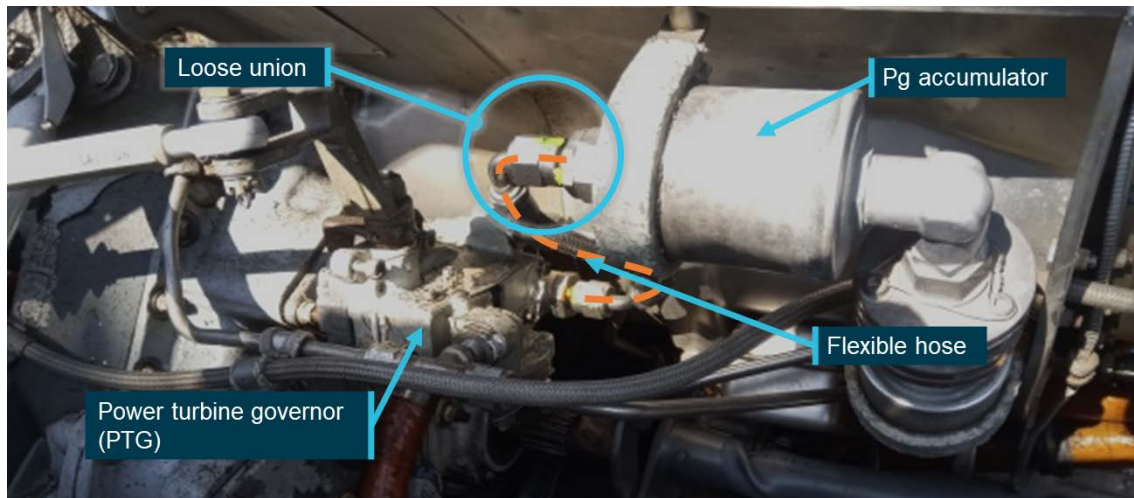
**Figure 4: Loose reference air union**

During the inspection of the wreckage it was found that an engine reference air line<sup>2</sup> union between the power turbine governor and the accumulator was loose (Figure 4). No other pre-existing problems with the helicopter were reported to be found during the wreckage examination.

<sup>2</sup> Reference air line: This line provides compressor discharge pressure to the fuel control unit (FCU). If this line leaks, the air pressure signal to the FCU is reduced or lost, resulting in the engine idling, or flaming out.

Based on the available evidence, the direct initiator of the engine power loss was the loose reference air line connected to the accumulator downstream from the power turbine governor (PTG). The reference air union was found loose at the accident site, and it was considered very unlikely that this would have loosened during the impact sequence.

In addition, a loose reference air union is consistent with the descriptions of the engine power loss. It would have vented air pressure from between the PTG and the fuel control unit, which the fuel control unit recognised as a signal to reduce fuel flow to idle. Reducing fuel flow to idle would have decreased the power generated by the engine.

In summary, the ATSB concluded that the loose union on the engine reference air line unscrewed in flight, creating a leak, and this leak resulted in a loss of engine power.

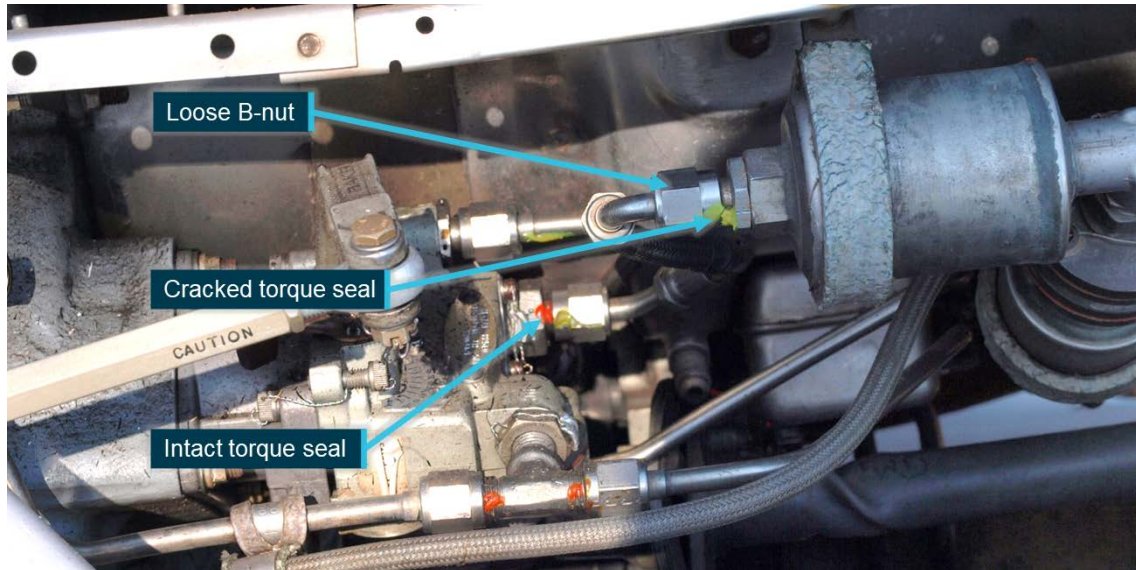
**Figure 6: Torque seal on air line unions as found on VH-FHW**

Orange torque seal had been applied to the several areas around the PTG, and these areas corresponded to the parts the engineer stated were manipulated when installing the PTG ( Figure 6). There was yellow torque seal applied where the loose reference air line was located and it was observed to be cracked following the accident (Figure 6). Yellow torque seal was also present on some other parts that were not manipulated during the last maintenance.

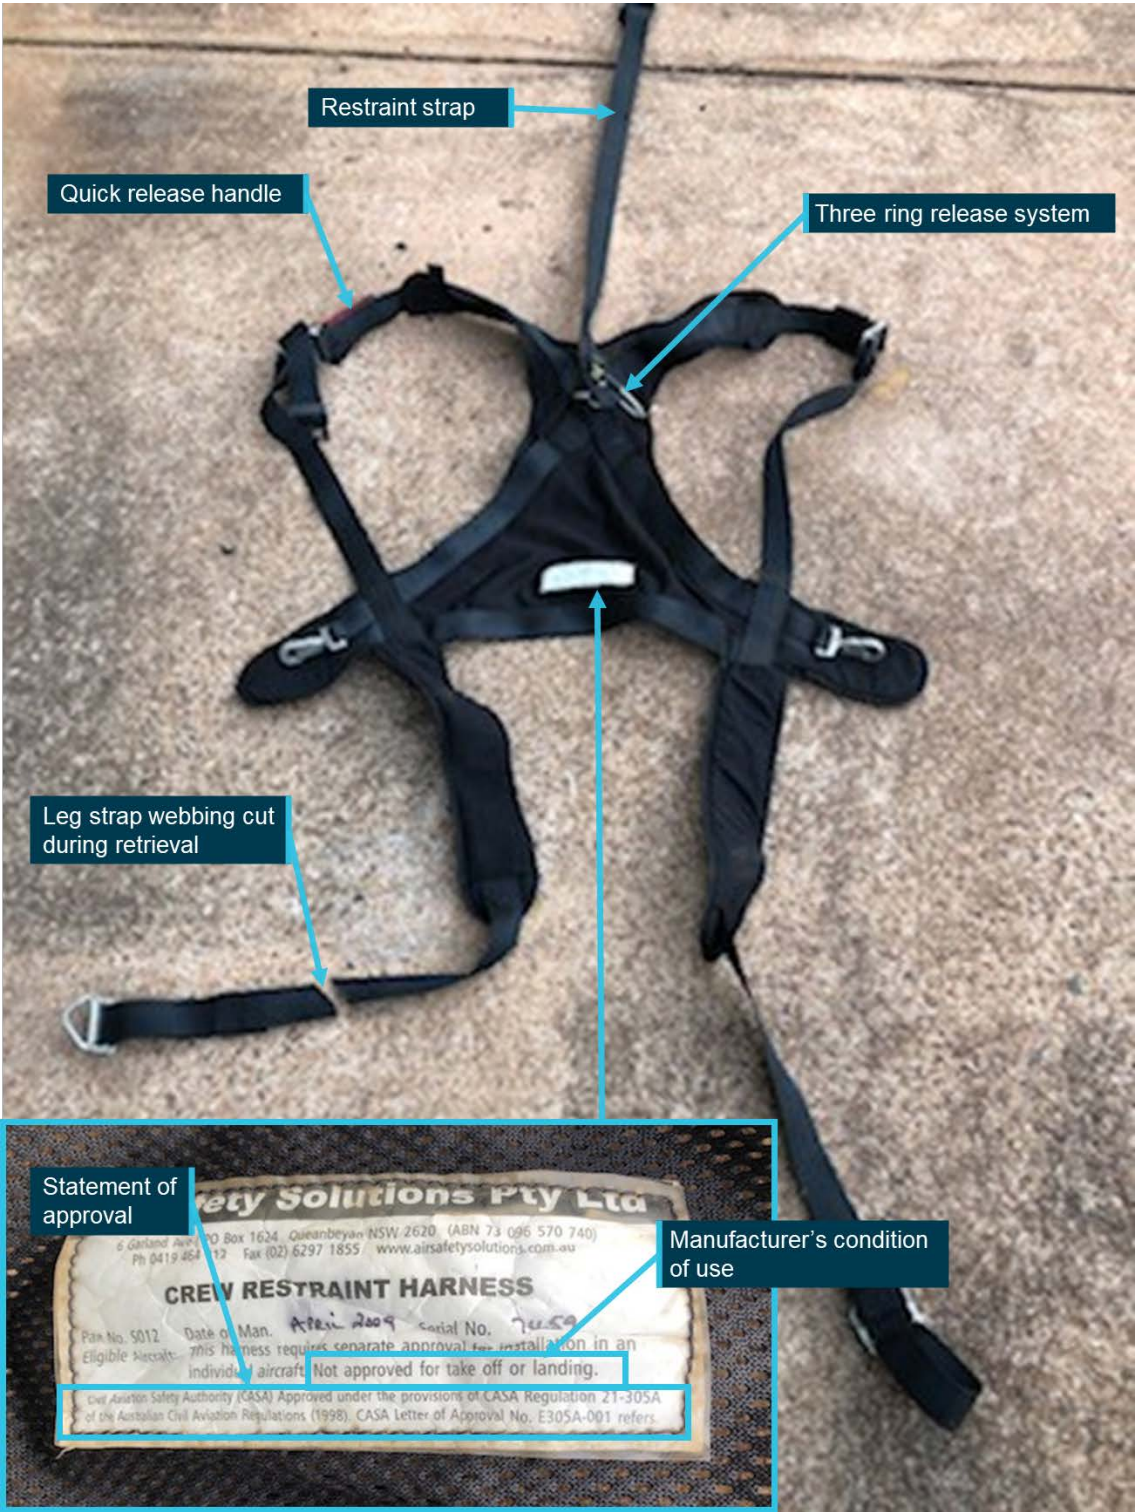
Figure 7: Shooter's harness, rear view

The harness used by the shooter did not fail in the accident sequence, though it was noted after the accident to be past its 10-year retirement date by 3 weeks (Figure 7). The operator took immediate steps to prevent third parties using expired equipment aboard their aircraft after discovering this post-accident.

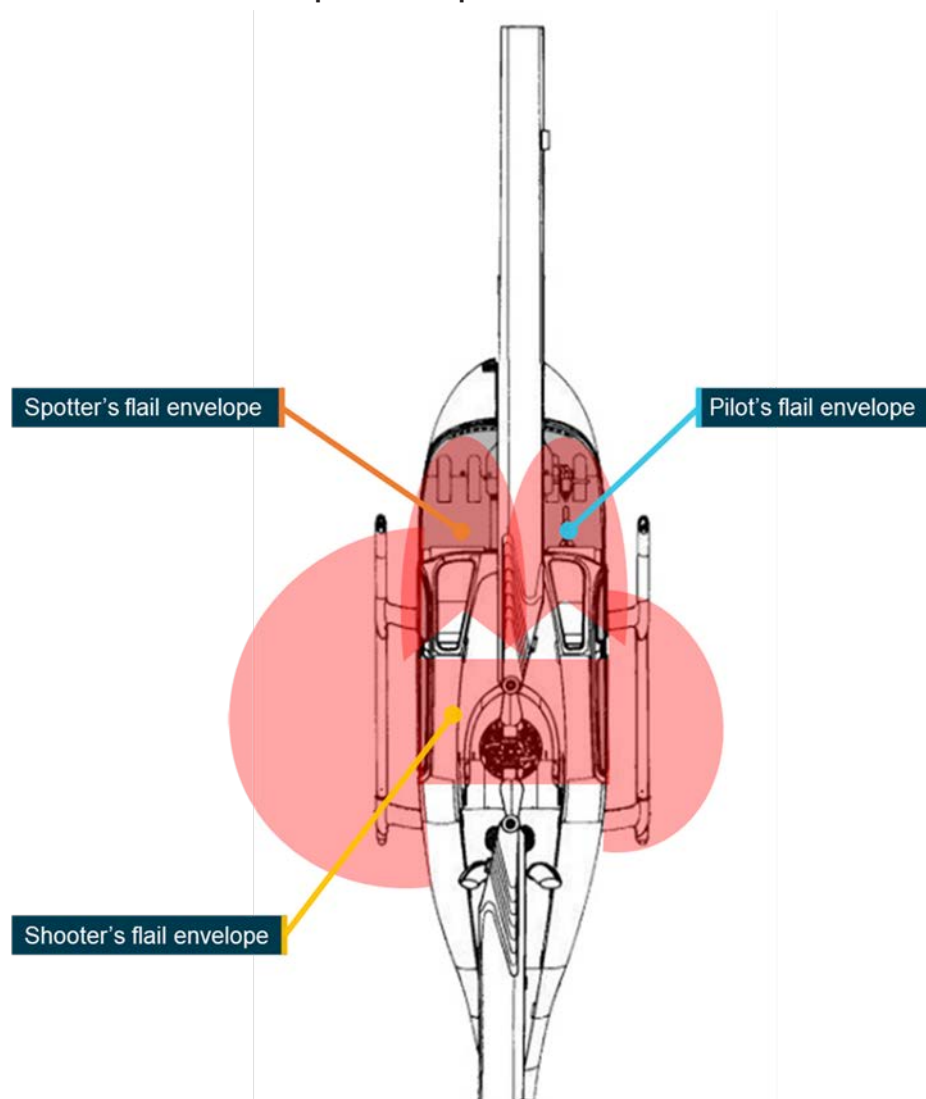
**Figure 10: Estimated flail envelope for occupants of VH-FHW**

In the event of an emergency (such as an impending impact), the shooter was required to throw their weapon out of the exit. The shooter advised that they understood this requirement. However, on this occasion they brought the live rifle into the cabin and pointed the barrel down.
