Collision with terrain involving Airbus Helicopters AS350B3e, VH-SZS

60 km east of Woomera Airfield, South Australia, on 20 March 2019

ATSB Transport Safety Report

AO-2019-015

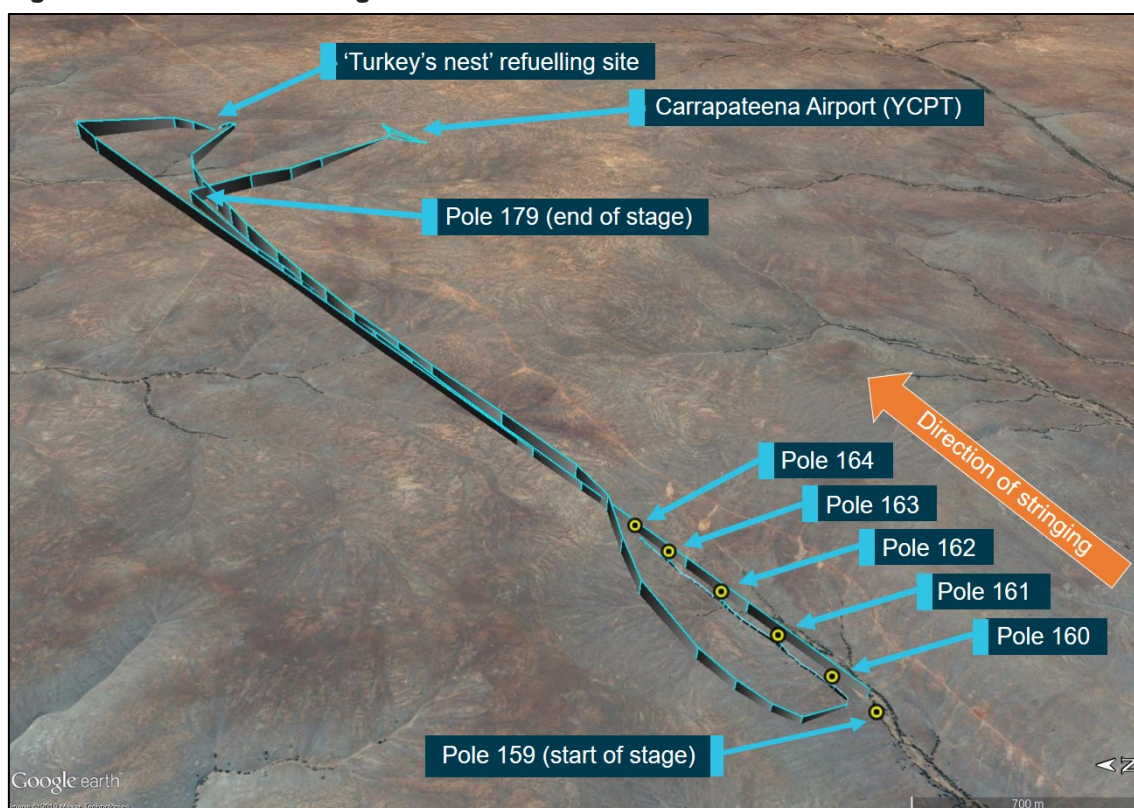
Figure 2: ADS-B³ derived flight data for VH-SZS on 20 March 2019.

Figure 2 Shows the ADS-B flight data for VH-SZS on the day of the accident.
Source: FlightRadar24 and Google Earth, annotated by ATSB.

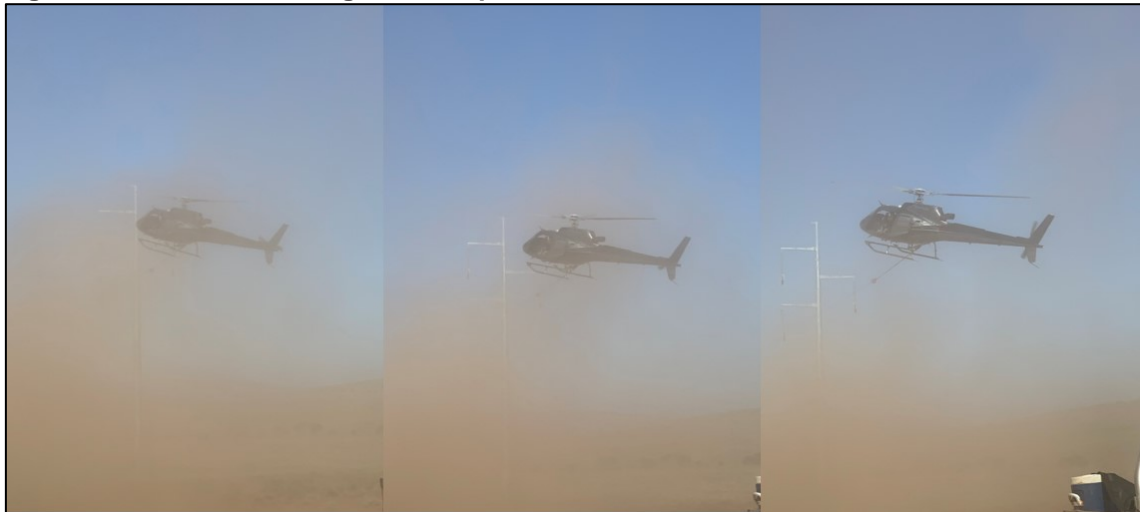
Figure 4: VH-SZS traversing between pole 163 and 164.

Additionally, the presence of a large amount of dust in the vicinity of the aircraft was noted by several witnesses. This can be seen in Figure 4, which shows a sequence of images of the aircraft traversing from pole 163 to pole 164.

Figure 4 shows VH-SZS traversing between pole 163 and 164. Pole 163 is visible in the image, while pole 164 is out of the frame to the right. The direction of travel is from left to right in this image.
Source: Witness

Analysis of the sun position and observations made on site indicated that the sun would have been in the general direction of the pilot's vision of pole 164. Although the pilot was wearing a helmet mounted visor at the time of the accident, sun glare, particularly in combination with dust, may have reduced visibility of the pole.

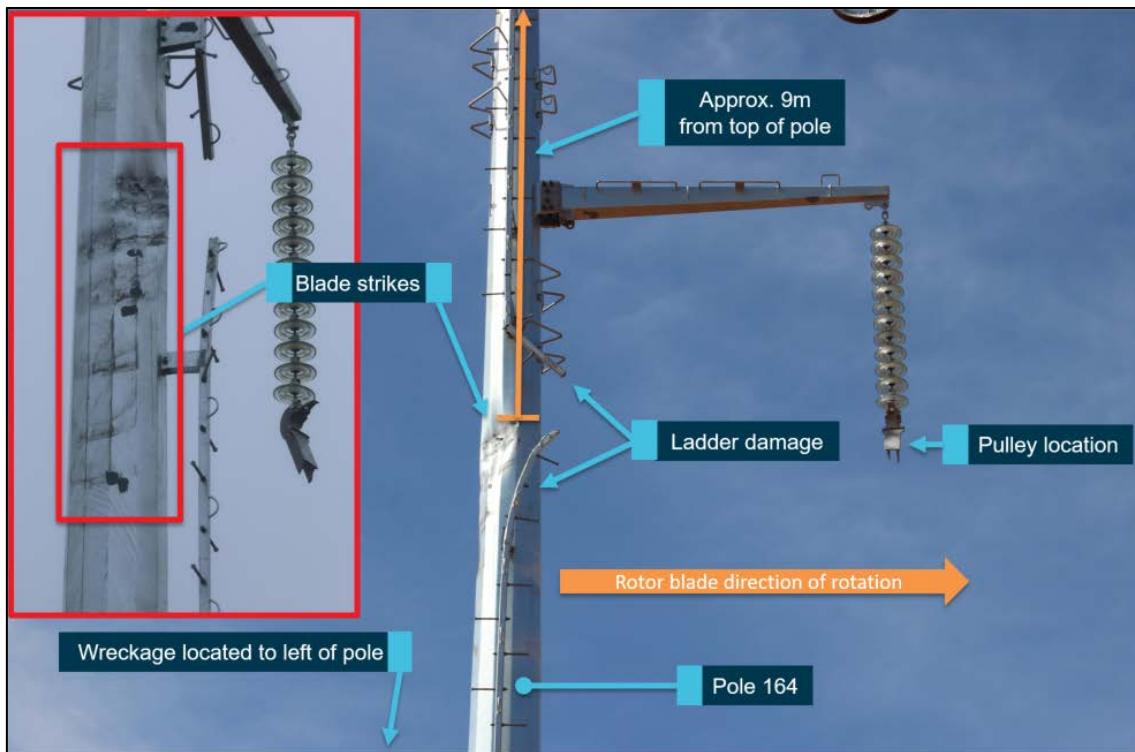
Figure 5: Impact marks and damage to pole 164.

Site and wreckage examination did not identify any aircraft defects or anomalies that might have contributed to the accident. Markings on pole 164 (Figure 5) indicated that the helicopter collided with the pole about 17 m above the ground. The main rotor blade (MRB) contacted the pulley mounted on the insulator, the ladder and pole during the accident sequence. The pulley fractured from its mounting bracket and came to rest on the access road, 15 m from the pole. The ladder was struck and bent toward the direction of the pulley, consistent with the direction of rotation of the MRBs. The pole had a number of MRB strikes, which progressed in a downward direction as the helicopter descended (inset in Figure 5).

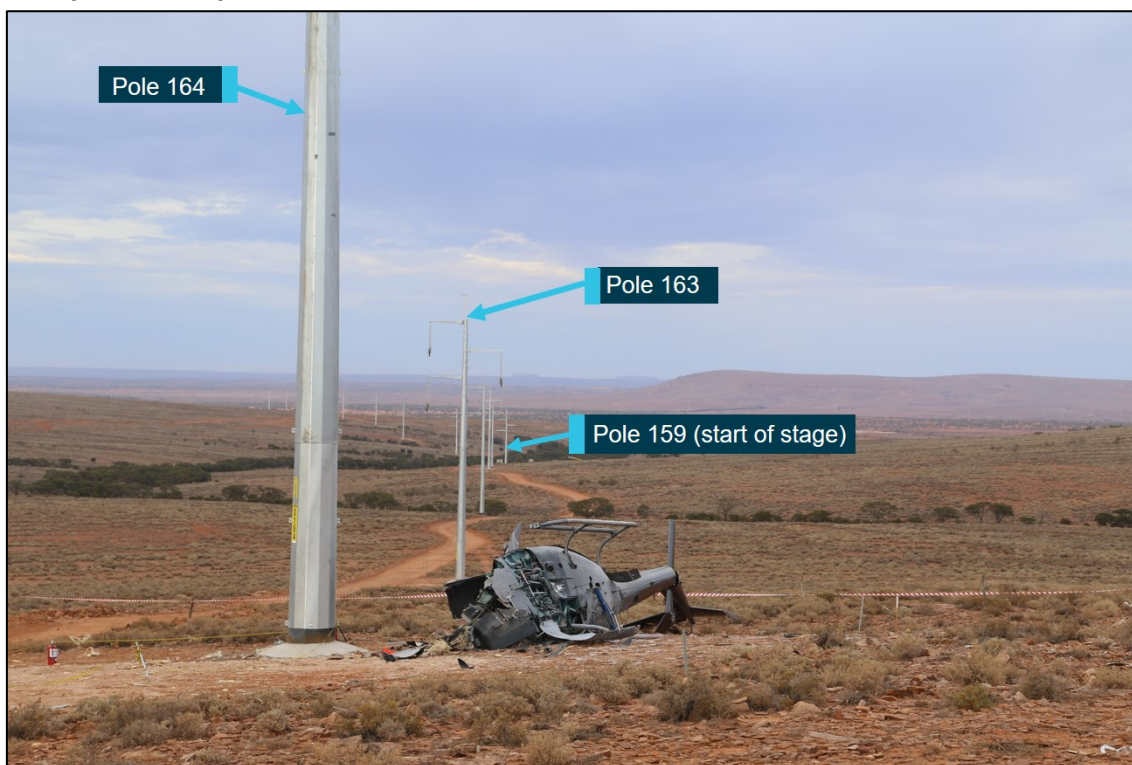
Figure 6: The accident site near pole 164. The direction of travel of the helicopter was from pole 163 to pole 164.

After impacting the pole, the helicopter came to rest on its right side approximately 2 m from the base of the pole (Figure 6). The aircraft had rotated approximately 90° to the left of its direction of travel.

The cockpit and fuselage roof were substantially disrupted from impact forces. The tail boom had almost entirely detached at the fuselage junction and fractured forward of the horizontal stabiliser, due to ground impact. Two of the MRBs had separated from the rotor head and came to rest side-by-side next to the fuselage. The third blade remained attached and had become entangled around the main rotor gearbox.

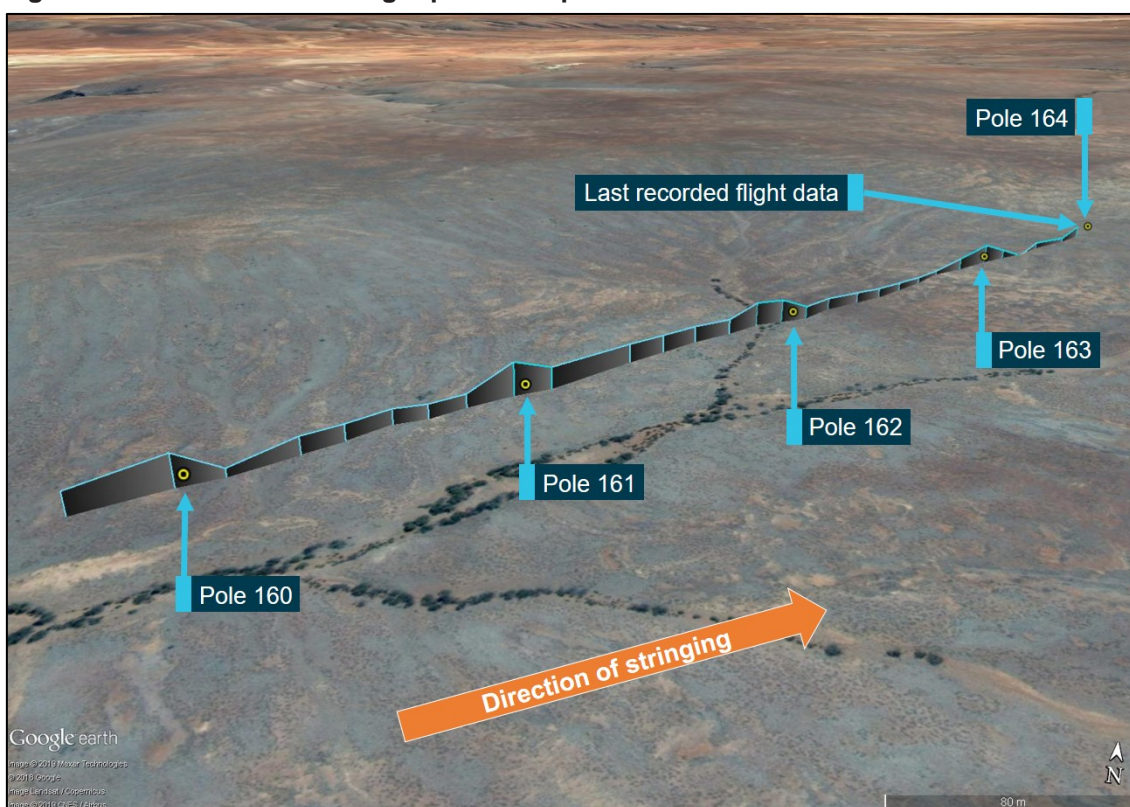
Figure 8: ADS-B data of the flight path from pole 159 to 164

This modified technique continued into tour 4 and was observed by a number of witnesses on the day of the accident. Witnesses stated that the helicopter never came above the height of pole 164 before colliding with it.

ADS-B data (Figure 8) from the day of the accident shows a flight path consistent with what was described by witnesses. The data shows that the aircraft maintained a low altitude between poles. Only once in close proximity to the next pole did the aircraft rise above the height of the pole. The data also shows the aircraft tracking to the left of the direct path and traversing around the pole rather than directly over it.
