VFR into IMC and loss of control involving Wittman Tailwind, VH-TWQ

Tooloom National Park, New South Wales on 12 January 2020

AO-2020-004

Final – 2 March 2021

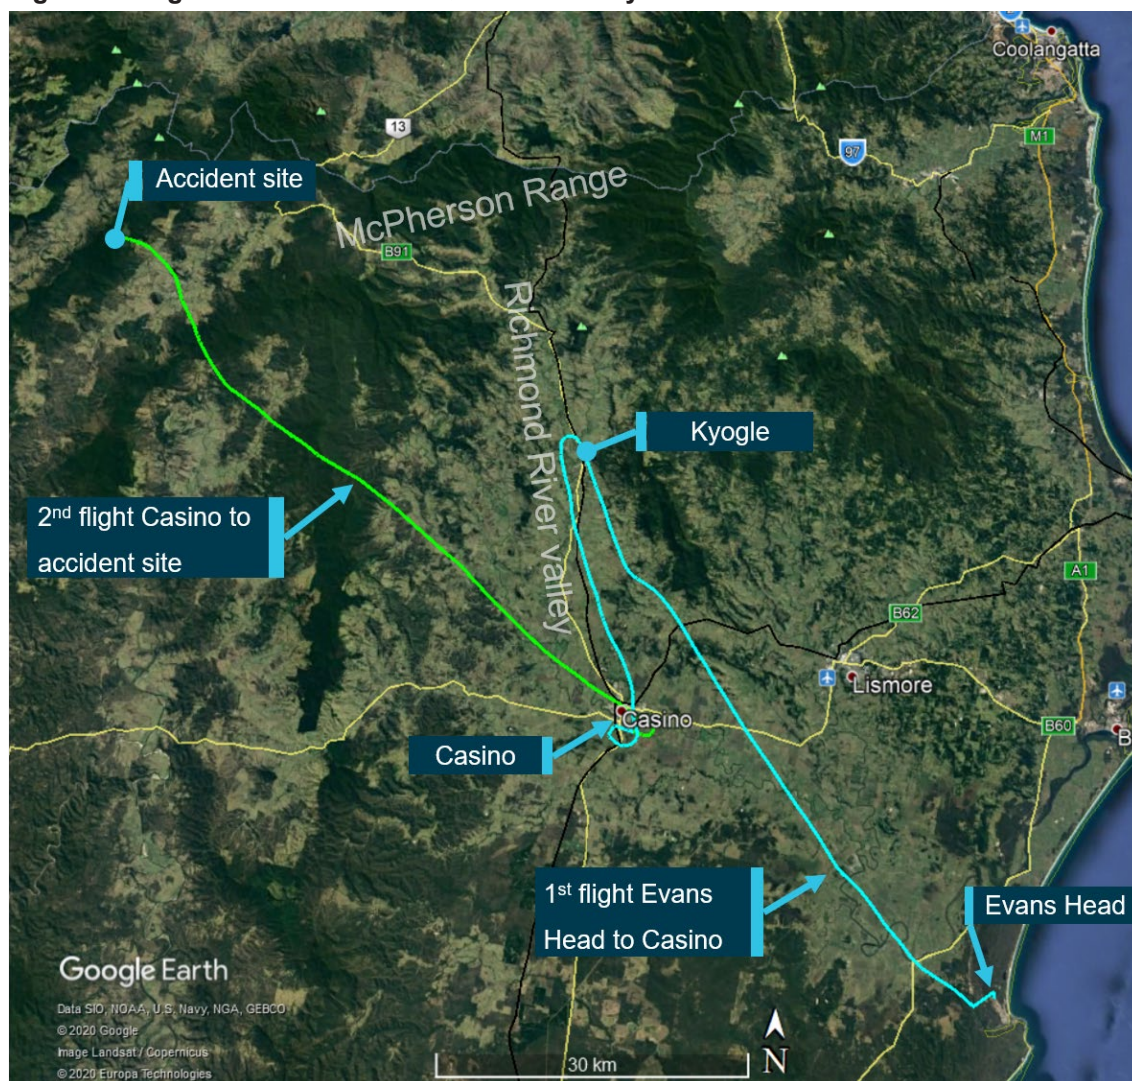
Figure 2 - Flight tracks for VH-TWQ on 12 January 2020

The pilot flew in a north-north-westerly direction towards Boonah via the Richmond River valley (Figure 2). The aircraft reached a maximum altitude of 1,950 ft above mean sea level³ just prior to

reaching Kyogle. At 1353, the pilot commenced a 180° turn overhead the township of Kyogle and diverted, likely due to low cloud on their intended flight path. At 1357 a family member contacted the passenger as they had seen the turnaround overhead Kyogle on OzRunways.⁴ The passenger replied to say they were 'going home due low cloud'. The pilot flew south back down the valley to Casino Aerodrome, landing at 1406.

At 1454, the pilot took off from Casino and flew in a west-north-westerly direction. At 1510 TWQ commenced a series of rapid descents and climbs, between 3,100 and 4,000 ft, followed by a left descending turn. Shortly afterwards TWQ collided with terrain. The pilot and passenger were fatally injured, and the aircraft was destroyed. There were no witnesses to the accident.

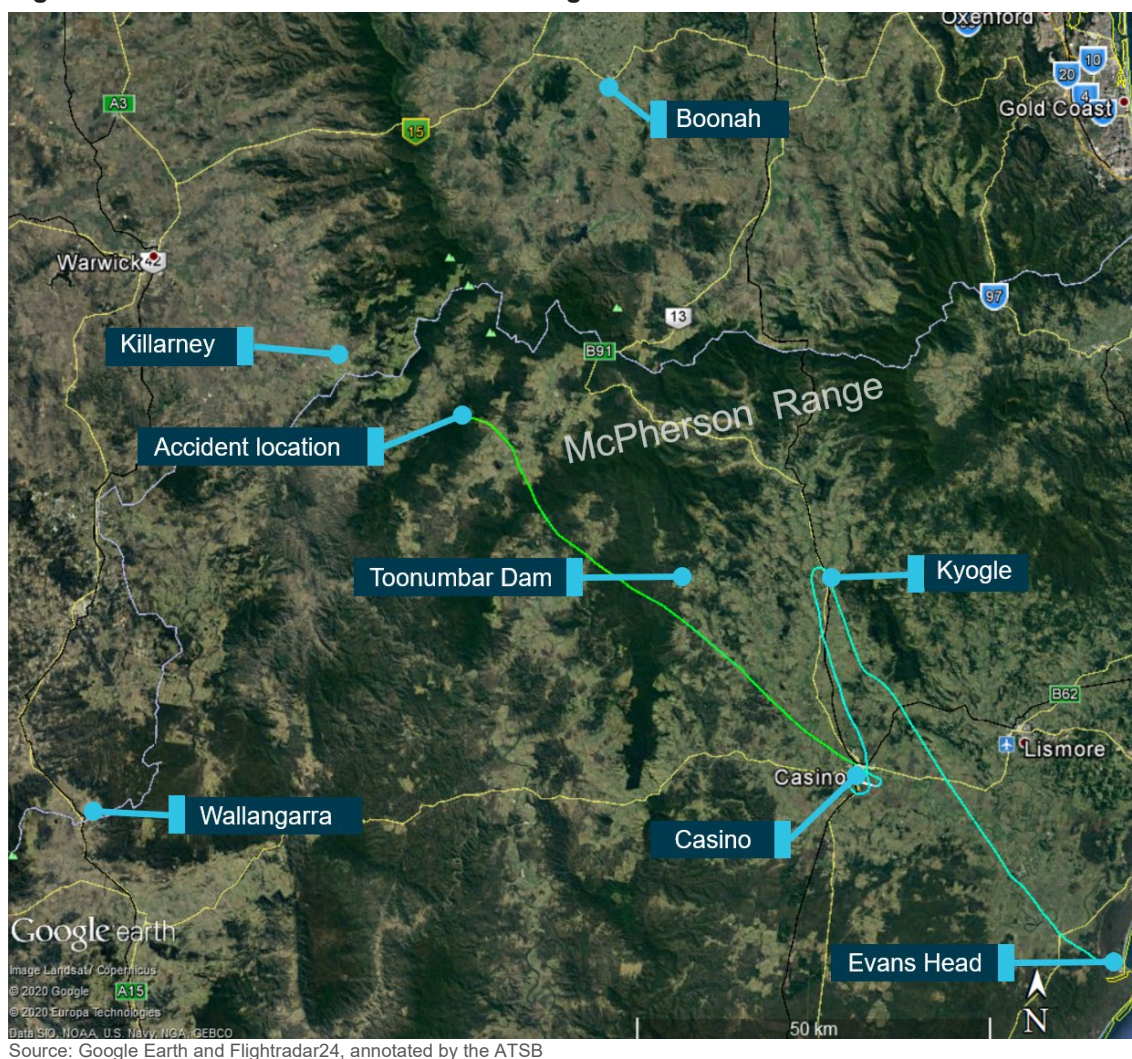
Figure 4 - Accident site and McPherson Range

The flight from Evans Head to Boonah required the pilot to cross the McPherson Range (Figure 4). The McPherson Range is a spur of the Great Dividing Range, heading in an easterly direction from near Wallangarra, Queensland, to the coast. It also forms part of the border between New South Wales and Queensland.

Terrain across the range varies in altitude with several areas above 3,000 ft and some peaks above 4,000 ft.

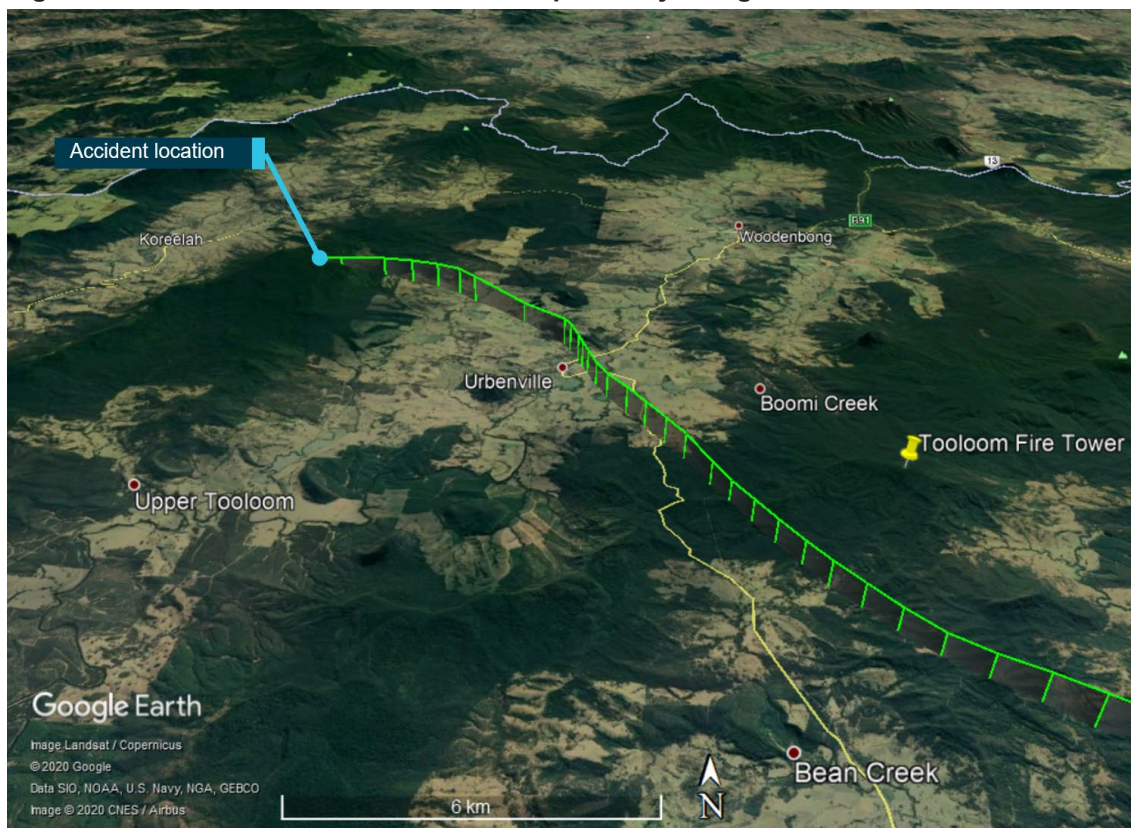
Figure 5 – Tooloom fire tower location and proximity to flight track

An observer was positioned in the tower on 12 January from 0900 to 1500 and recorded weather conditions on the hour. Throughout the day, visibility remained at 0 km, with the cloud recorded as 8 oktas. In addition, the relative humidity was recorded at 98 per cent or above throughout the day. The wind was from the south-south-east around 9 kt with an average gust of 19 kt.

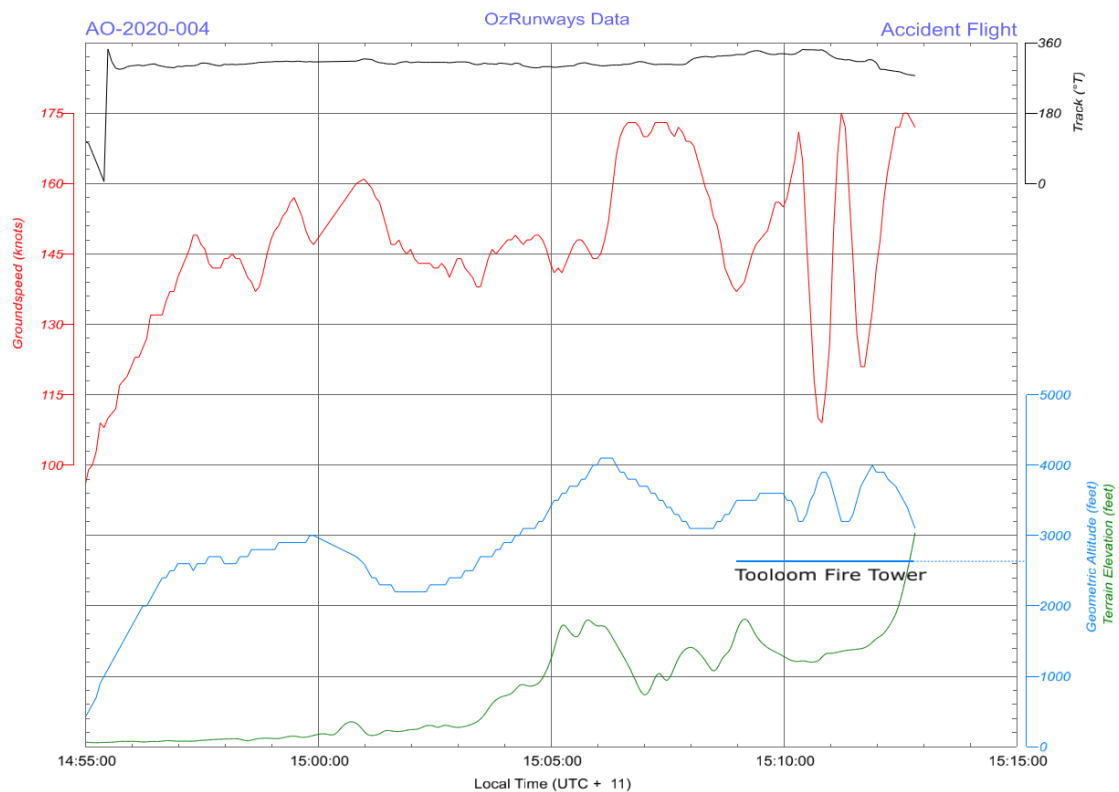
Figure 6 - OzRunways data and terrain elevations for the final flight of TWQ

Figure 5 shows the aircraft's flight data from OzRunways. Groundspeed is annotated in red, altitude in light blue and track in black. The altitude of Tooloom fire tower is also marked in blue. This line starts from the time where TWQ was abeam the fire tower. Terrain directly underneath the flight path is marked in green.

this area is approximately 1,800 ft high. At about 1506, the aircraft reached a maximum altitude of 4,100 ft then entered a 600 ft/min descent where the groundspeed rapidly increased from 145 kt to 173 kt. It is likely that the pilot initiated the climb to clear terrain and then descended when the cloud conditions became unsuitable. This climb took TWQ above the forecast and observed cloud heights in the area, which indicated a cloud base of around 2,600 - 2,800 ft. The descent levelled out at 3,100 ft, and the terrain underneath was about 1,430 ft, allowing the pilot to continue the descent a further 1,670 ft and remain clear of the terrain, if the pilot was visual with terrain. It is possible that the pilot entered an area of deteriorating visibility at this time leading to the rapid descent and level off well above terrain.
