Near hit with rail worker by passenger train 283D

Dora Creek, New South Wales on 9 May 2020

Rail Occurrence Investigation

RO-2020-006

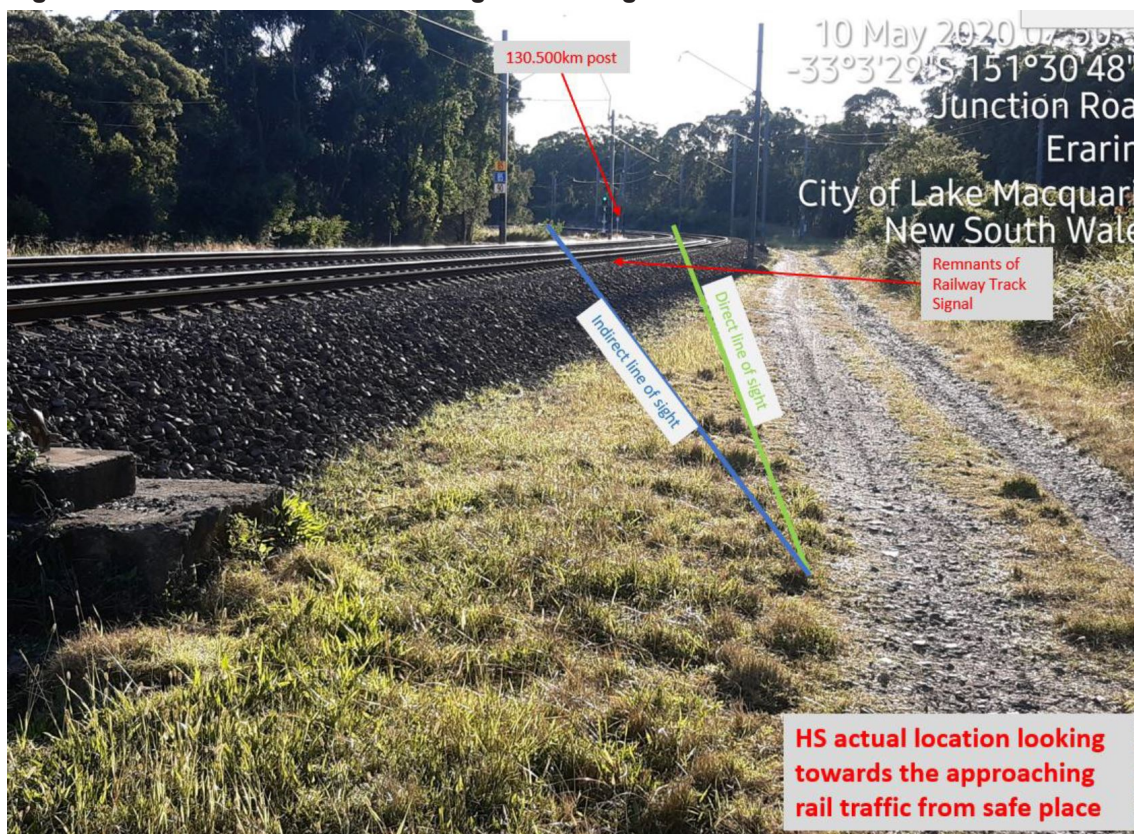
Figure 2: View from the outer handsignaller's original location

The location of the OHS was noted on the WPP as at 130.500 km, however the position the OHS adopted after relocation at 0900 was closer to 130.380 km.

The OHS decision to relocate was made without consultation or knowledge of the PO and placed the OHS slightly within the required 2500 m distance to the inner handsignaller, who was located at 128.000 km. This is a technical breach of NPR 702, however there is no evidence to suggest it had an adverse effect on the worksite protection.
