# Pilot incapacitation and collision with terrain involving Kawasaki Heavy Industries BK117, VH-JWB

9 km west of Ulladulla, New South Wales, on 17 August 2018

## **ATSB Transport Safety Report**

AO-2018-057

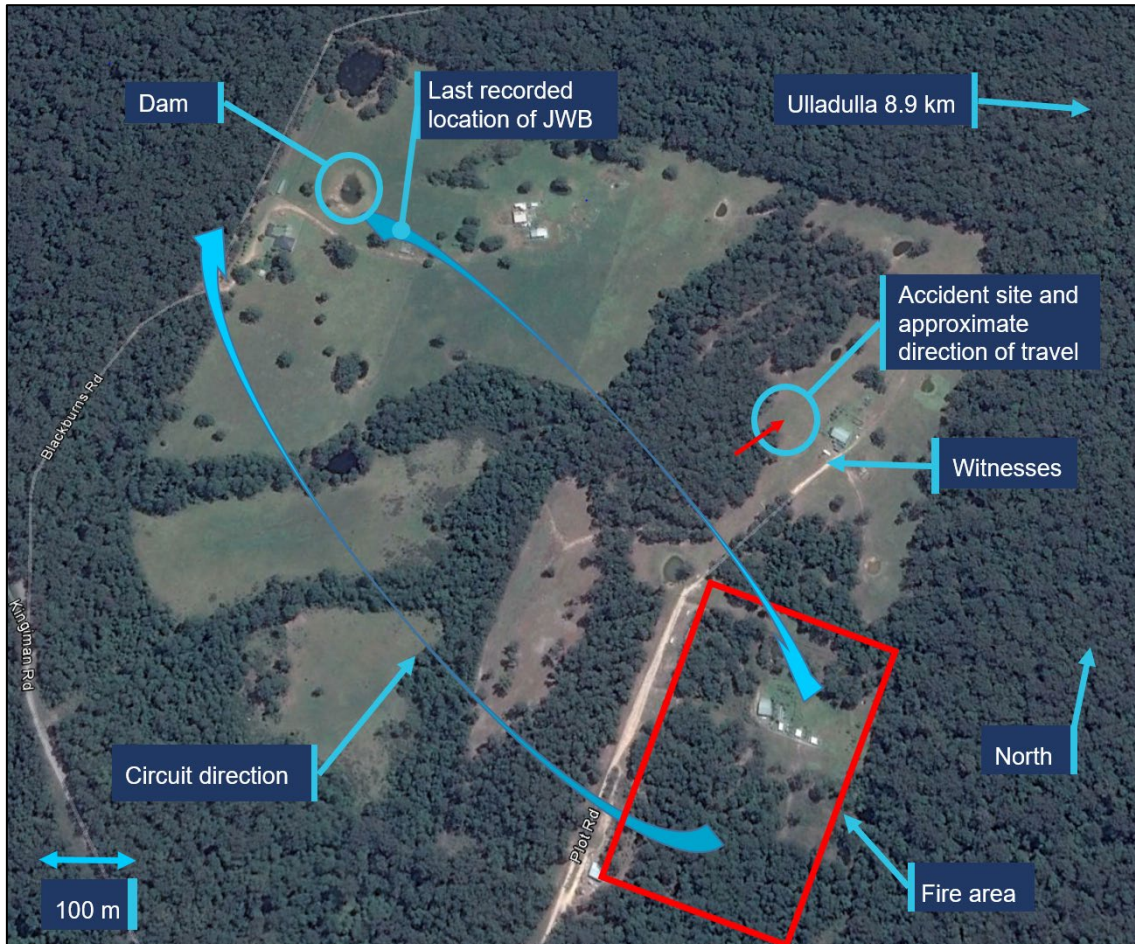
**Figure 2 - Area of operations**

Figure 2 shows the area of operations with circuit direction arrows that are indicative of the average track of JWB during the previous 4 circuits.

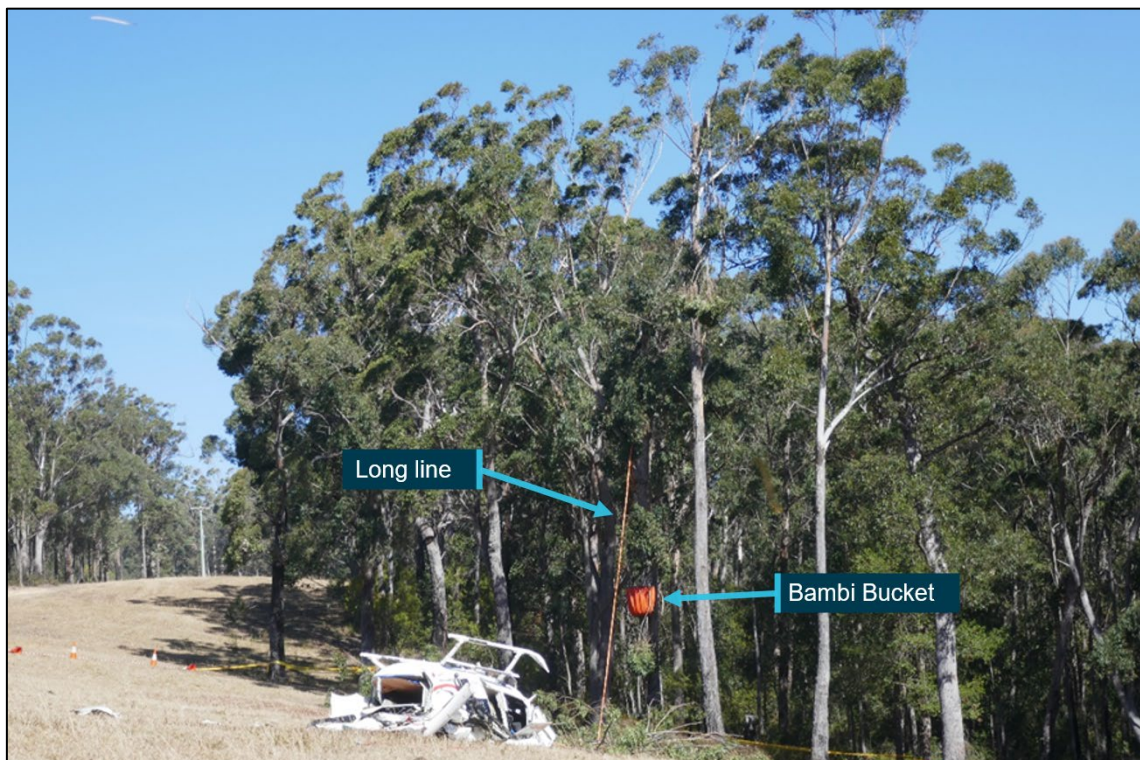
**Figure 3 - Accident site and wreckage**

The main cabin of the helicopter was found inverted in a clearing with the bucket and longline still attached (Figure 3). The bucket and longline were caught in a 22 m tall tree at the edge of the clearing.

Rub marks from the longline were found on the trunk of the tree that the bucket was hanging from. These marks indicated the bucket snagged the tree at least 13 m down from the top of the tree.

In the later part of the circuit the helicopter bucket would normally have a minimum of 6–9 m clearance above the tree tops. Taking this into account, and the tree contact 13 m below the canopy, the bucket was at least 19–22 m lower than expected when it snagged the tree and brought the helicopter down.
