# Fuel exhaustion and forced landing involving Cessna 441, VH-LBY

39 km east-south-east of Broome Aerodrome, Western Australia on 2 March 2018

## **ATSB Transport Safety Report**

AO-2018-019

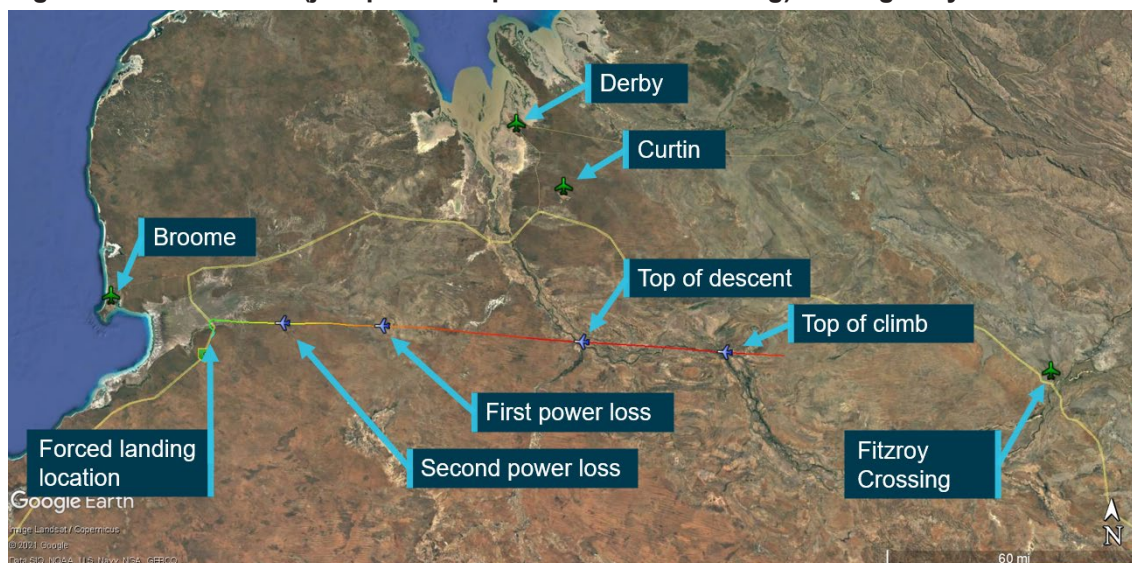
**Figure 1: Aircraft track (just prior to top of climb until landing) and highway**

The pilot landed the aircraft safely on the highway approximately 21 NM east-south-east of Broome without injuries or aircraft damage (Figure 1).

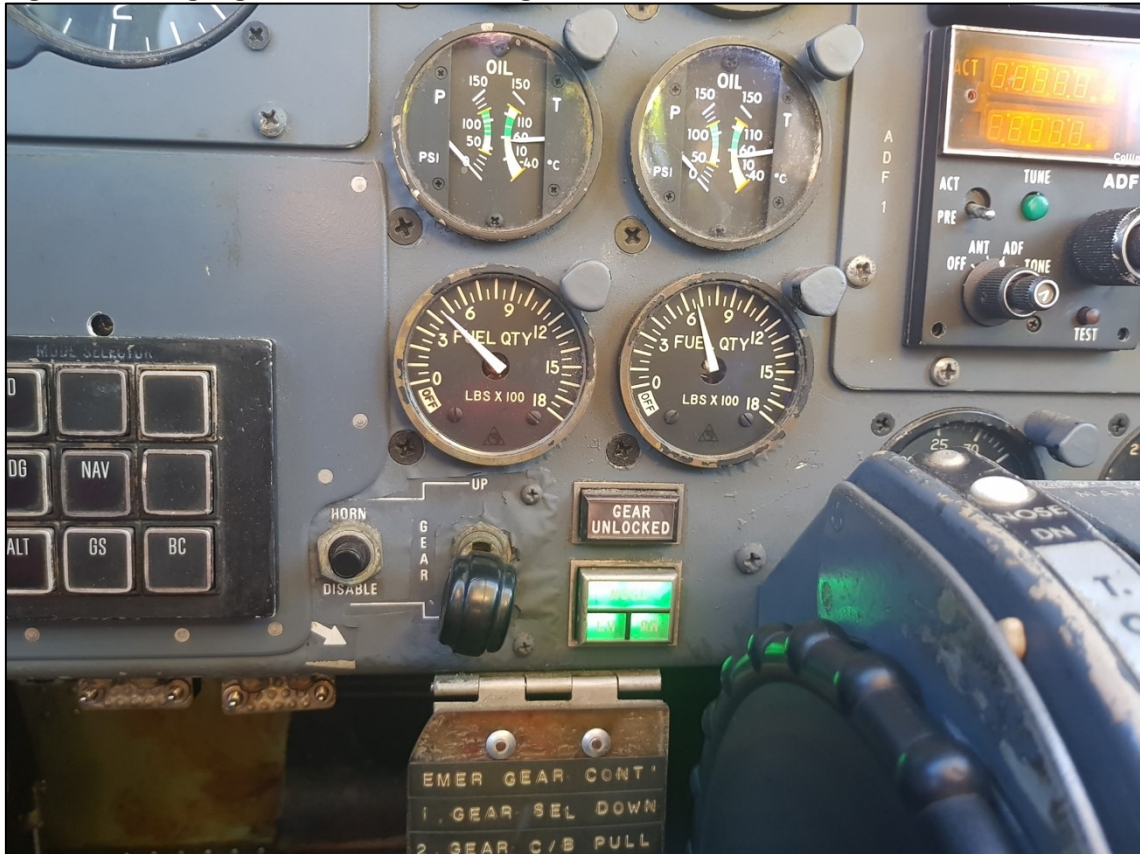
**Figure 2: Fuel gauges after forced landing**

The image shows the fuel gauges indicating a total of about 1,120 lb of fuel on board, about 1 hour after landing on the highway. With the addition of fuel calibration card corrections, the indicated amount should have represented 1,220 lb.  
Source: Pilot of VH-LBY following occurrence flight

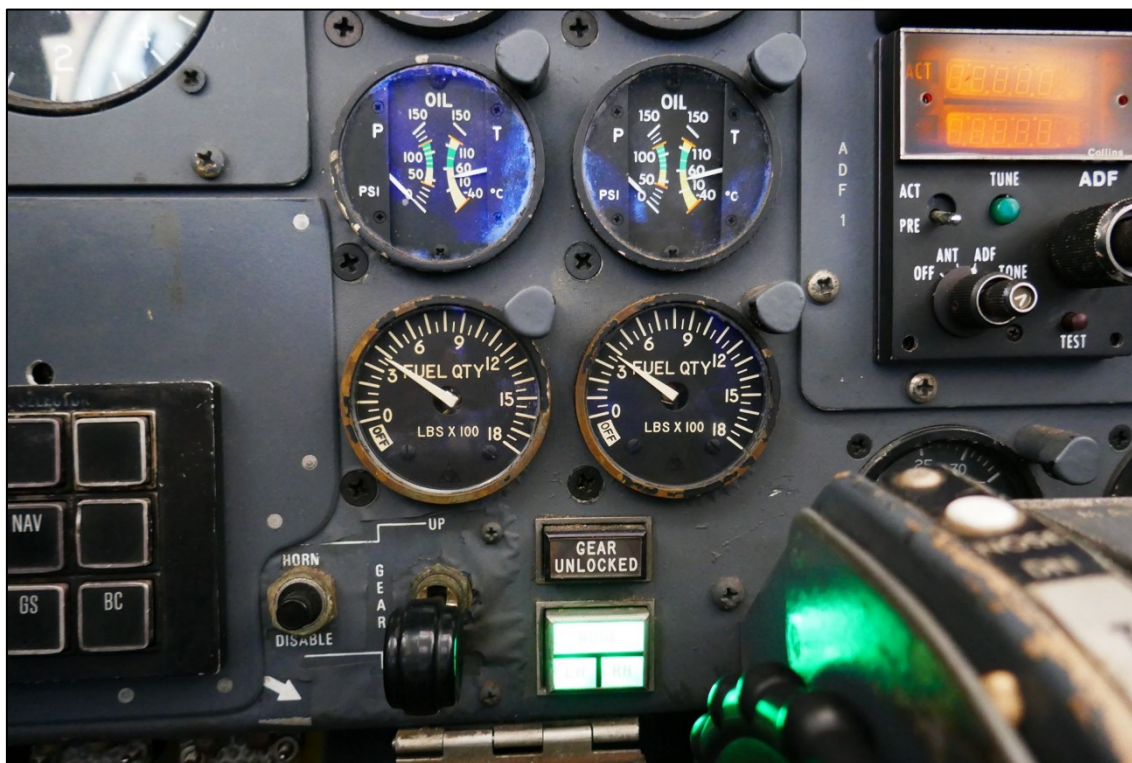
**Figure 3: Fuel quantity gauges after defueling in Broome**

If a contaminant is in contact with the probes, then the quantity indications will be altered based on the capacitance property of that contaminant. Water has a much higher dielectric constant than fuel. Therefore, the presence of water on the probes would likely cause an over reading of the fuel quantity.

On arrival in Broome, all usable fuel was drained from the aircraft by diverting boost pump output into drums. Accounting for the quantity of fuel added on the highway and consumed during the ferry flight, the operator estimated there was little or no usable fuel on board the aircraft at the time of landing on the highway. The operator also noted that the fuel quantity gauges indicated 370 lb per tank even though all the usable fuel had been drained (Figure 3).

*The image shows the fuel gauges indicating 370 lb per tank, though all usable fuel had been drained from both tanks.*  
Source: ATSB

Inspection of the tank interiors showed significant water beading on the internal surfaces and on the fuel quantity probes. A grey substance, later identified as fungus, was also observed in the tanks, although not on the probes.

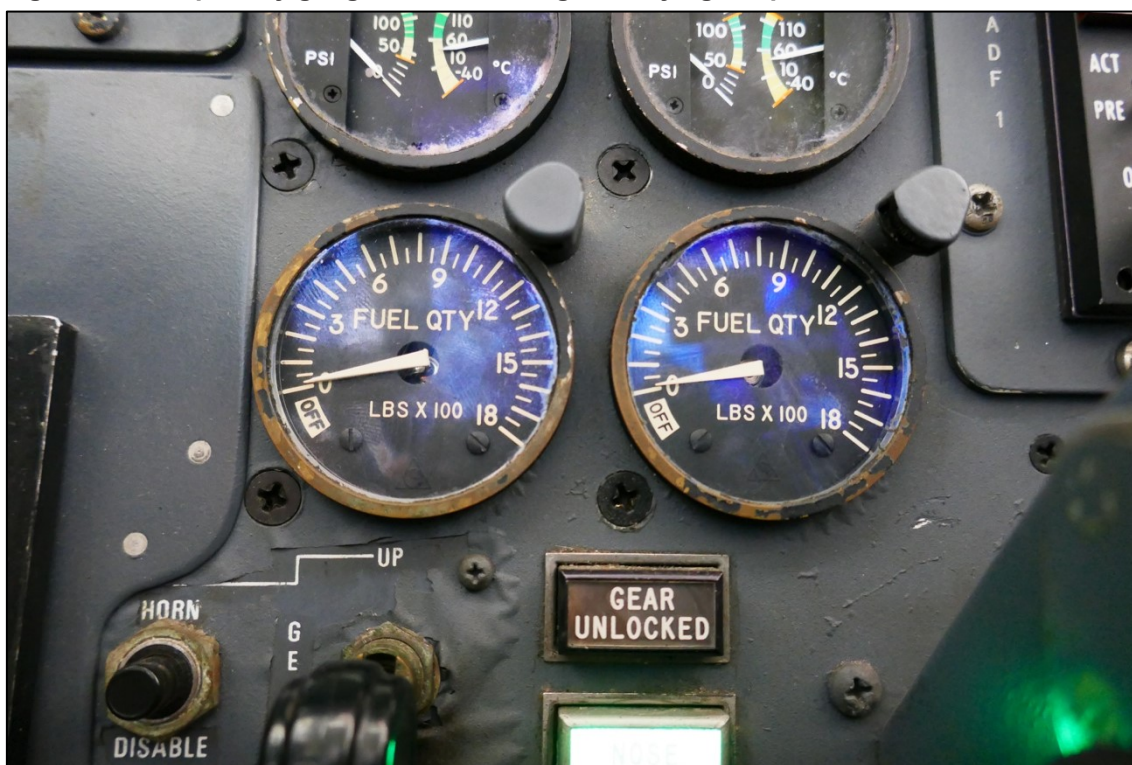
**Figure 4: Fuel quantity gauges after cleaning and drying the probes**

When tested, the probes did not conform to capacitance specifications. The probes were cleaned and dried overnight. When retested, the probes passed the capacitance test, and the fuel quantity gauges indicated the correct zero fuel state (Figure 4).

*The image shows the fuel gauges indicating zero usable fuel on board, following cleaning and drying of the fuel quantity probes.*  
Source: ATSB

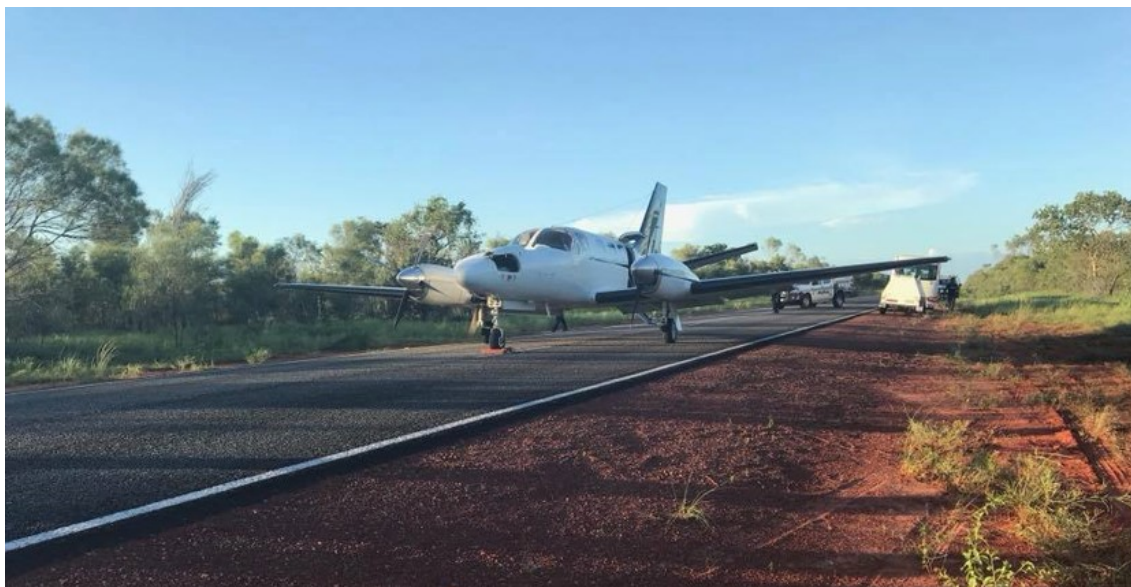
**Figure 5: The emergency landing area**

The emergency landing area was a single carriageway road with two-way traffic. The road was only just sufficiently wide for the aircraft to land on (Figure 5). For comparison, the runway at Broome Airport is 45 m wide and other aerodromes the operator used C441 aircraft normally had runways of 30–45 m wide (and occasionally a narrow runway of 23 m wide). The wingspan of a C441 is about 15 m.
