Loss of control and collision with water involving Bell UH-1H helicopter, VH-UVC

5 km south-west of Anna Bay, New South Wales, on 6 September 2019

ATSB Transport Safety Report

AO-2019-050

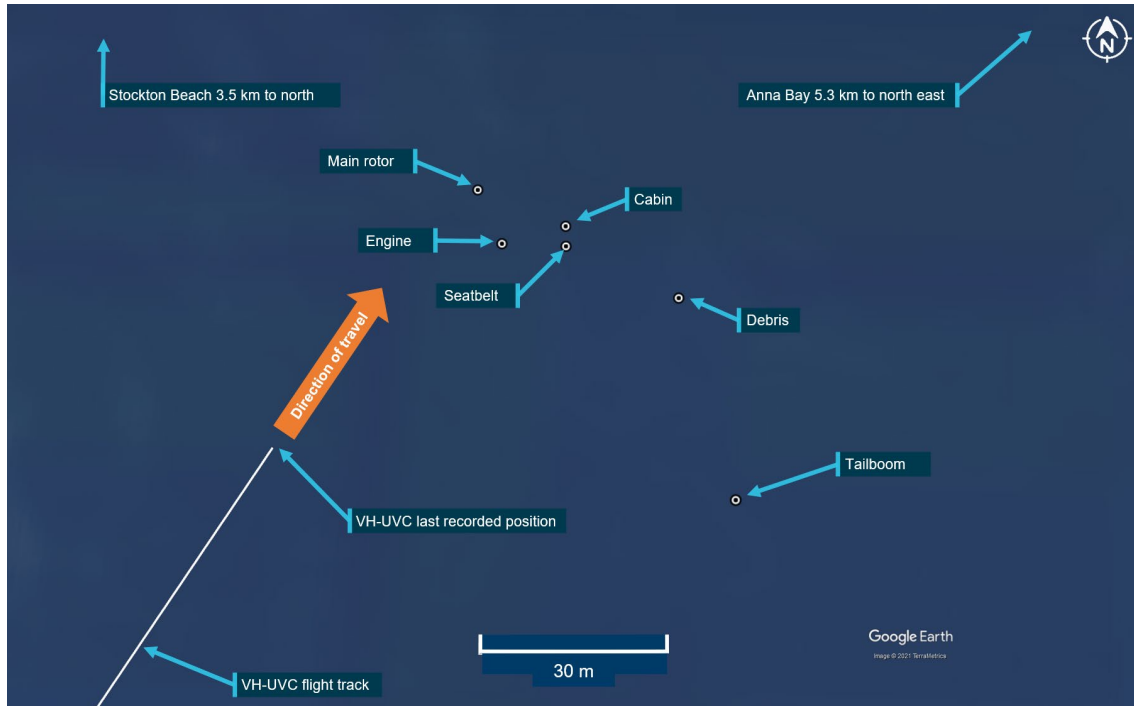
Figure 5: Map showing relative positions of helicopter wreckage on the ocean floor relative to UVC's flight path

A Royal Australian Navy vessel tasked to assist the search, located the helicopter wreckage field about 3.5 km offshore, in about 30 metres of water. NSW police divers located parts from the helicopter and provided the ATSB with a series of location coordinates from a GPS-enabled dive camera. The positions of the helicopter parts were mapped to show their relative positions on the ocean floor (Figure 5).

The heaviest items, including the main rotor system and the engine, were located within 10 metres of each other. Other debris and parts of the cabin were also nearby. The tailboom was located about 51 metres to the south-east of the engine's position.

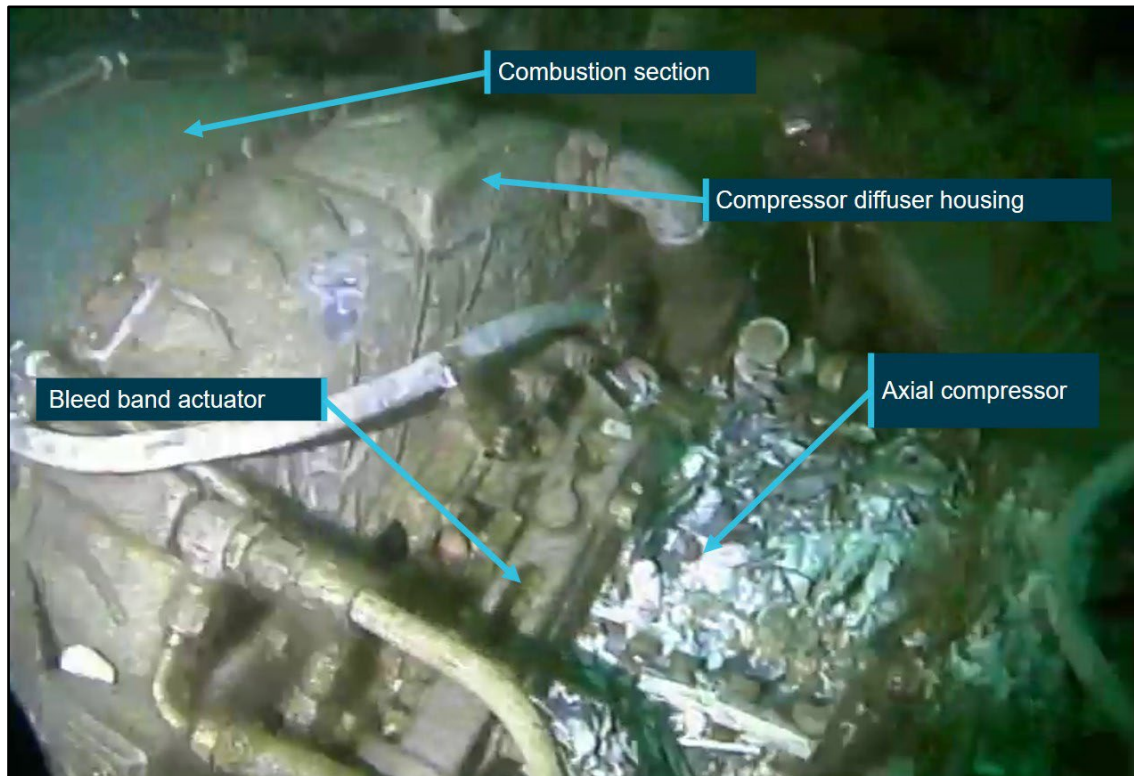
Figure 6: Engine from VH-UVC located within the wreckage field

The engine was located on the ocean floor in the vicinity of the main rotor system and the cockpit and cabin remains (Figure 5). The engine was intact, with the exception of the exhaust pipe. It was not possible to determine the integrity of the engine, or its serviceability from available imagery, however no obvious defects were identified.

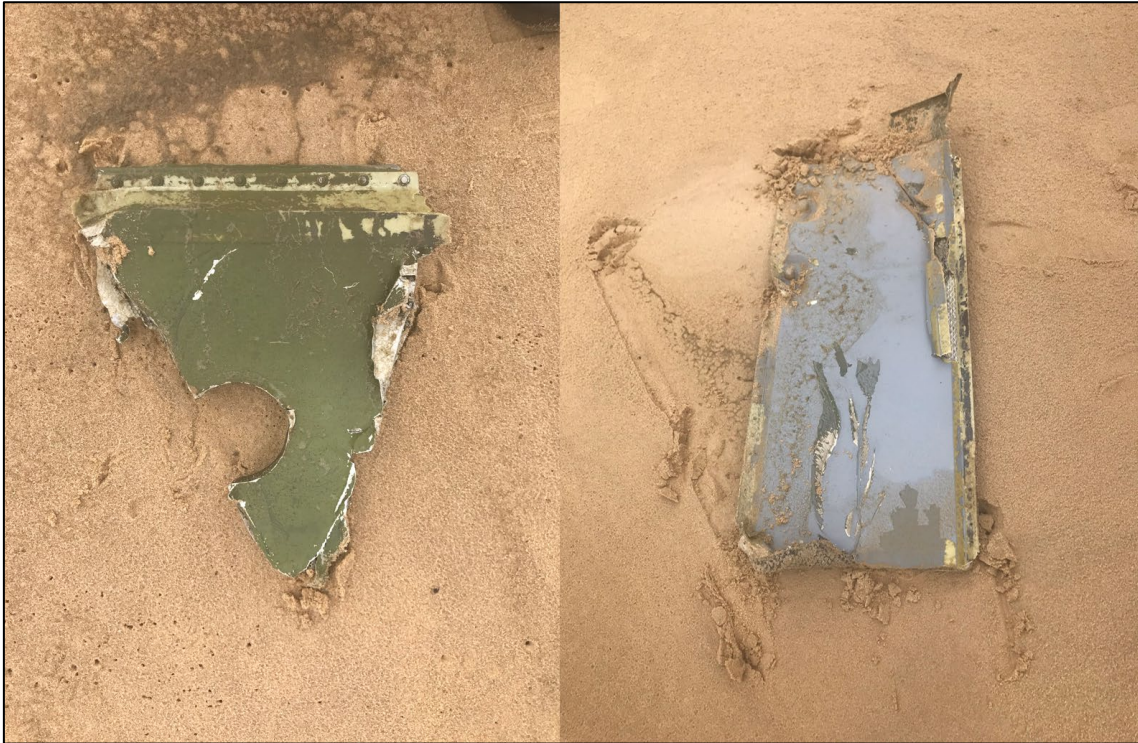
Figure 7: Items of honeycomb construction found on Stockton Beach, probably from UVC

Two other pieces were found and reported to NSW police on 18 September 2019. They were also of honeycomb construction (Figure 7) and were found at separate locations on Stockton Beach, NSW. The construction and paint colour of the panels were similar to structural panels used in UVC, however no features specifically linking the items to UVC were identified.

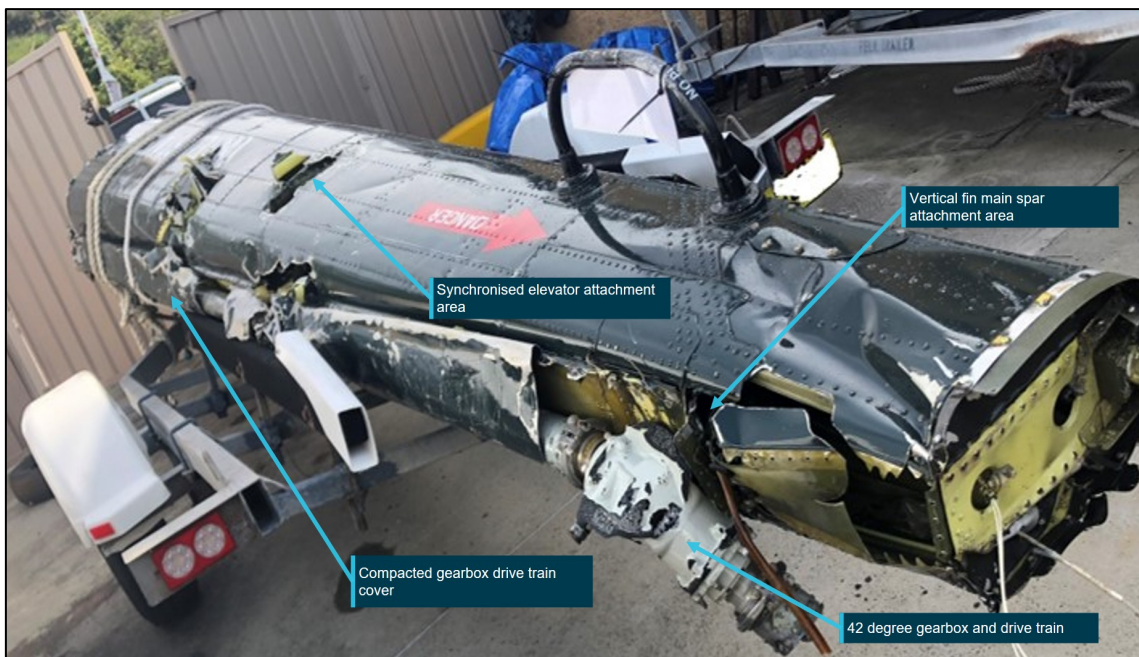
Figure 8: VH-UVC tailboom following recovery from the ocean floor

UVC's tailboom was retrieved by NSW police divers and made available to the ATSB for examination. The tailboom (Figure 8), without the vertical fin, synchronised elevators, tail rotor gearbox and tail rotor assembly (Figure 3), had separated at the fuselage rear bulkhead due to overstress failure of the rear fuselage structure.

Internally, the remains of the synchronised elevator control system and the tail rotor pitch control systems were present. Failures of the control tubes and cables were attributed to overstress. Examination of the tailboom did not identify any pre-existing defects likely to have influenced the accident sequence.

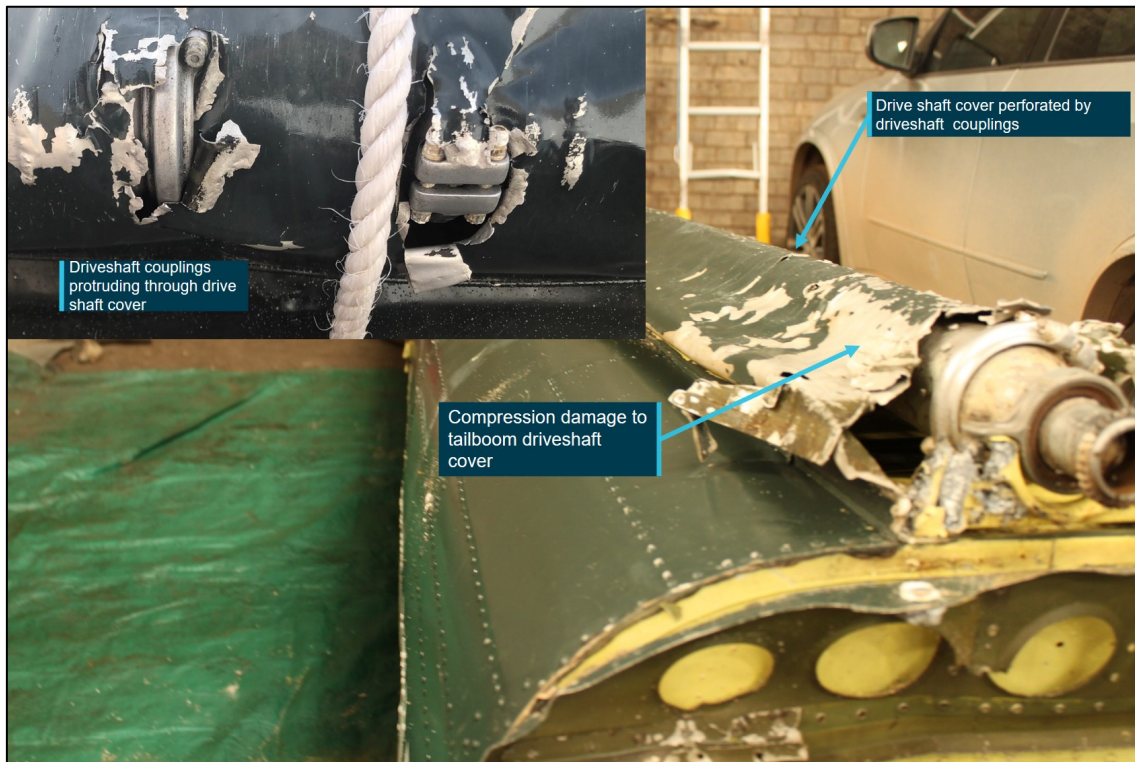
Figure 9: Tailboom driveshaft cover with inset showing driveshaft coupling imprints

The tail rotor drive train from the rear fuselage tailboom junction to the 42° gearbox was also present. Compression damage to the tailboom driveshaft cover was consistent with water impact. Drive shaft coupling imprints were noted on the cover (Figure 9). The imprints were consistent with the driveshaft not rotating at the time of impact. However, rotational damage signatures were also present at either end of the recovered tail rotor drive train. Additionally, multiple contact marks were evident on the side of the boom in the vicinity of the synchronised elevator attachment points. Those marks were consistent with repeated movements of the elevators.

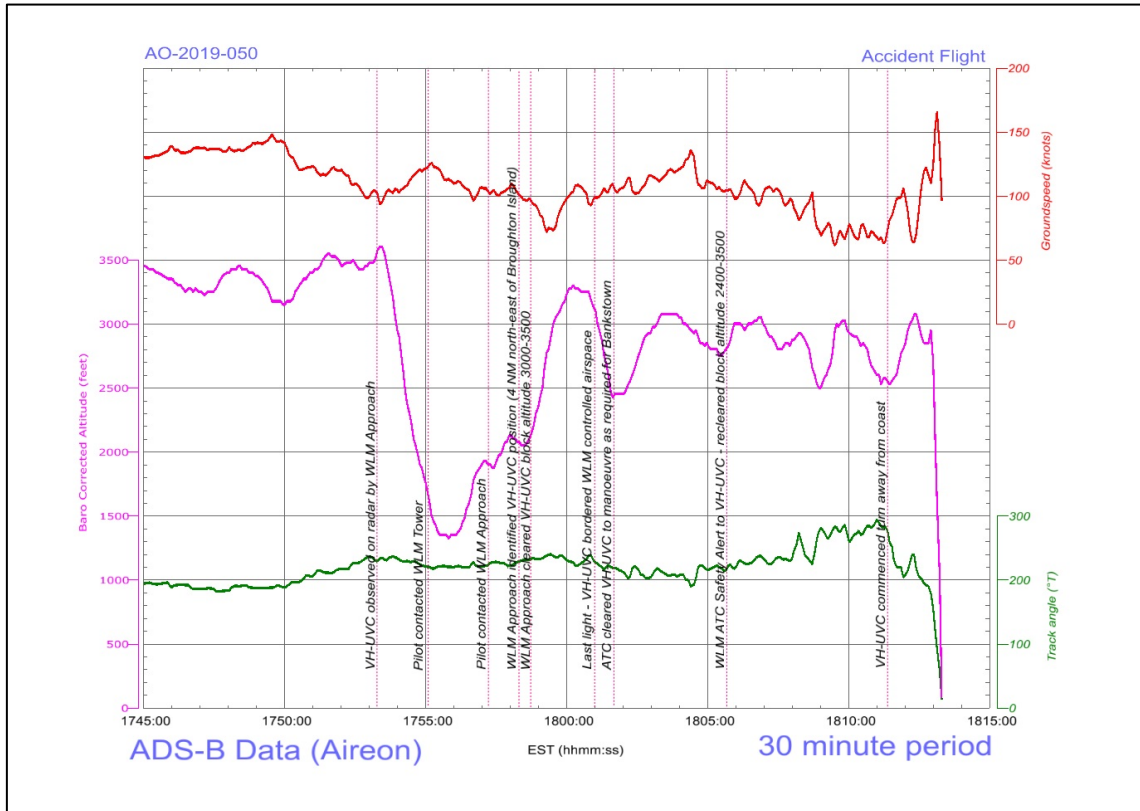
Figure 13: UVC flight parameter variation over the final 30 minutes

- the average variations in altitude increased by a factor of 2 compared to daylight operation.
- excluding what appeared to be a deliberate turn by the pilot at about 1809, the average variations in track increased by a factor of 3 compared to daylight operation.

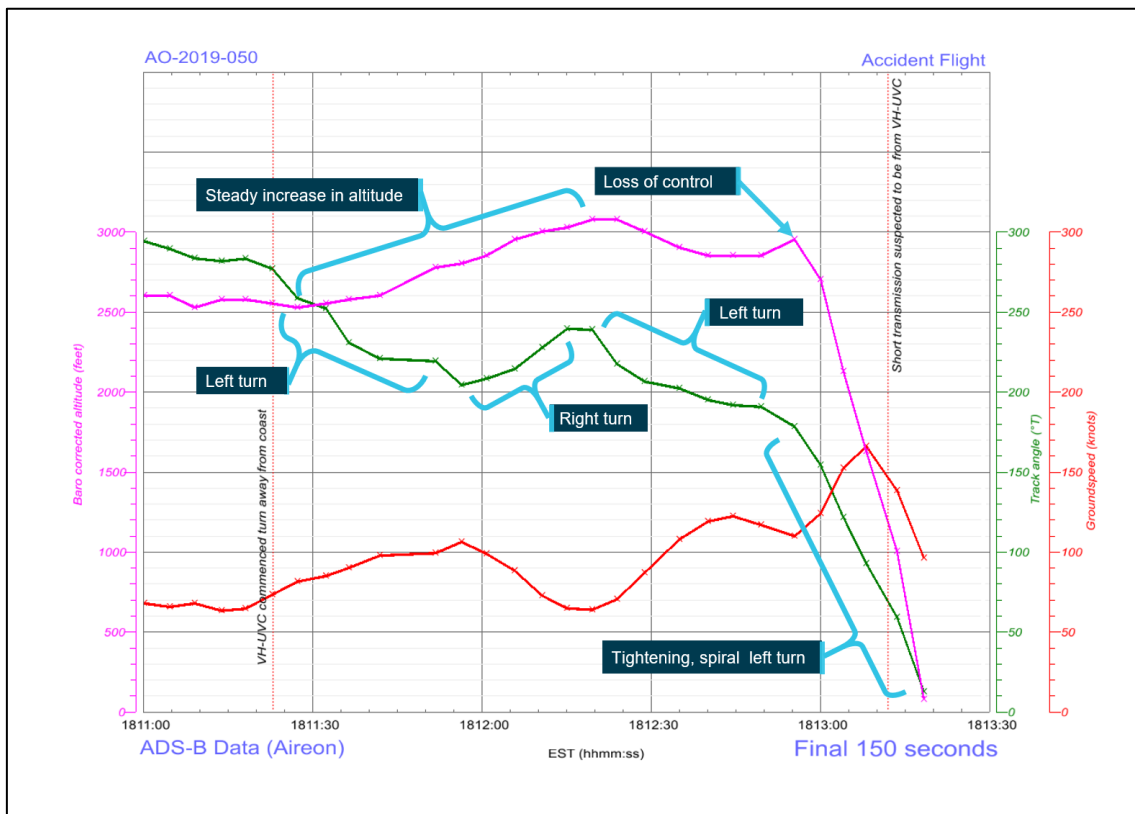
Figure 15: UVC flight parameter variation over the final 150 seconds of flight

Once past Anna Bay, UVC's flight path from the turn to seaward to the spiral descending turn was further examined. The flight path is presented in a graphical format in (Figure 15) with key aspects noted below:

- Based on wind speeds recorded at WLM it is estimated that in the last 14 seconds of the descent, UVC's V_{NE}^{13} limit was exceeded by up to 45 kt.

The turn offshore at 1811:23 was observed on WLM radar. An indistinct transmission, which was assumed by ATC to be from UVC, was heard at 1813:12, about 17 seconds after the loss of control had likely occurred (Figure 15). UVC was observed on radar in a rapid descent from about 2,900 ft, disappearing from WLM radar coverage at 1813:26. By 1813:27, the APP controller had alerted the Tower controller of the unfolding situation, and made two standard radio calls seeking a response from UVC.
