Flight below the minimum safe altitude involving Fairchild SA227, VH-OZV

9 km east of Melbourne Airport, Victoria on 18 January 2021

ATSB Transport Safety Report

AO-2021-003

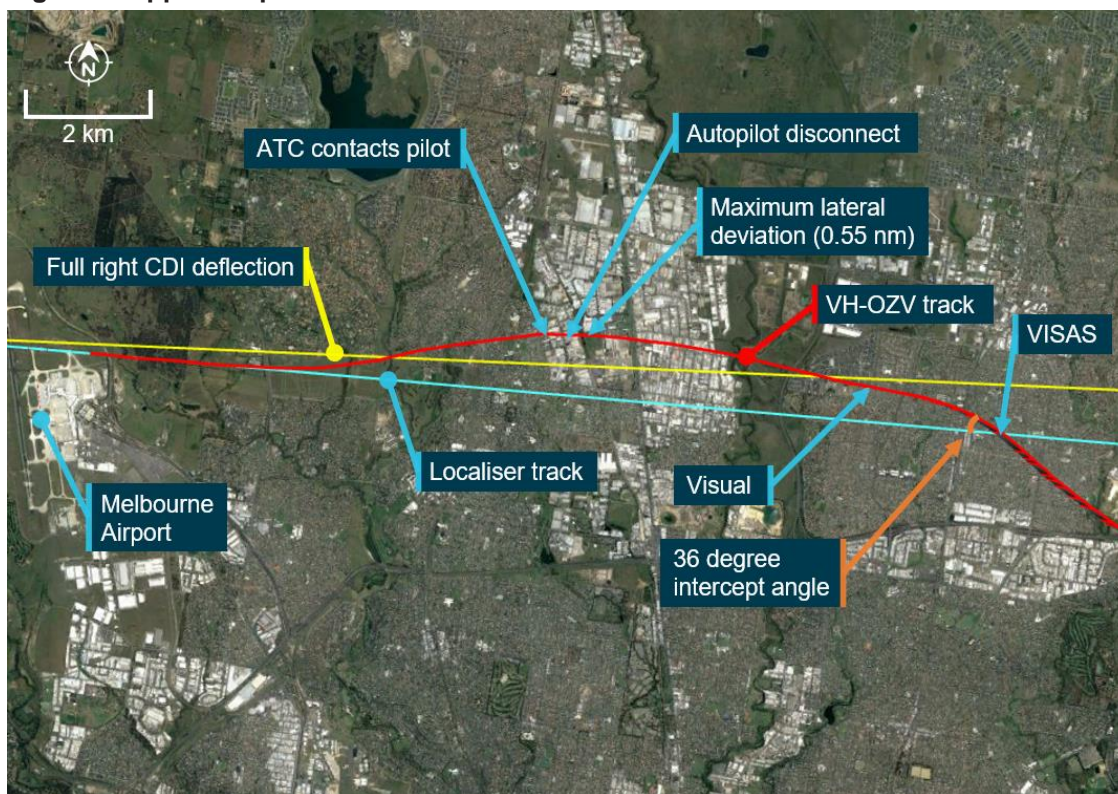
Figure 2: Approach profile

At 2133, as the aircraft approached the ILS localiser track from the south-east, in preparation to intercept the localiser track, the pilot changed the autopilot mode from navigation (NAV) to heading (HDG).² The selected heading, in combination with the prevailing southerly wind, resulted in a 36° intercept angle of the ILS localiser track (Figure 2).

The aircraft crossed the localiser track at the waypoint³ VISAS on a continuation of the intercept angle. After the aircraft crossed the localiser track, the pilot reselected NAV mode to commence the intercept and establish the aircraft on the inbound track. However, the autopilot-commanded turn toward the localiser track did not occur as quickly as the pilot anticipated so HDG mode was again selected with a commanded heading of 250° magnetic. Soon after selecting HDG mode, the aircraft approached the ILS glideslope. The pilot reported that the aircraft was still within half scale of the localiser course deviation indicator (CDI) so commenced descending along the glideslope and extended the landing gear.

At about 2133, the aircraft was descending toward Melbourne Airport prior to commencing a night-time ILS approach to runway 27. The intercept of the ILS localiser track did not begin until after the aircraft had already crossed that track at an angle of about 36°. The southerly wind acting on the westbound aircraft resulted in it quickly deviating to the right of the localiser track.

The pilot reported that they did not observe the CDI exceed full-scale deflection, instead assessing that the visual approach could be continued. Continuing the approach took the aircraft significantly beyond the localiser tracking tolerance at altitudes as low as 980 ft AMSL (2,320 ft below the minimum sector altitude).

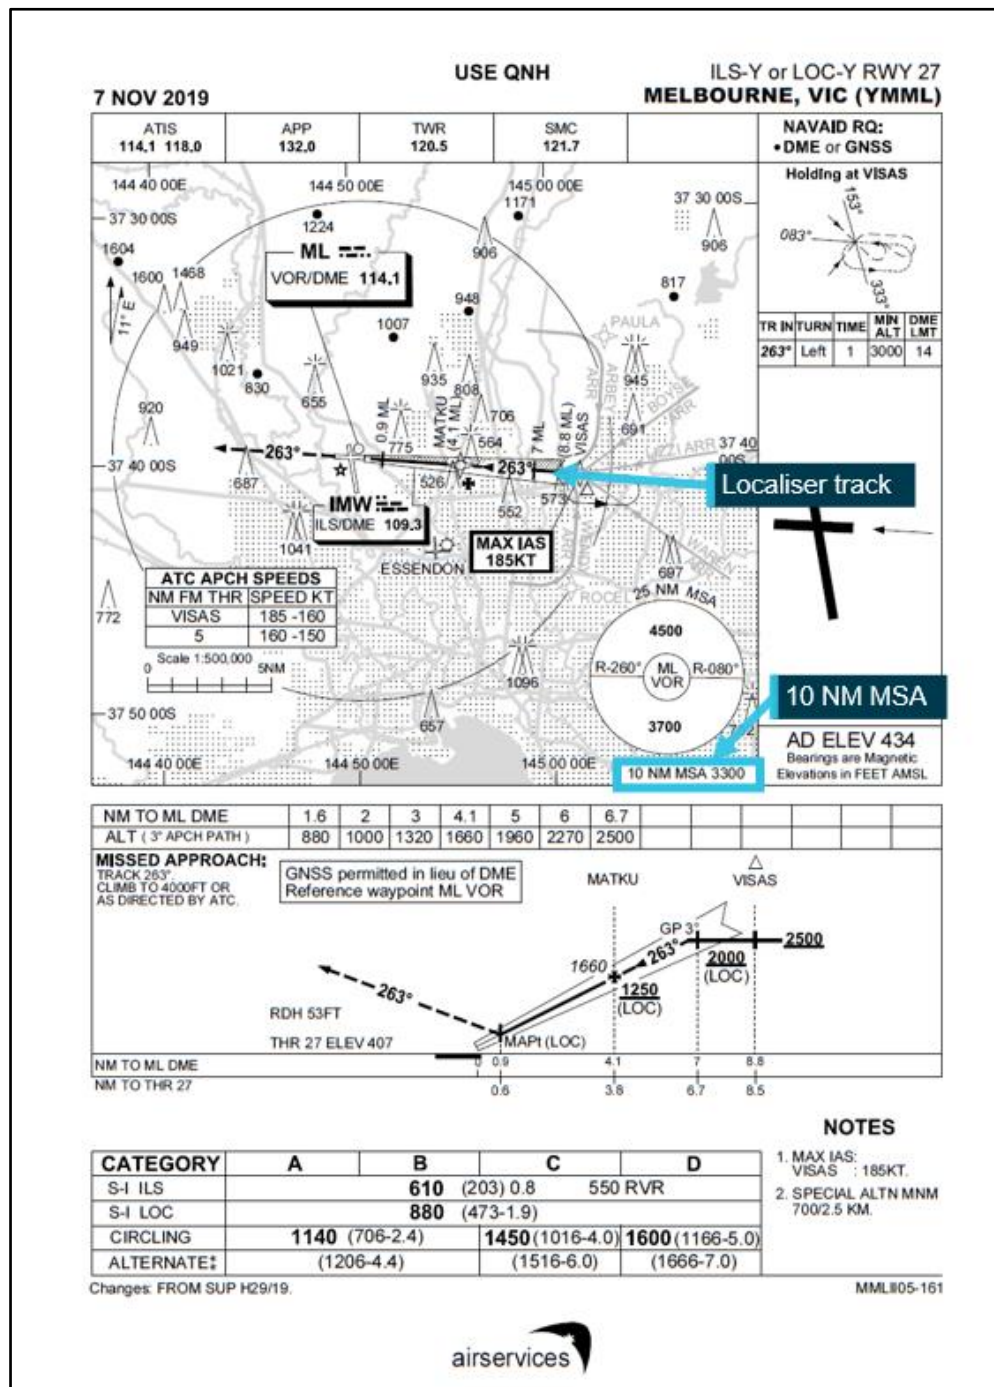
Figure 3: Melbourne Airport runway 27 ILS approach chart

The ILS approach chart (Figure 3) included minimum sector altitudes (MSAs) that provided a minimum terrain clearance of 1,000 ft above all objects located inside a defined area. Within a 10 NM radius of Melbourne Airport, the MSA was 3,300 ft AMSL.
