Collision with water involving Textron Aviation (Cessna) 206, VH-AEE

near Happy Valley, Fraser Island, Queensland on 29 January 2020

ATSB Transport Safety Report

AO-2020-010

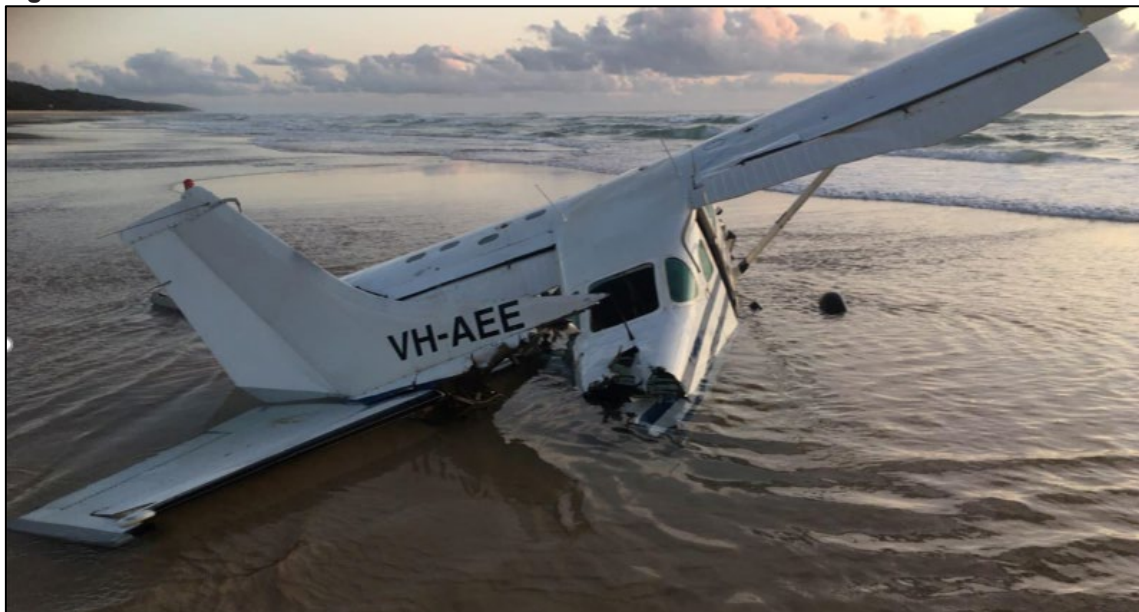
Figure 2: VH-AEE on the beach at Fraser Island

The training pilot then observed the trainee on the other side of the aircraft and after making them swim around the aircraft, put the life jacket on them. The training pilot subsequently put their arm through the life jacket and they both started swimming back to shore. They were met by a paramedic from the Happy Valley ambulance station who had entered the water to assist them to shore. Both pilots suffered minor injuries and the aircraft was destroyed (Figure 2).

It was reported that the aircraft's nosewheel leg was found on the beach on the afternoon of the accident, approximately half-way between where the go-around commenced and where the aircraft collided with water. The aircraft, without the engine, washed up on the beach the morning after the accident. At the time of writing, the engine had not been recovered (Figure 2).

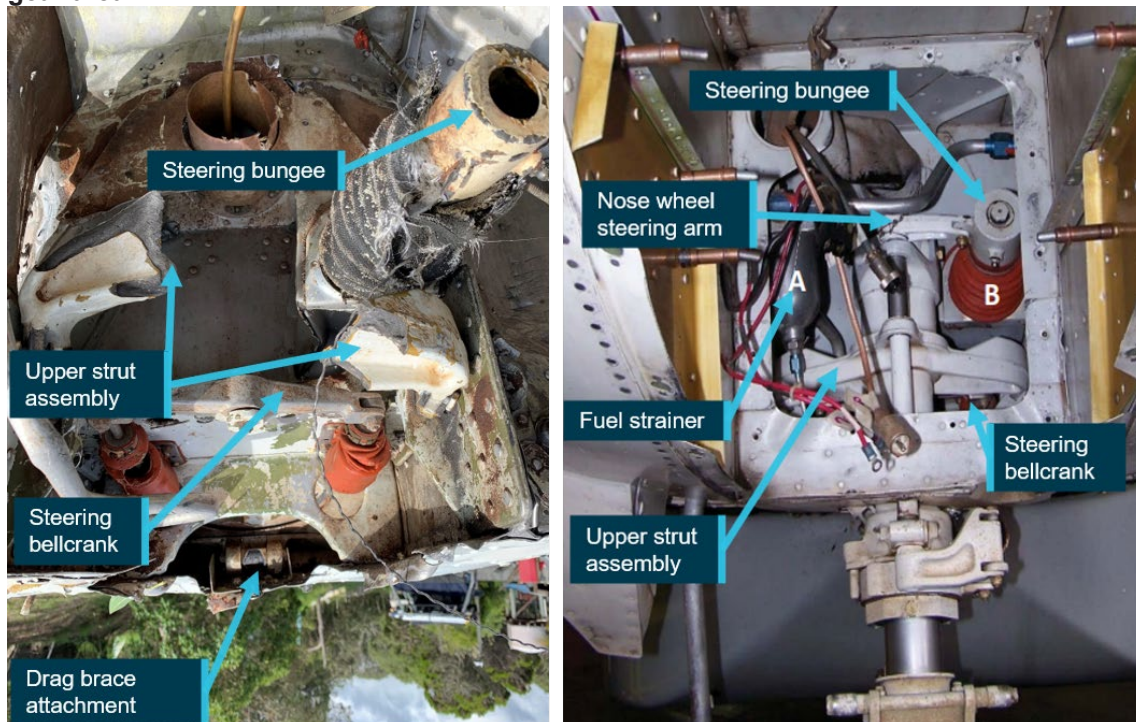
Figure 3 : Nose landing gear area (image rotated 180°) and exemplar C206 nose landing gear area

While the ATSB did not attend the accident site, a review of supplied images identified the following damage to the nose landing gear area (Figure 3 and Figure 4):

- the nose wheel assembly had detached at the upper strut assembly and the steering bungee had separated
- the drag link had fractured at both ends
- both lower trunnion braces had fractured at their attachments
- the fuel line to the fuel strainer had fractured and fuel strainer bowl was missing.

From the photographs of the aircraft, all fractures appeared to be overstress failures with no evidence of pre-existing damage. However, it could not be determined which failure occurred first.

Examination of the nose gear fracture surfaces revealed they were consistent with the attachments failing in overstress, with no indication of a pre-existing fault. It could not be established which part of the nose landing gear failed first nor why the training pilot's rudder pedals were affected as described.

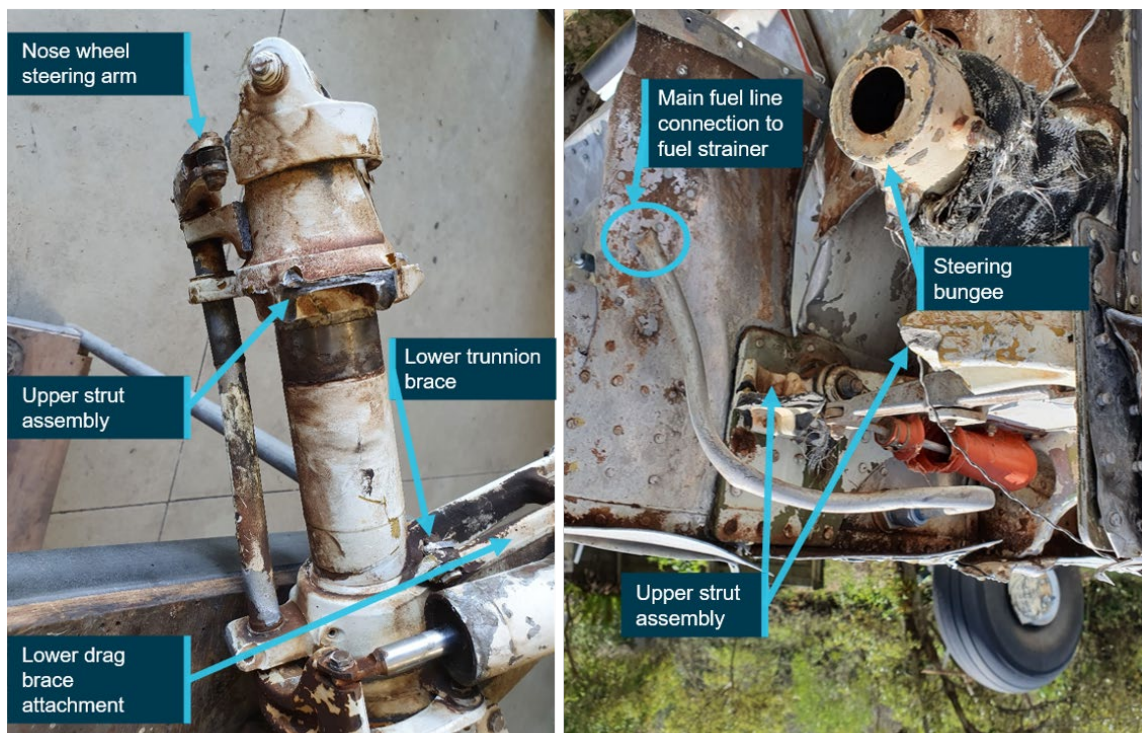
Figure 4: Nose landing gear leg and front of aircraft showing the main fuel line (image rotated 180°)

Supplied images showed that the fuel strainer was missing, and the fuel line that fed the strainer was fractured. These components were in the nose gear bay and directly fed the engine fuel system. Loss of fuel supply at this location would have resulted in almost immediate engine stoppage. As the engine continued to provide power for approximately 1-1.5 minutes after take-off, it is highly probable that the nose gear separated and fractured the fuel line, as the aircraft collided with the water.

It is also possible, although considered less likely, that the damage to the landing gear in turn damaged the fuel strainer/fuel line during the final stages of the flight, again leading to fuel starvation.

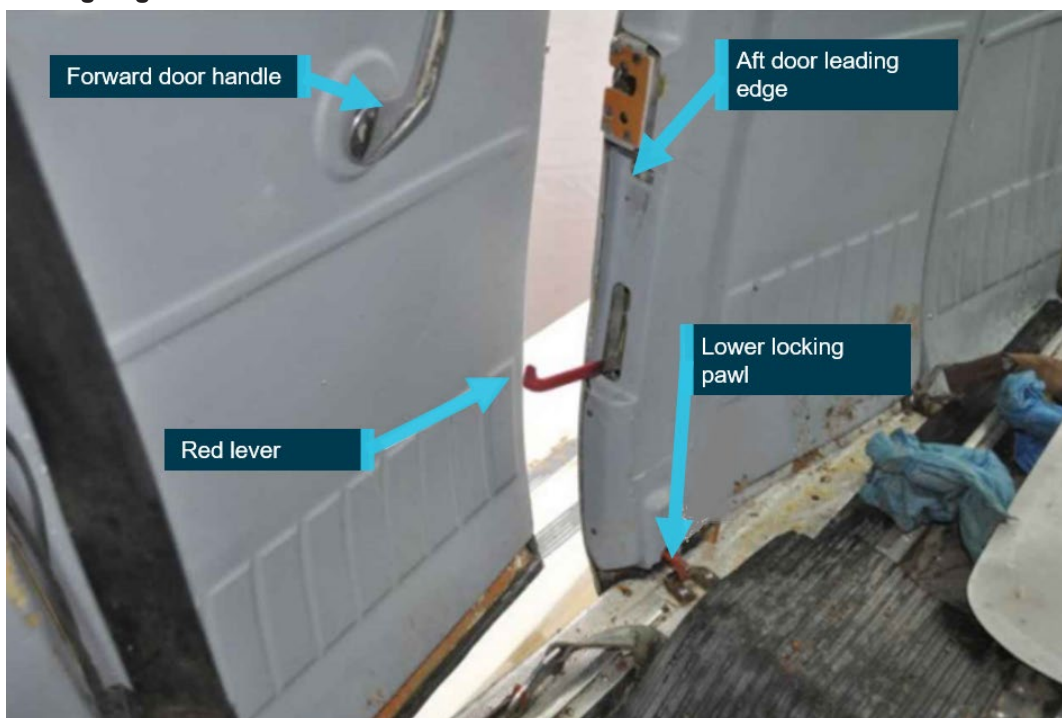
Figure 7: Cessna 206 forward cargo door open showing red lever activated on the leading edge of rear door

A red lever, mounted in the aft door leading edge, is used to unlatch the aft door (see Figure 7: Cessna 206 forward cargo door open showing red lever activated on the leading edge of rear door). However, this lever is in line with the backrest of the right middle row seat. As such, it is difficult to reach for the passenger occupying the middle seat and is again difficult to operate by passengers in the back-row seats.

This image shows an aircraft where service bulletin SEB91-4 has not been incorporated and the red handle does not retract automatically. Before the door can be opened, the red lever is required to be restowed without the door relatching. This is not indicative of the accident aircraft.

A service bulletin was subsequently released by Cessna to improve the red lever operation so that the lever automatically restowed (see Cessna service bulletin *SEB91-4 Cargo door latch improvement* in Australian requirements). Having to keep the forward door open to operate the lever in the forward edge of the aft door, adds to the difficulty of the procedure, especially when attempting to open the doors from the rear seats.
