Avionics system event involving Fokker F100, VH-FNR

West Angelas Aerodrome, Western Australia, on 1 September 2020

ATSB Transport Safety Report

AO-2020-046

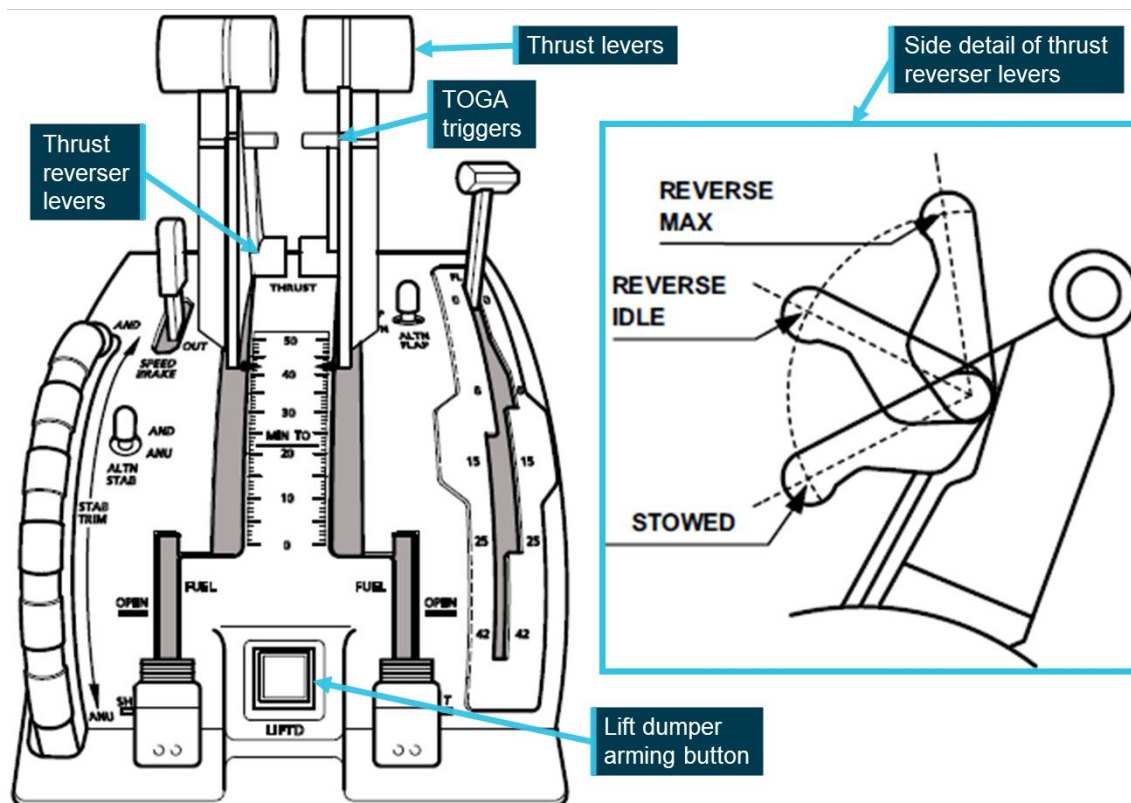
Figure 1: Fokker 100 throttle quadrant

The take-off and go-around modes are selected by pulling two TOGA triggers located on the thrust levers (Figure 1). When pulled in-flight, the go-around mode is selected, and the aircraft will direct a rotation to a safe climb-out pitch attitude and maintain the current heading. The thrust levers are initially advanced to go-around thrust and then managed to maintain a climb rate of 2,000 ft per minute or airspeed of 200 kt. In addition, the speed brake is automatically retracted if it has been extended and the lift dumpers are disarmed.

Each TOGA trigger contains three internal switches that are operated simultaneously when the trigger is pulled. One switch is connected to each of the flight control computers, and one energises relays to inhibit the anti-icing system and disarm the lift-dumpers. It is only necessary for a single trigger to be pulled for the aircraft to respond.

The flight crew reported that the motion to actuate the TOGA triggers was an intentional movement that they did not believe could happen accidentally. With one hand resting on the thrust levers, the two middle fingers would need to be extended down behind the thrust levers to reach under the TOGA triggers and pull them up.

Based on the required hand action and the flight crew's recollection of the incident, the ATSB assessed that the flight crew did not likely activate TOGA mode inadvertently by pulling the TOGA triggers. Rather, the FO's hands would have been in the process of reaching for and lifting the thrust reverser levers.

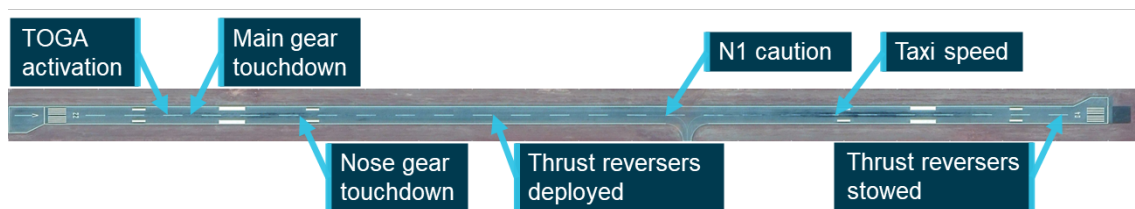
Figure 2: Landing sequence of events

- At the activation of TOGA mode, the aircraft had an airspeed of 126 kt with engines at idle.
- The main landing gear touched down within 0.6 seconds after TOGA mode activation.
- The nose wheel touched down after about 3 seconds, however, it took a further 5 seconds before the aircraft recognised that it was on the ground (had positive weight on wheels), and deployed thrust reversers and lift dumpers.

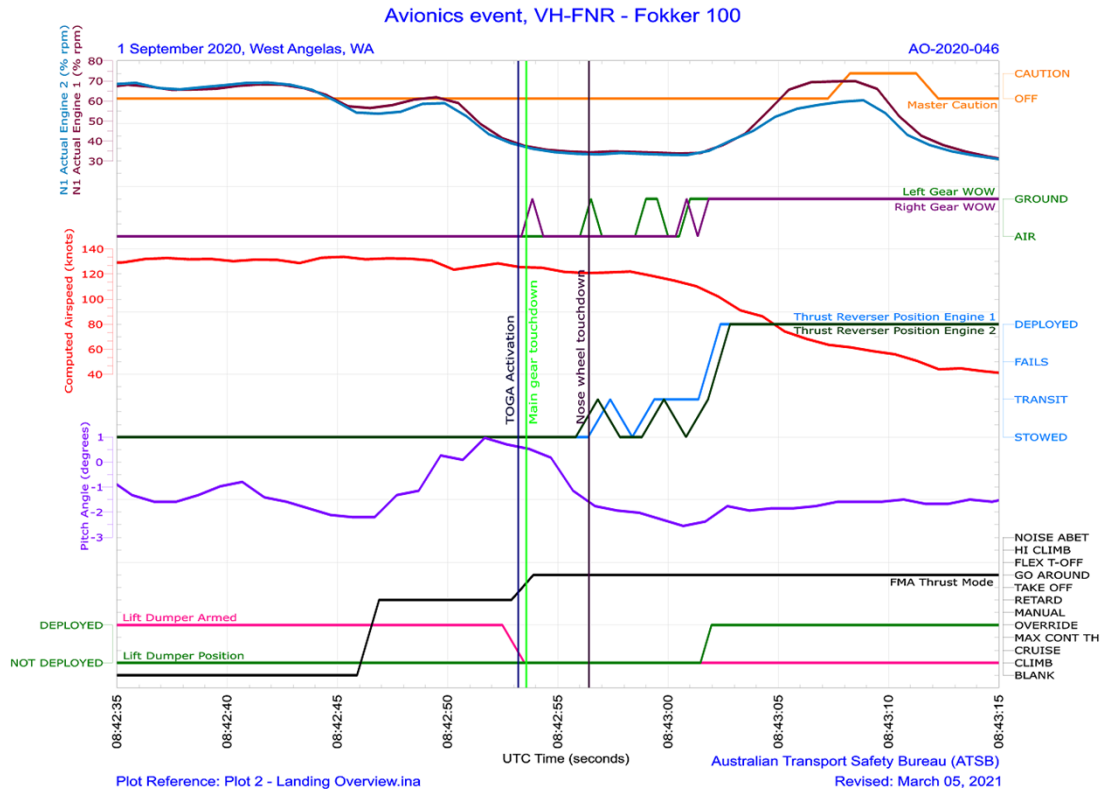
Figure 3: VH-FNR flight data for the landing

The weight on wheels sensors gave an intermittent weight on wheels signal during landing, even after all wheels had touched down. This prevented reverse thrust from being deployed and the lift dumpers from extending manually. While not an issue in this incident, research has shown that a delay in the deployment of reverse thrust and/or lift dumpers have contributed to runway overrun events (Jenkins & Aaron, 2012).

The intermittent signal was most likely due to a softer than typical landing, combined with the lift-dumpers not automatically deploying. Failure of the sensors was unlikely, as the sensors settled to a ground state and no further incidents with the sensors had been recorded at the time of publication of this report.
