Collision between light engine LET0 and empty coal train EE16

Westwood, Queensland, on 18 June 2021

ATSB Transport Safety Report

RO-2021-007

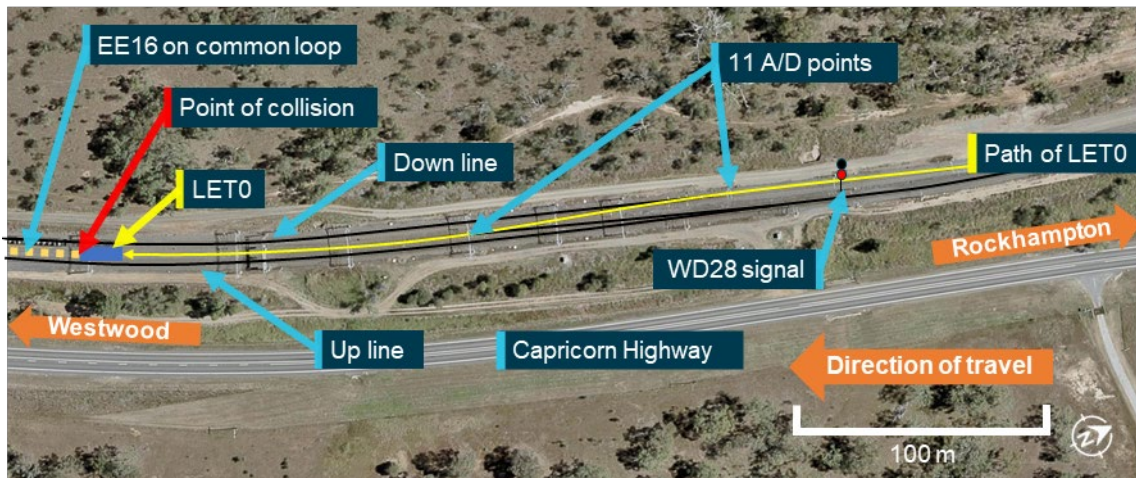
Figure 2: The route of LET0 into Westwood common loop

At 1107, the NCO set up the route for LET0 to travel to Westwood signal WD28, located to the east of Westwood (Figure 2). The NCO planned to route LET0 via the Westwood common loop and then for all traffic (EE16 and LET0) to travel via the Up line from Westwood to Windah. The signal interlocking system was set up to show a yellow (caution) aspect in the approach signal WD28P and a red (stop) aspect in WD28. That meant that LET0 would be required to stop at signal WD28 outside Westwood until EE16 had vacated the common loop, at which time the signal aspect in WD28 would change to proceed.

At 1119, while LET0 was travelling towards Westwood, the NCO set the 11 A/D points as planned from the Down line into the common loop at Westwood in preparation for the locomotive to enter the common loop after EE16 had departed (Figure 2).

The yellow solid line within the image shows the path of the locomotive on approach and after passing signal WD28.
Source: Queensland Globe, annotated by the ATSB

At 1125:43, a SPAD (signal passed at danger) alarm was generated in the Aurizon network control centre, indicating that LET0 had passed signal WD28 while it was displaying a red (stop) aspect.

At 1125:46, LET0 entered the 11 A/D points. The locomotive's data logger showed that it entered the 50 km/h turnout⁶ from the Down line to the common loop at approximately 72 km/h.

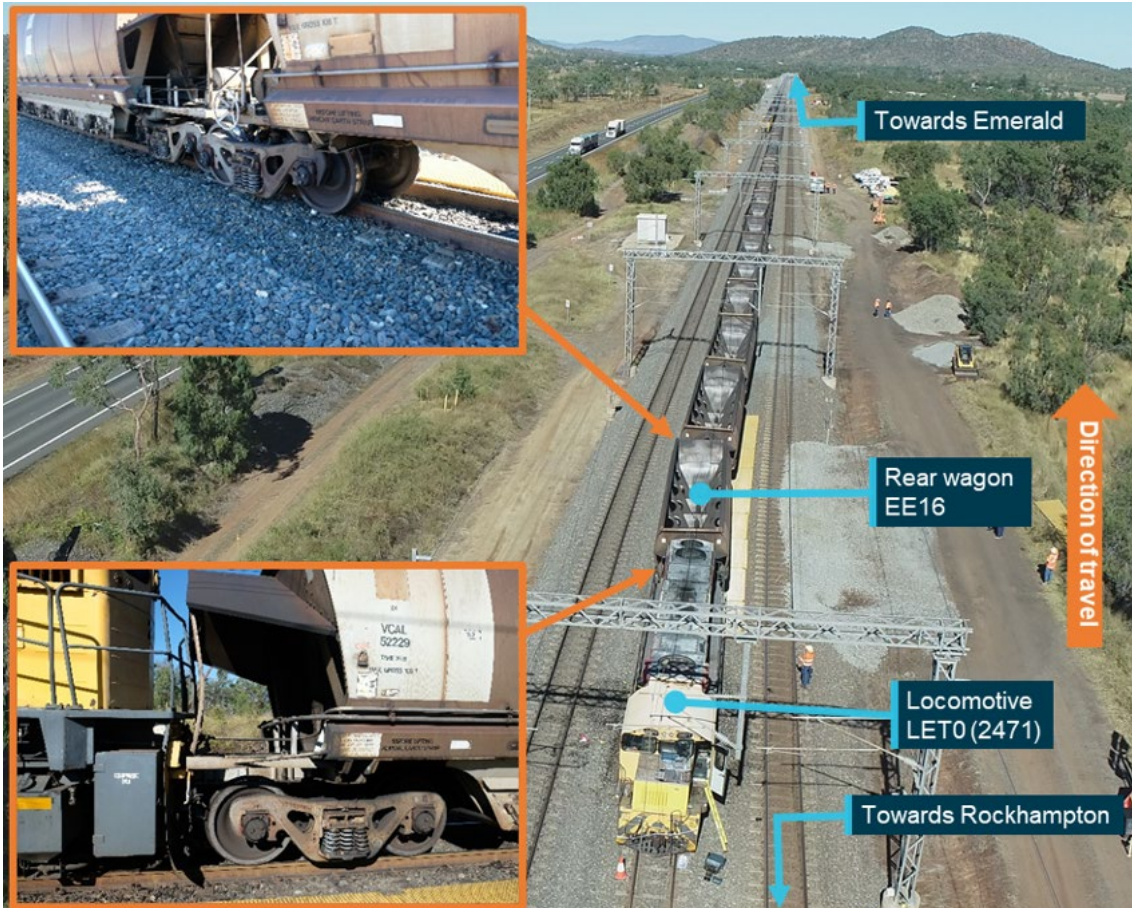
Figure 3: Collision site at Westwood, Queensland

At 1125:59, LET0 collided with the rear of EE16 at a speed of approximately 44 km/h. The collision occurred just after the locomotive entered the Westwood common loop. Figure 3 shows the collision point between the locomotive and the coal train on the common loop (centre track) of the three-track Westwood yard.

The locomotive and the last nine wagons of the coal train sustained significant damage from the collision. The driver was fatally injured, the co-driver sustained serious injuries and the tutor driver received minor injuries.

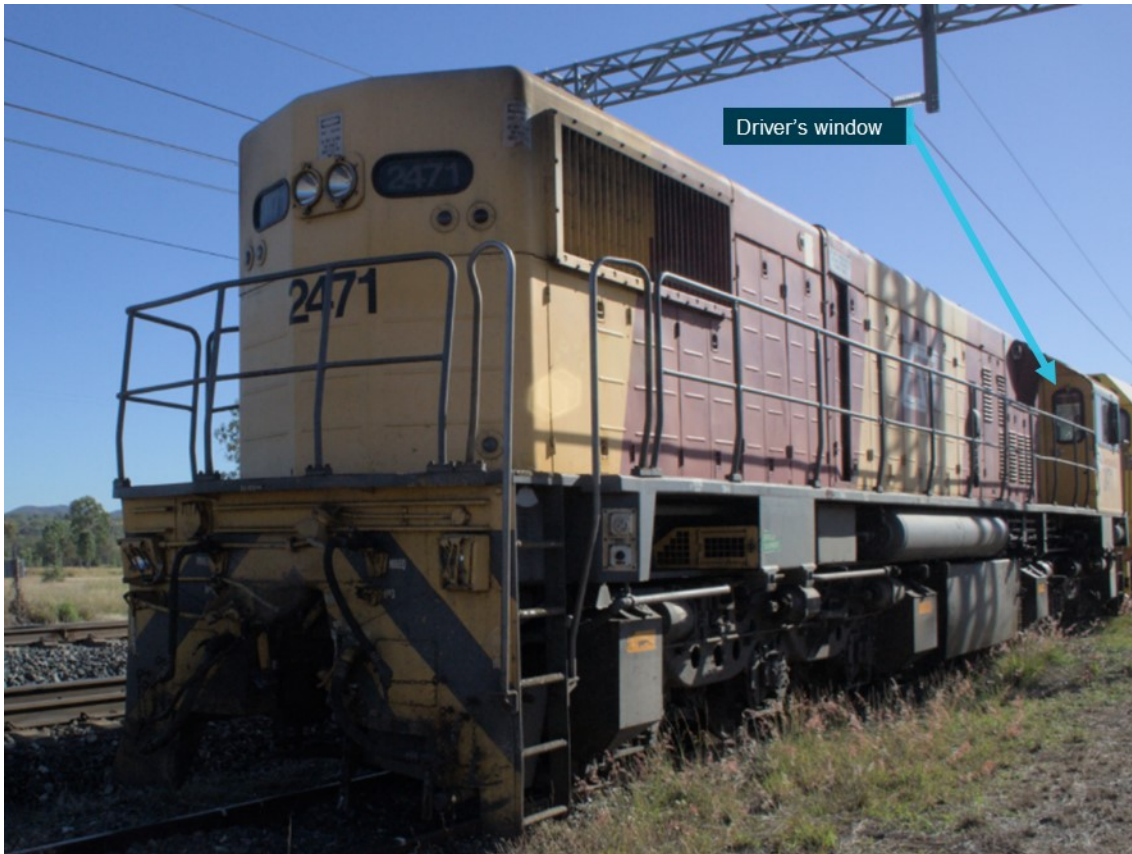
Figure 7: Driver's viewport when long end leading

'Long end leading' occurs when a locomotive travels with the driving cabin at the rear for the direction of travel. Figures 7 and 8 shows the limited view for the driver during this method of operation on a 2470 class locomotive, with a significant amount of the forward view being obstructed by the leading portion of the locomotive and the back wall of the cabin.

On 21 June 2021, QR suspended all mainline long end leading operations both on its own network, and as an operator of its trains on other networks. Permitted operations for long end leading were limited to shunting, turning of a locomotive, setting back and propelling movements.

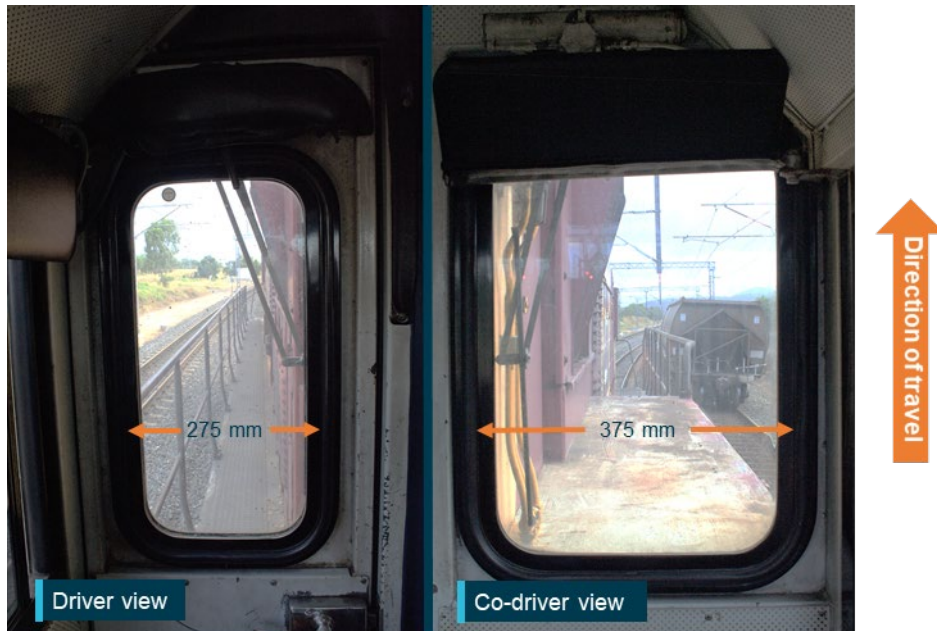
Figure 8: View from inside the cabin from driver and co-driver perspective with long end leading

The image on the left shows the driver's view from the locomotive's active driving station when long end leading. The image on the right shows the view from the co-driver's seat when long end leading.
Source: ATSB

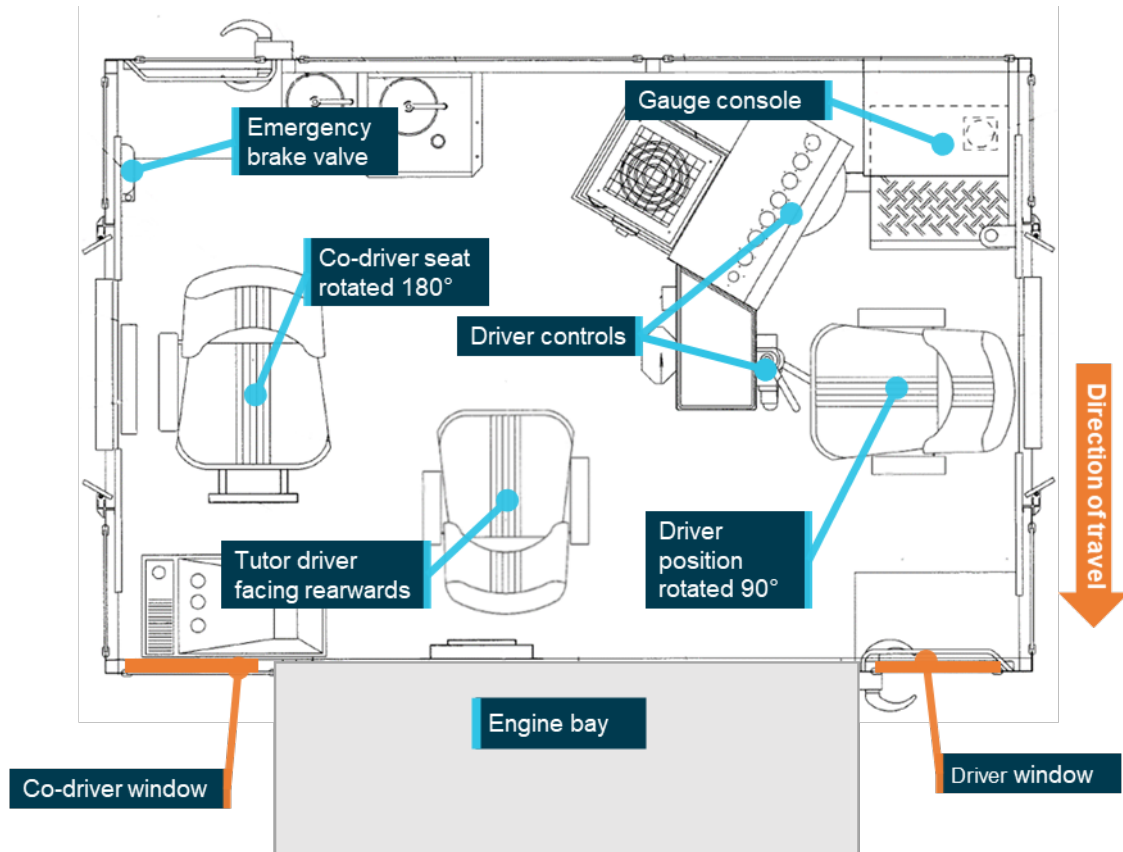
Figure 9: Plan view of driver’s cabin configured for long end leading

Figure 9 is a plan view of the driver's cabin configured for long end leading. The driver's position was such that they were required to face 90° to the direction of travel to enable use of the driver

controls. The driver’s attention was split between the driver controls, the gauge console and the view ahead.

The co-driver’s seat was rotated 180°. The co-driver was relied upon to convey observations to the driver because the driver’s view was obscured on the right side of the locomotive. When the co-driver was positioned this way, they could no longer reliably operate the emergency brake valve without moving from their seat.

On LET0, the tutor driver’s temporary seat was positioned as shown in Figure 9. They were facing rearward in relation to the direction of travel and had no forward view.
