# Engine failure and collision with water involving Garlick Helicopters UH-1H, VH-ONZ

Ben Boyd Reservoir, New South Wales, on 9 January 2020

## **ATSB Transport Safety Report**

AO-2020-003

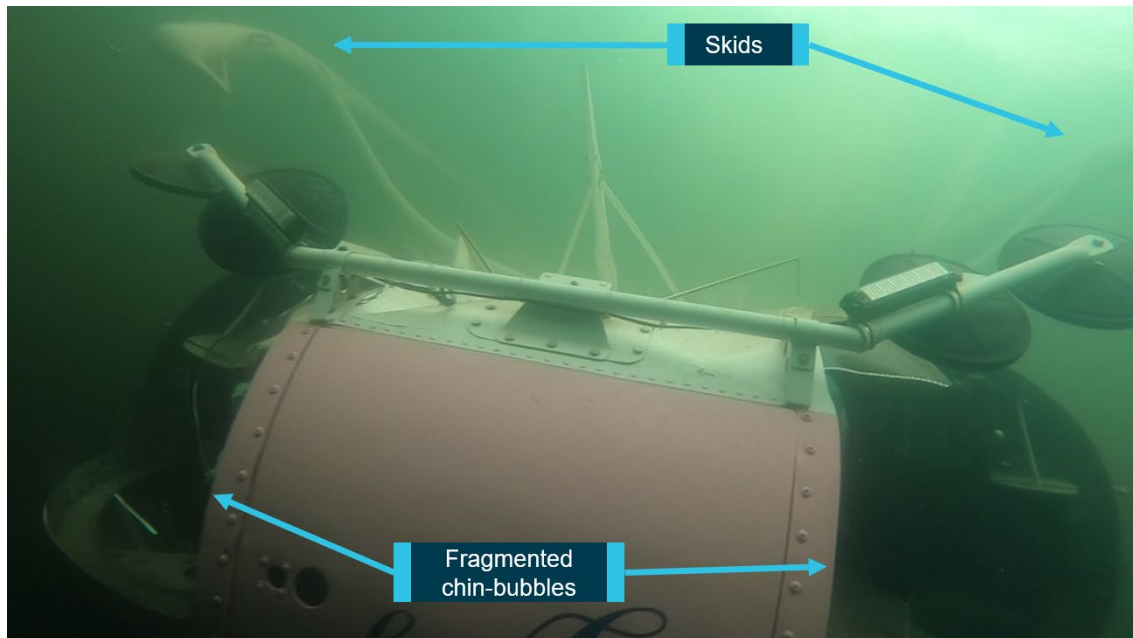
**Figure 2: Helicopter inverted in reservoir**

The pilot reported making several emergency broadcasts and using all the main rotor energy available to reduce the rate of descent before the helicopter impacted the water in what was described as a ‘belly-flop, straight down’. On impact, the chin-bubbles fragmented, and the helicopter rolled inverted, filled with water, and sank (Figure 2).

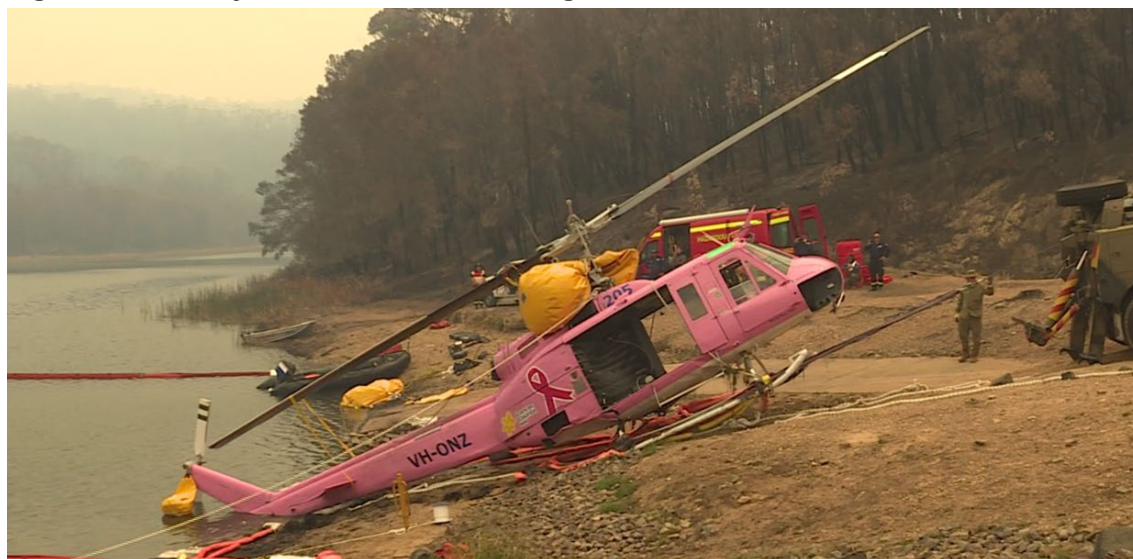
**Figure 3: Recovery of VH-ONZ - cabin sliding doors removed**

After exiting the cabin, the pilot inflated the lifejacket, swam to shore, and then walked about 1 km to a road to be collected. About 15 minutes later, an ambulance arrived to take the pilot to hospital for a medical examination. The pilot sustained a minor injury, and the helicopter was substantially damaged and later recovered from the reservoir (Figure 3).

Following the recovery of the helicopter from the reservoir, the operator checked the pilot and co-pilot doors and found that they were both jammed due to airframe distortion and could not be opened. The rear of the airframe was less distorted, and the cabin doors could be opened.

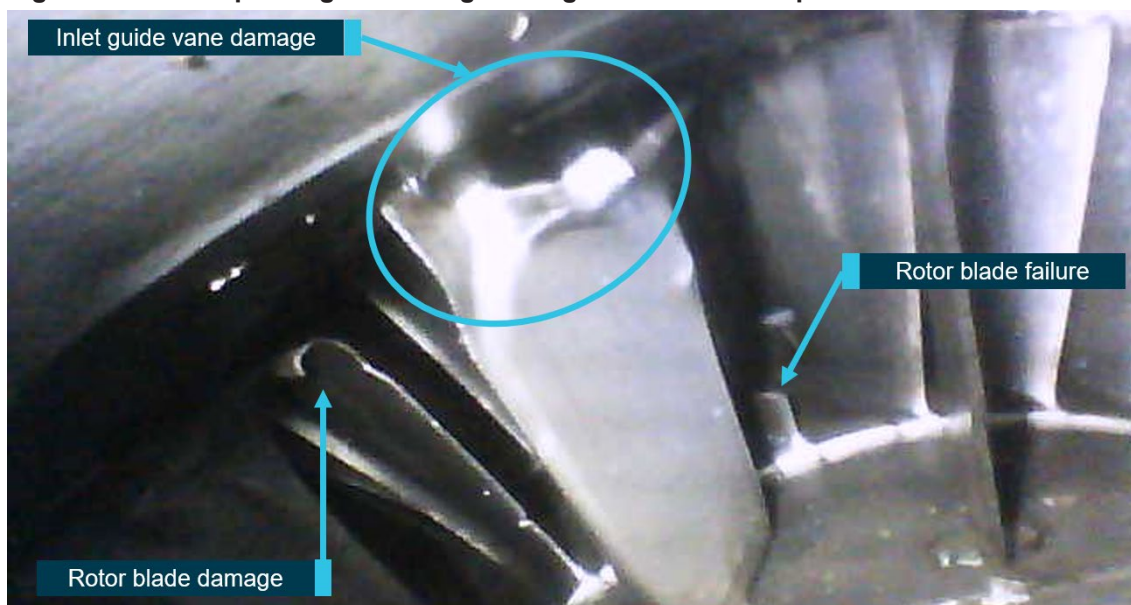
**Figure 5: Borescope image of damage to engine inlet and compressor**

Following recovery of the helicopter from the reservoir, the engine was inspected by the operator's maintenance organisation. A borescope inspection of the engine compressor section revealed a rotor blade failure in addition to other rotor blade and inlet guide vane damage (Figure 5). The engine was sent to Honeywell Engines in the United States for a teardown inspection and failure analysis. The following engine information sections summarise their findings.

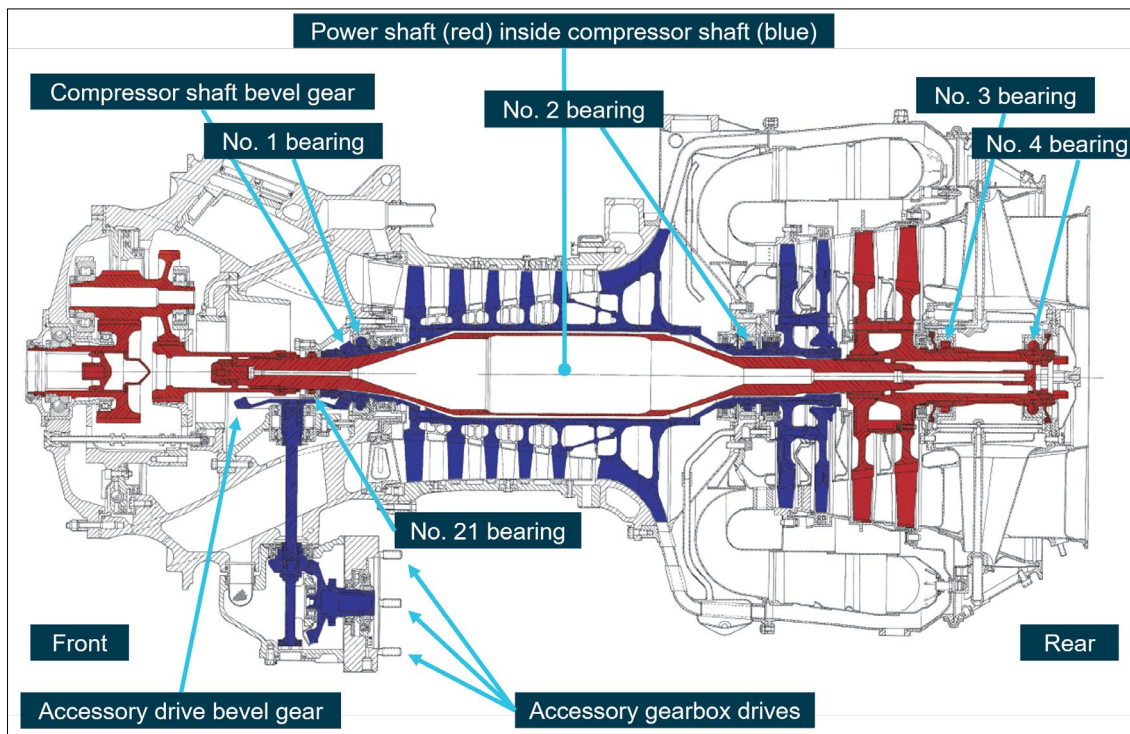
**Figure 6: Cross-section of a T53-L-13 engine showing the location of the main components and bearings**

Honeywell's examination found that the bearings at the front of the engine (no. 1 compressor shaft bearing and no. 21 power shaft bearing) had failed and exhibited excessive heat damage (Figure 6). However, the main bearings located at the rear of the engine (no. 2, no. 3 and no. 4) did not exhibit this damage. This indicated that a reduction in oil flow had occurred to the front section.

Figure 6 depicts the compressor (N1 in blue) and power (N2 in red) sections of the engine, the locations of the main bearings for the front (no. 1 and no. 21) and rear (no.2, no.3 and no.4) sections, and the accessory drive system (includes drives for the oil pump and fuel control).

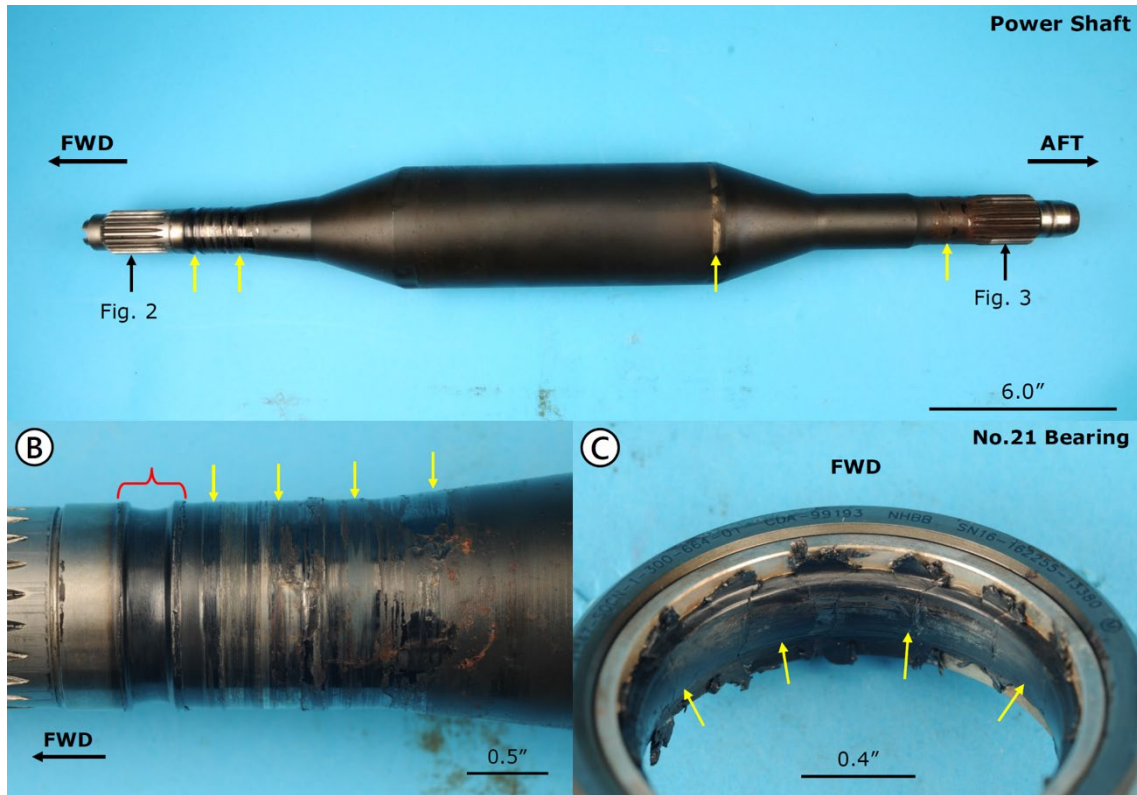
**Figure 7: Damaged power shaft and no. 21 bearing**

- Lubrication oil to the no. 21 and the no. 1 bearings was reduced or blocked.
- The no. 21 bearing began to overheat and fail, resulting in excessive heat being generated in the power shaft and nearby components.

- The forward compressor shaft seal assembly began to fail resulting in additional heat input to the nearby components.
- The no. 1 bearing began to fail due to excessive heating.

- Due to the no. 1 bearing failing, the forward end of the compressor shaft was no longer properly retained. This allowed contact between the compressor and power shafts as well as axial compressor blade tip contact with their respective shrouds. This likely resulted in the 'grinding noise' heard by the pilot shortly before the loss of engine power.

Figure 7 depicts the damage found to the power shaft (top and bottom left) and no. 21 bearing (bottom right). The yellow arrows depict wear, and the red bracket (bottom left) depicts a groove in

the shaft at the location of the no. 21 bearing. Figure 8 depicts a comparison no. 21 bearing fitted to its power shaft bearing retainer.

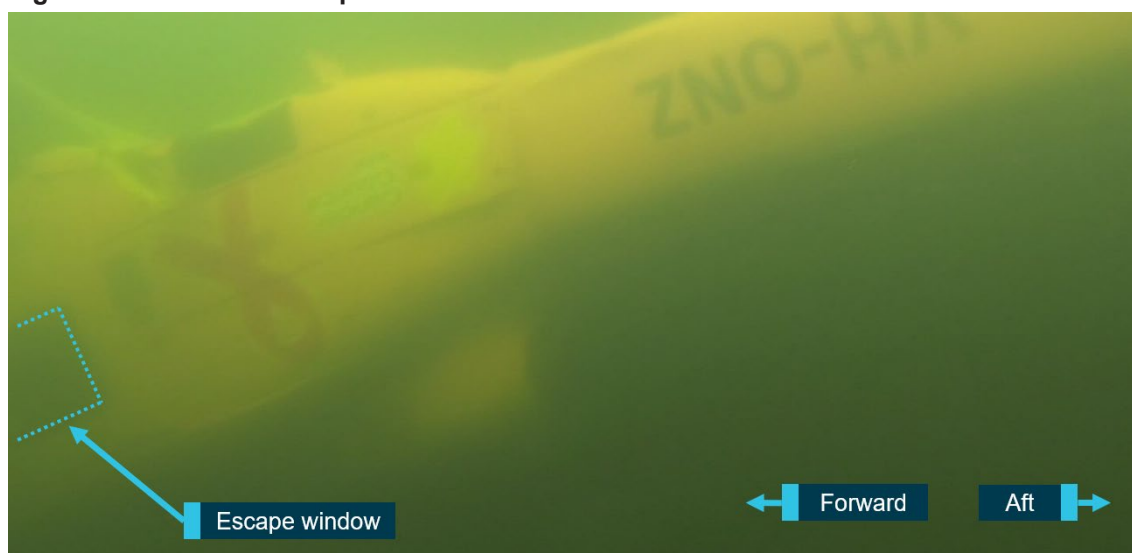
**Figure 9: Location of escape window**

Figure 9 depicts the helicopter inverted in the reservoir and the location of the right sliding door rear window, used by the pilot for the underwater escape.
