# **Derailment of SCT Logistics freight train 2PM9**

near Koolyanobbing, Western Australia on 27 October 2020

**ATSB Transport Safety Report**

RO-2020-018

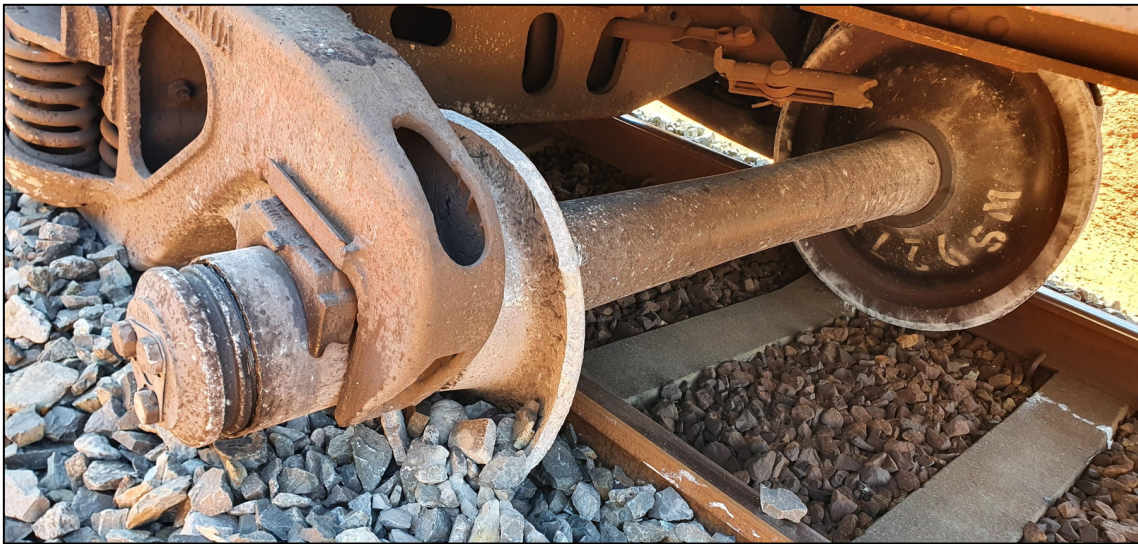
**Figure 1: The derailed wheelset on ARFY2253s**

On the morning of 27 October 2020, train 2PM9, operated by SCT Logistics, departed Perth, Western Australia for Melbourne, Victoria. The train was 1,658 metres long, and consisted of 2 locomotives hauling 68 wagons, with a trailing load of 3,690 tonnes. At 0816 Western Standard Time,<sup>1</sup> the train was approaching a restricted speed zone and the driver applied the automatic brakes. At 0841, while approaching Koolyanobbing, the trailing left wheel on wagon ARFY2253s fragmented, and two large pieces of the wheel were ejected. ARFY2253s was the 58th wagon in the consist. The wagon's braking system used a WF2 triple valve, and the wagon was unloaded with a tare mass of 30.84 tonnes. The train continued without incident, and the driver applied the dynamic brake in preparation for an upcoming turn. At 0843, approximately 3.5 km beyond the initial wheel fragmentation, a third piece of the wheel was ejected, and the wagon derailed (Figure 1).

At this point, the crew observed dust towards the rear of the train, and applied both the dynamic and automatic brakes until the train came to rest at 0846. Upon inspection it was found that ARFY2253s and the trailing ten wagons had separated from the train. No other wagons derailed. Track damage was observed over a distance of 2.4 km between the wagon derailment and its stopping point.

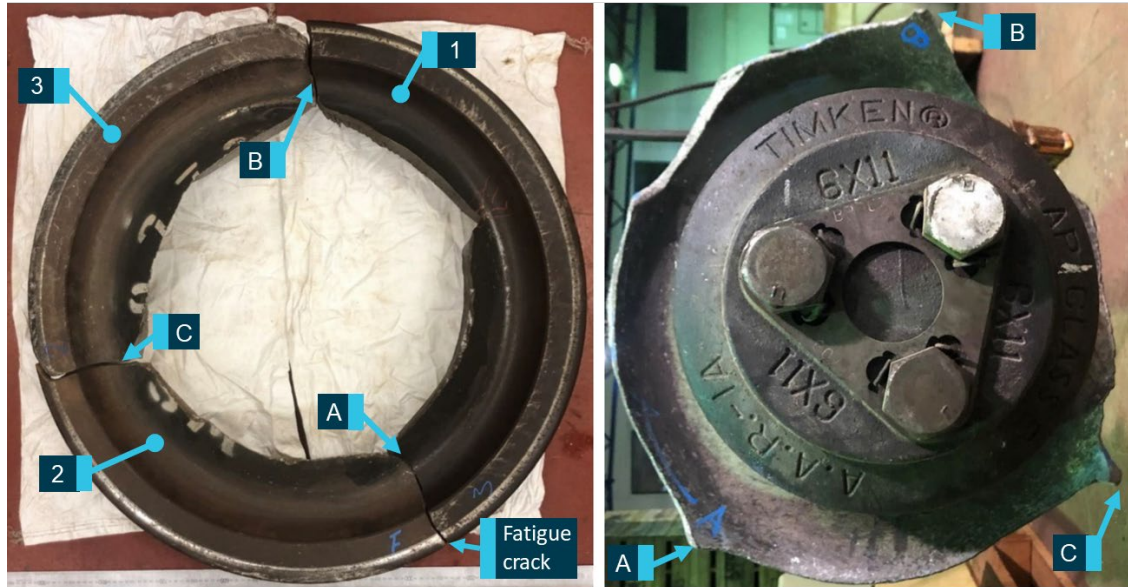
**Figure 2: Reassembled wheel fragments (left) and wheel hub (right)**

Figure 2 shows the recovered fragments of the rim, labelled 1-3, and the three fractures that separated the different pieces, labelled A-C. Fragments 1 and 2 were the first to be ejected from the wheel during the incident journey, with fragment 3 ejected after the brakes were applied.

The skid marks, flat spot and heat-affected regions at fracture A (Figure 2) all indicated that a skidding event occurred at this location, probably when the automatic brakes were applied before the restricted speed zone. This skidding event would have generated considerable heat, and the heat tint observed on the fracture surface is evidence that the brittle cracking occurred at the same time as this heat generation. It is therefore likely that the skidding event induced the brittle cracking at fracture A. Once the brittle cracking commenced, it quickly propagated through the wheel, resulting in the failure and subsequent derailment.

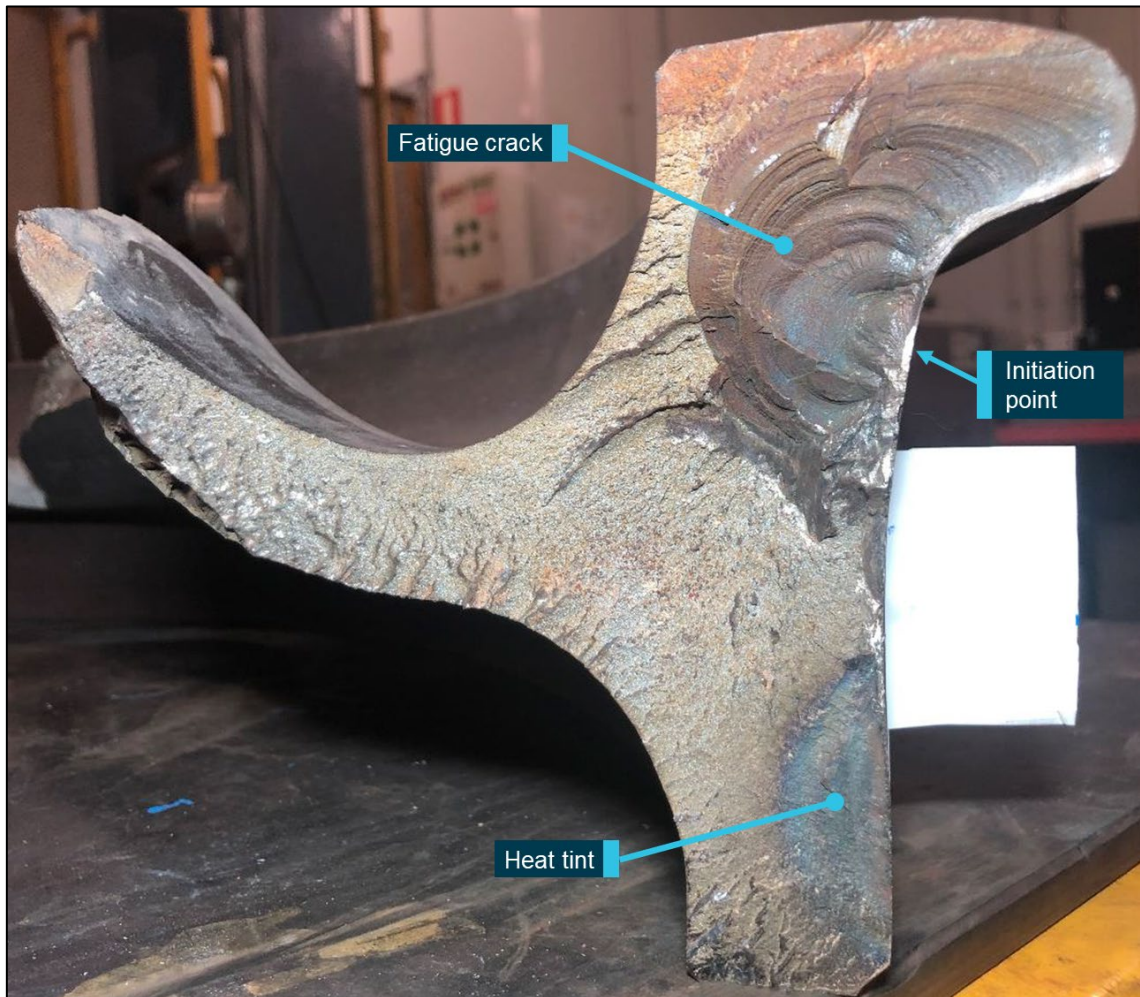
**Figure 3: Fracture A on fragment 1 of the wheel**

The Bureau Veritas analysis identified a fatigue crack at the surface of the wheel, within fracture A (Figure 3). The fatigue crack presented as a darkened region on the fracture surface, with distinct beachmarks indicating crack propagation into the wheel rim and flange from the initiation point on the surface. The fatigue appeared to have propagated through approximately 40 per cent of the wheel rim's cross section. Bureau Veritas made no comment on the age of the fatigue crack.

The Bureau Veritas report concluded that the wheel failure originated from this fatigue crack. At some point, the fracture mode changed from fatigue to brittle cracking, indicated by the colour and surface texture change between the fatigue crack and the rest of the wheel cross section. The brittle cracking progressed towards the wheel hub. It then propagated circumferentially around the wheel, branching out to the wheel surface, resulting in the ejection of the three wheel fragments.

A heat tint mark was also present on the fracture surface. Heat tinting such as this is indicative of oxidation, a result of freshly exposed steel that is subjected to heat and oxygen. The Bureau Veritas examination also identified skid marks on the wheel surface near fracture A.

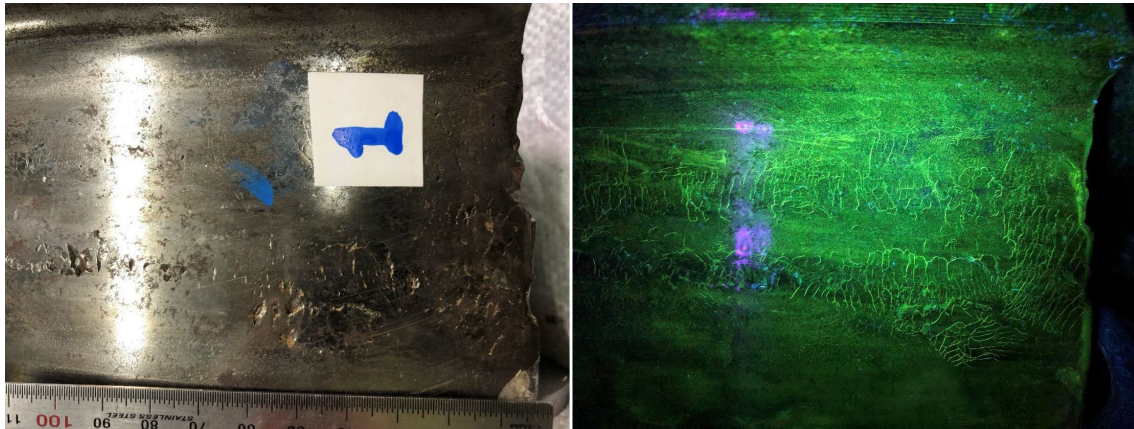
**Figure 4: Wheel surface adjacent to fracture A**

In addition to skid marks, the wheel surface near the fatigue crack had multiple spalls and gouges (see Figure 4). Fluorescent magnetic particle inspection also revealed multiple transverse and longitudinal cracks around these surface defects. Several cracks were found that extended below the wear condemning limit<sup>2</sup> of the wheel rim.

The left image shows the various spalling and gouging observed on the wheel surface. The right image shows numerous surface cracks under fluorescent magnetic particle inspection.  
Source: Bureau Veritas, modified by ATSB
