Collision on runway between Extra EA-300 aeroplane, VH-EXR and Guimbal Cabri G2 helicopter, VH-LTO

Caloundra Airport, Queensland, on 18 September 2020

ATSB Transport Safety Report

AO-2020-051

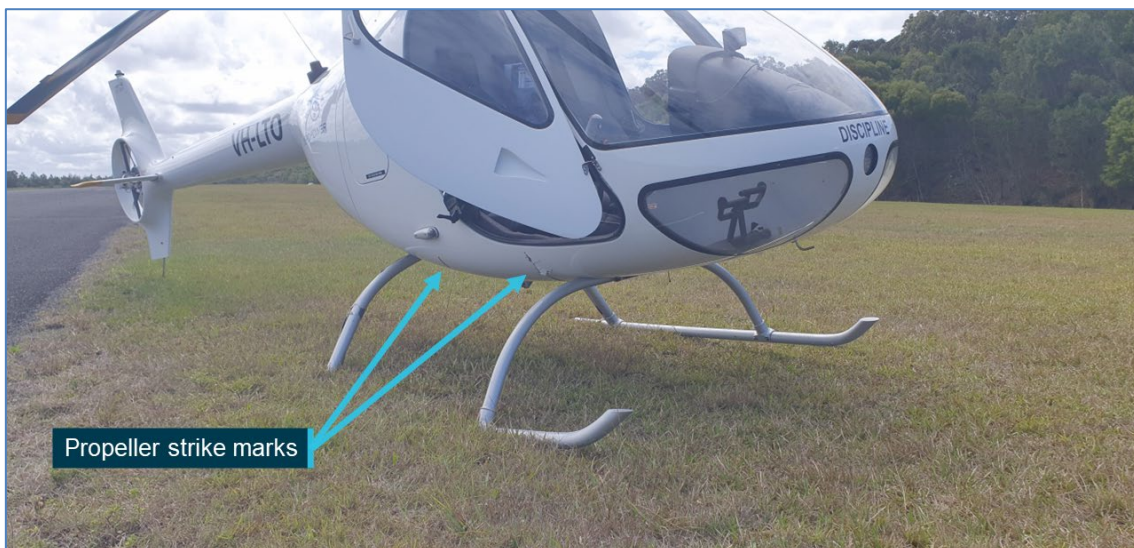
LTO sustained multiple propeller strikes underneath the cabin and separation of the right landing skid (Figure 1).

Figure 1: Propeller strike mark and skid damage to VH-LTO

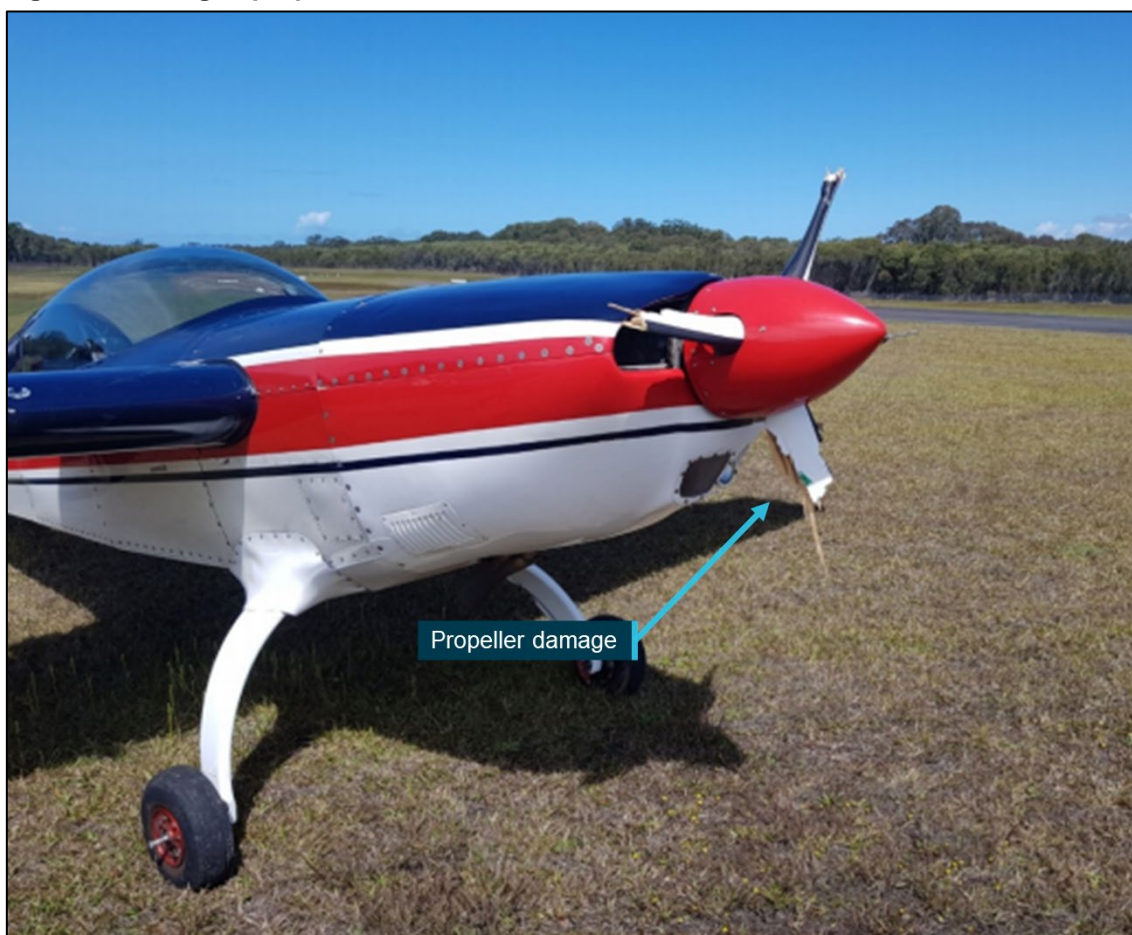
The propeller of EXR was destroyed by the impact with the fuselage and landing skid of LTO (Figure 2). The right landing skid of LTO punctured the leading edge and fuel tank of the right wing of EXR (Figure 3). The rear seat pilot reported that the after impact the canopy of EXR was covered in fuel. There were no injuries.

Figure 2: Damaged propeller of VH-EXR

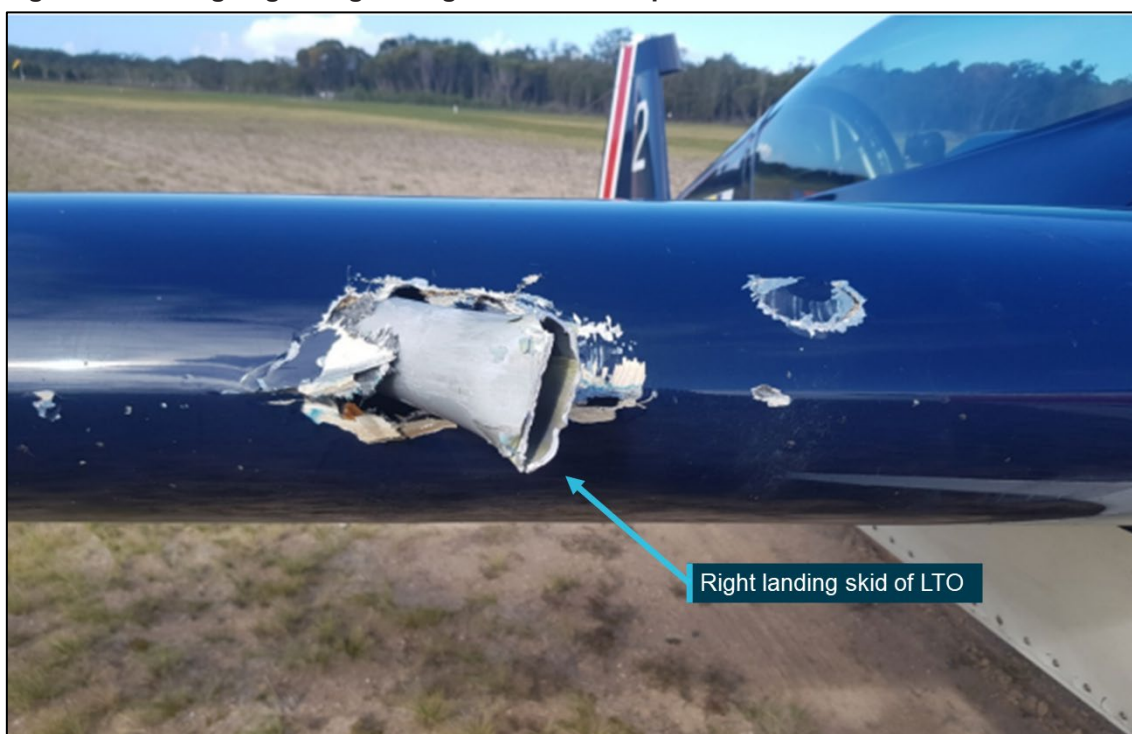
Figure 3: Leading edge wing damage and fuel tank puncture of VH-EXR

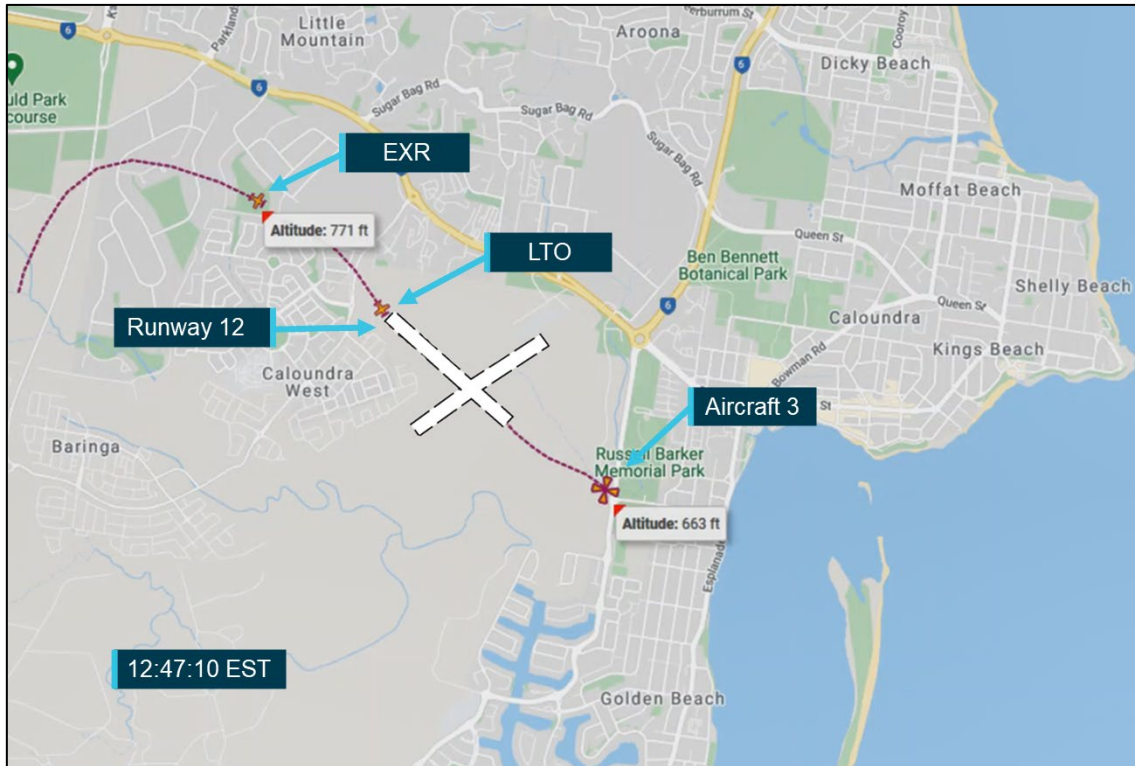
- Aircraft 3 was airborne and departing runway 12
- LTO on late final for runway 12
- EXR on early final for runway 12

Figure 5: WebTrak data snapshot with aircraft positions prior to collision at 12:47:10
